AIC 15-1003

**PAPUA NEW GUINEA
ACCIDENT INVESTIGATION COMMISSION
SHORT SUMMARY REPORT**

RP-C5058

Wire strike

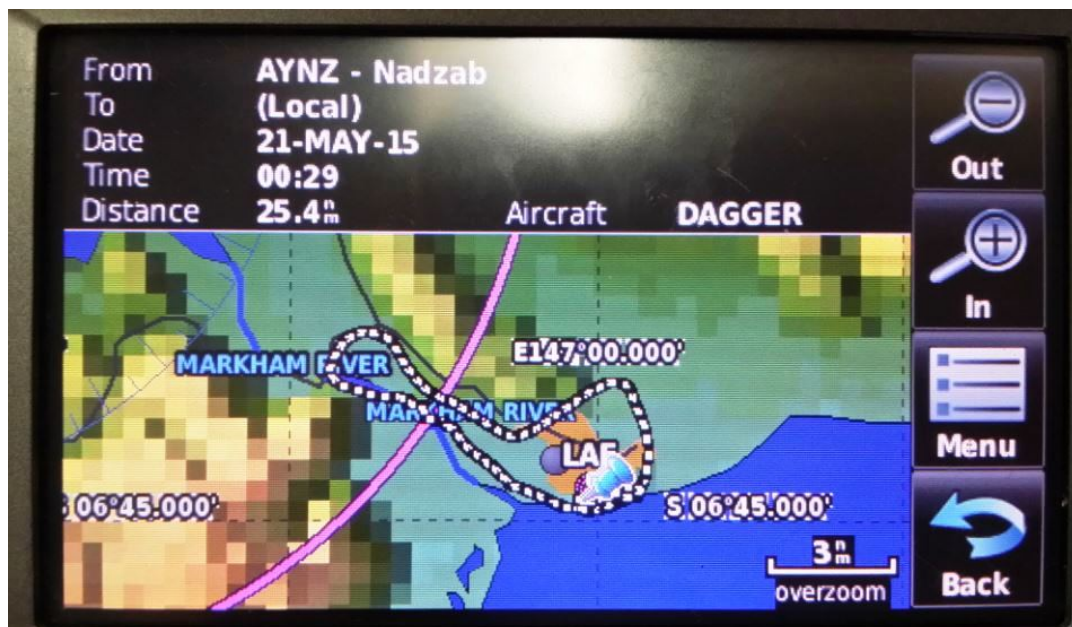
Approaching Lae it turned left and tracked to near Igam Barracks and made a right turn and tracked south to the mouth of the Bumbu River. During the flight the helicopter entered Nadzab controlled airspace without an air traffic control clearance. The flight lasted 29 minutes and covered 25.4 nm. The investigator checked the GPS settings and confirmed that the date/time settings were accurate.

Figure 1: GPS recorded data for 21 May 2015

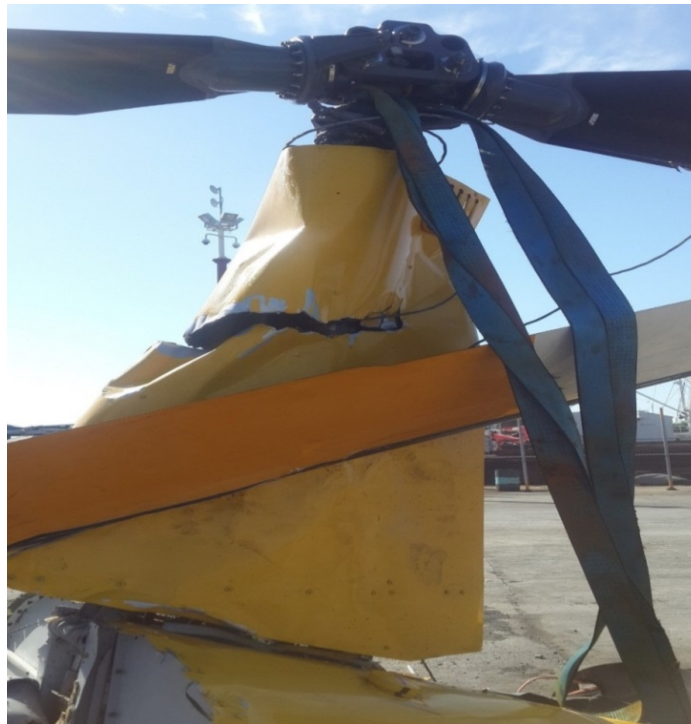
Neither the pilot nor the passengers saw the wire across the river until they flew into it at between 100 ft and 150 ft above sea level. The wire tore through the main-rotor mast cowling, severed and became wrapped around the top of the helicopter's main-rotor mast, dragging the helicopter into the river.

Figure 2: Wire Strike on the main rotor mast

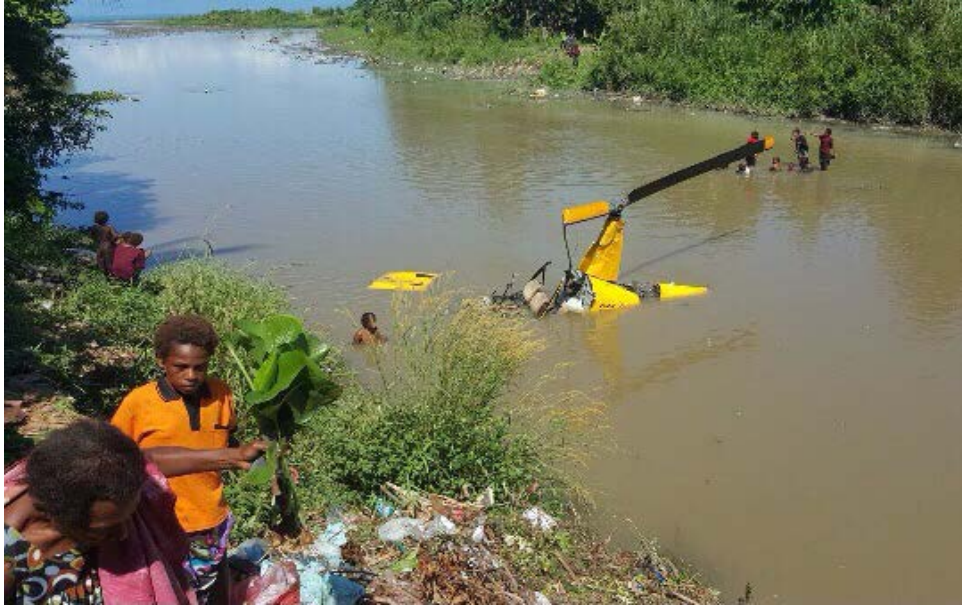
Figure 3: Accident Site
