FINAL SHORT SUMMARY REPORT

AIC 17-2001

PNG Air & SIL Aviation
P2-MCH & P2-SID
de Havilland Canada DHC-8-102 & Quest Kodiak 100
Reciprocal track airspace proximity incident
6.8 nm West of Nadzab Airport
Morobe Province
PAPUA NEW GUINEA
2 June 2017

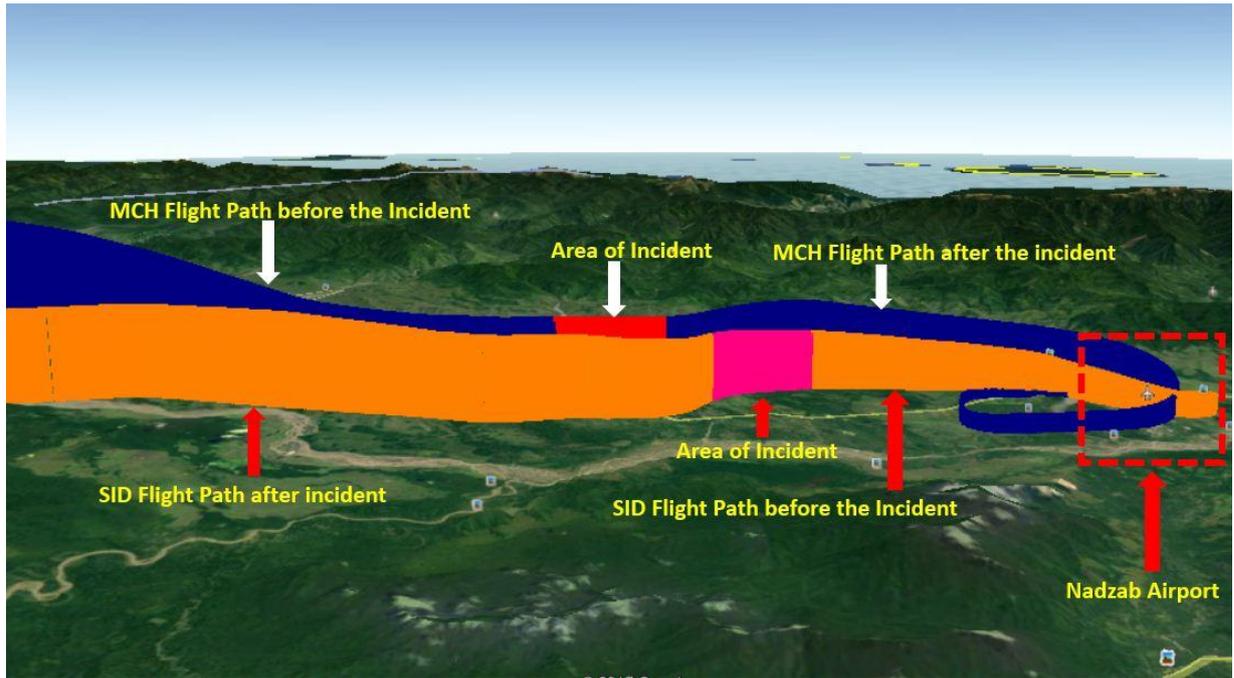
Figure 1: Aircraft tracks with reference to Nadzab Airport

Rather than continuing the vertical separation the controller issued further descent instructions to MCH to descend below 7000ft, and less than a minute later advised SID to climb to 11,000ft. Both aircraft were tracking on the reciprocal tracks (088 to Nadzab and 268 from Nadzab).

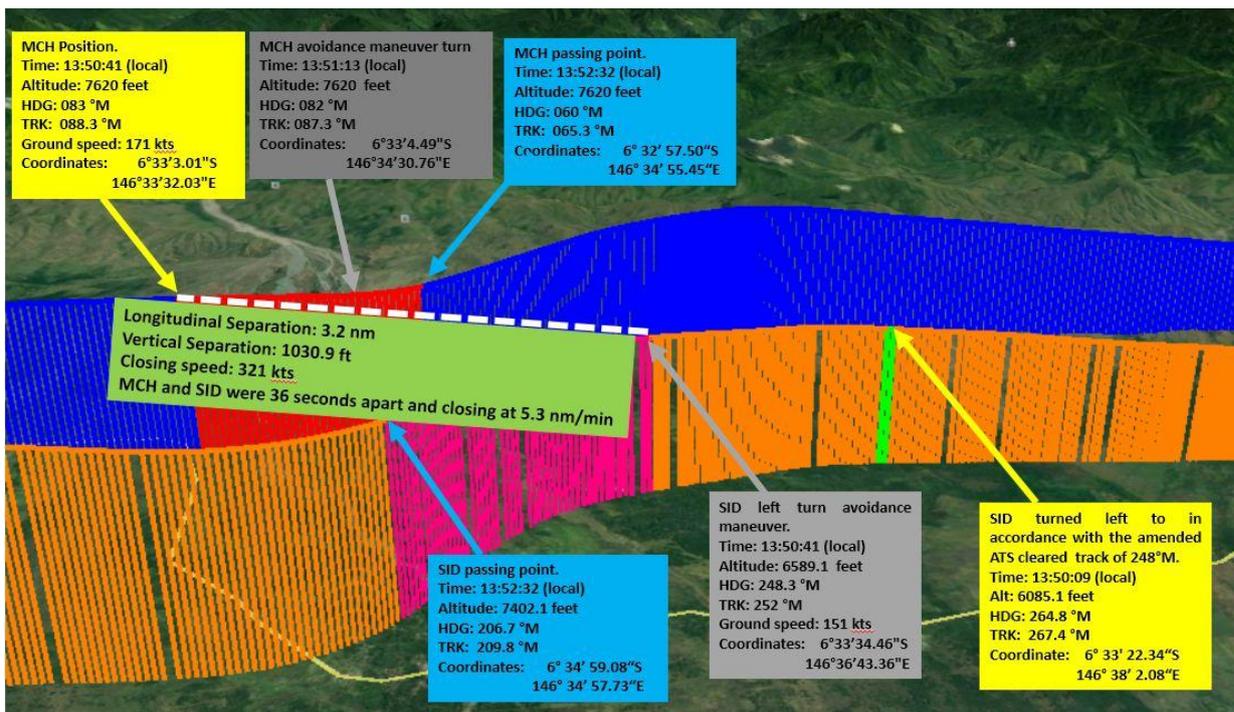
Figure 2: Aircraft tracks at point of SID commencing the avoidance manoeuvre

Recorded data showed the closing speed of the aircraft was 321 kts immediately before SID made the avoidance manoeuvring left turn. At that point the aircraft were 3.2 nm apart on reciprocal tracks with a closure speed of 321 kts. MCH and SID were 36 seconds apart and closing at 5.3 nm/min.

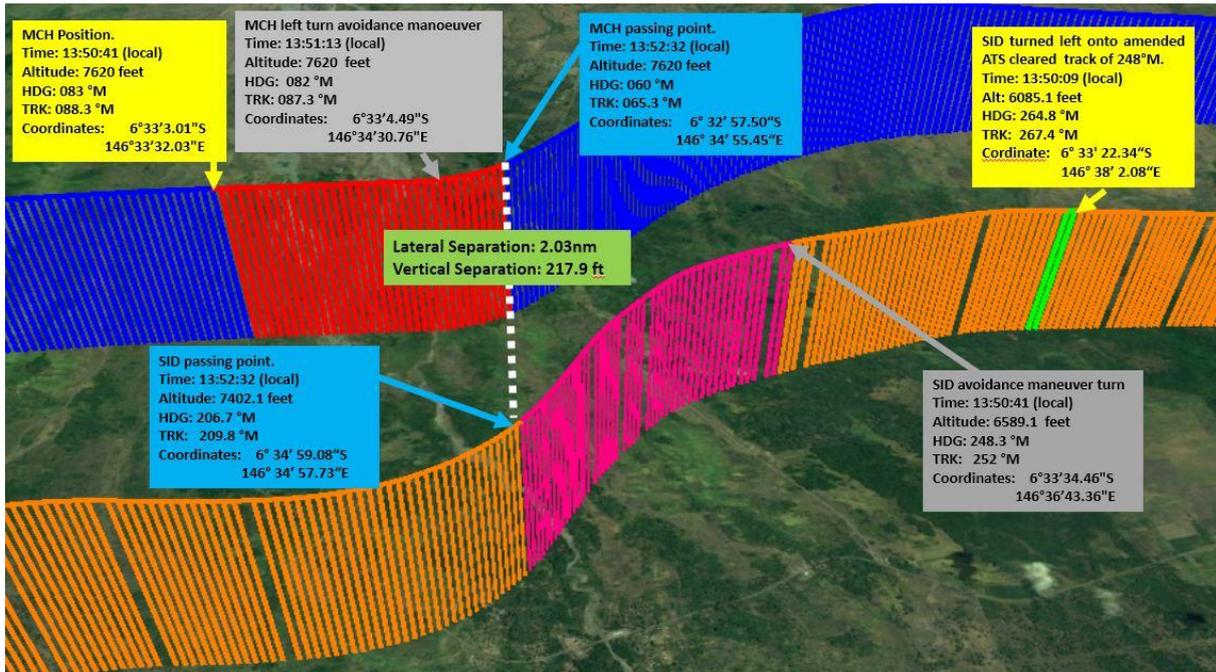
Figure 3: Aircraft tracks at point of MCH and SID passing

Neither the Approach Controller nor the crew of MCH detected the tracking errors. The undetected tracking errors, and the Approach Controllers incorrect application of the lateral and vertical separation methods, likely contributed to the potentially unsafe reciprocal track airspace proximity incident between MCH and SID.
