PRELIMINARY REPORT

AIC 17-1002

de Havilland Dash 8-202

Burst tyre at 20,000 feet during climb

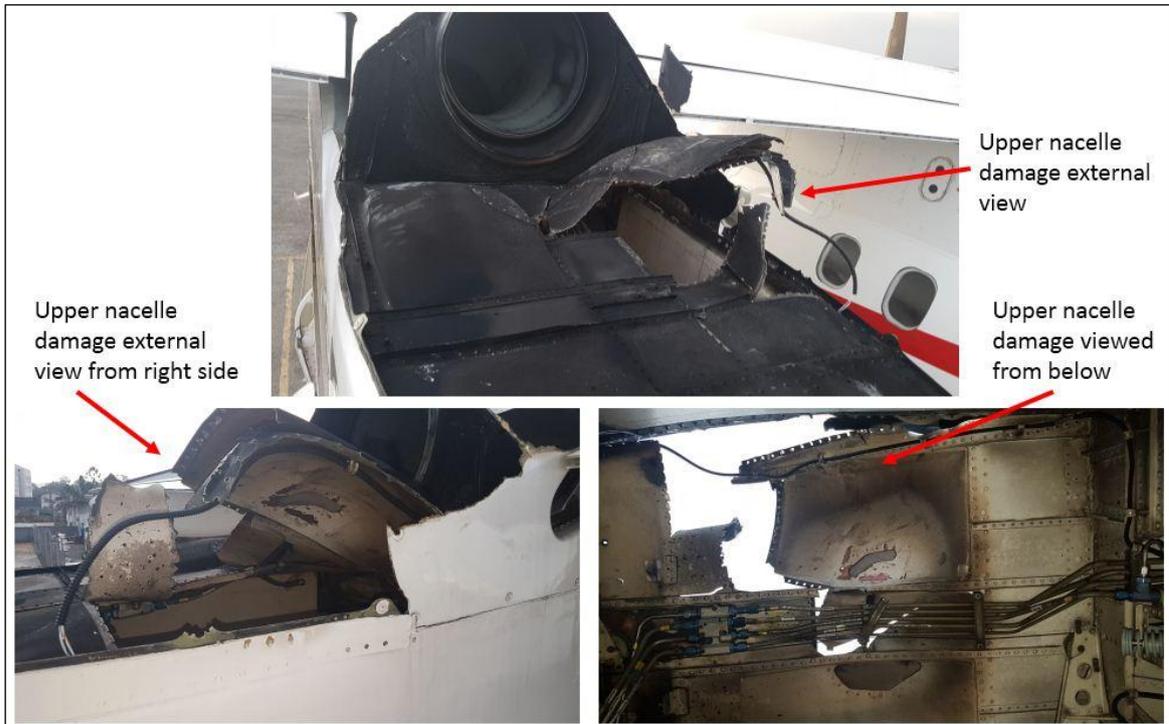
Further inspection found the left main landing gear number-2 tyre was deflated and damaged. It was apparent that when the tyre blew out in the wheel well, it caused substantial damage to the main structure on the inside of the nacelle. It was then the crew realised the bang sound they heard was the tyre exploding in flight at 20,000 feet.

Figure 1: Damage area left nacelle

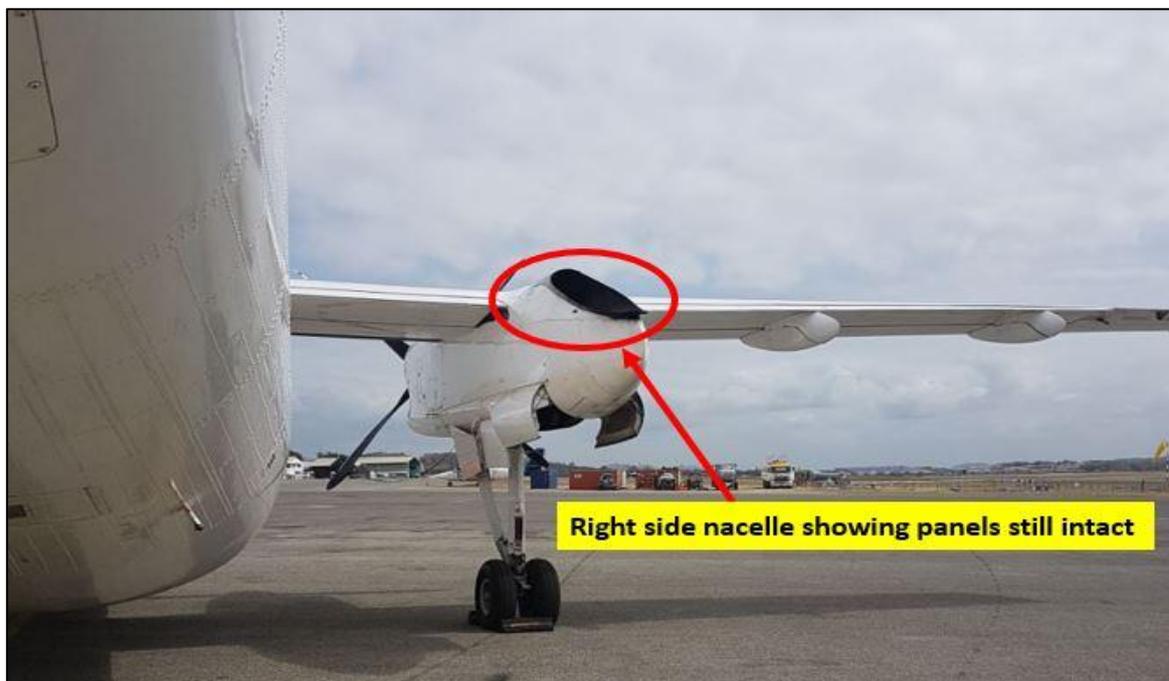
Figure 2: Right nacelle fully intact

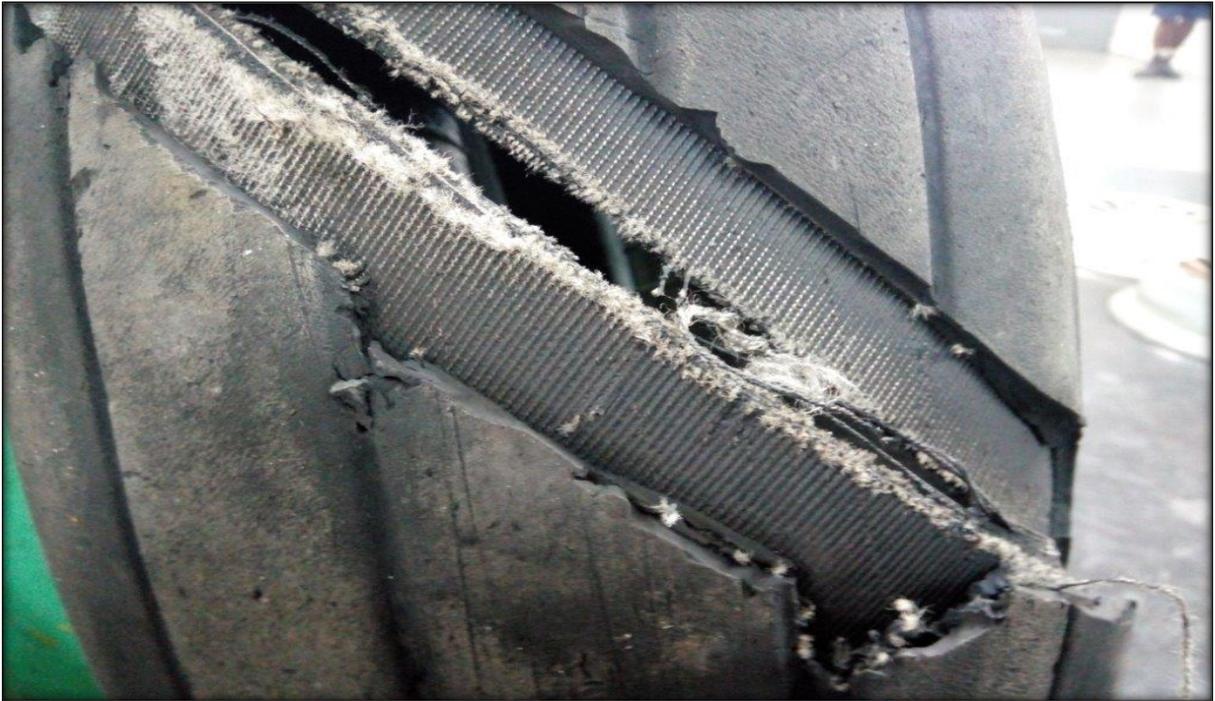
Figure 3: Damage number-2 left main wheel tyre

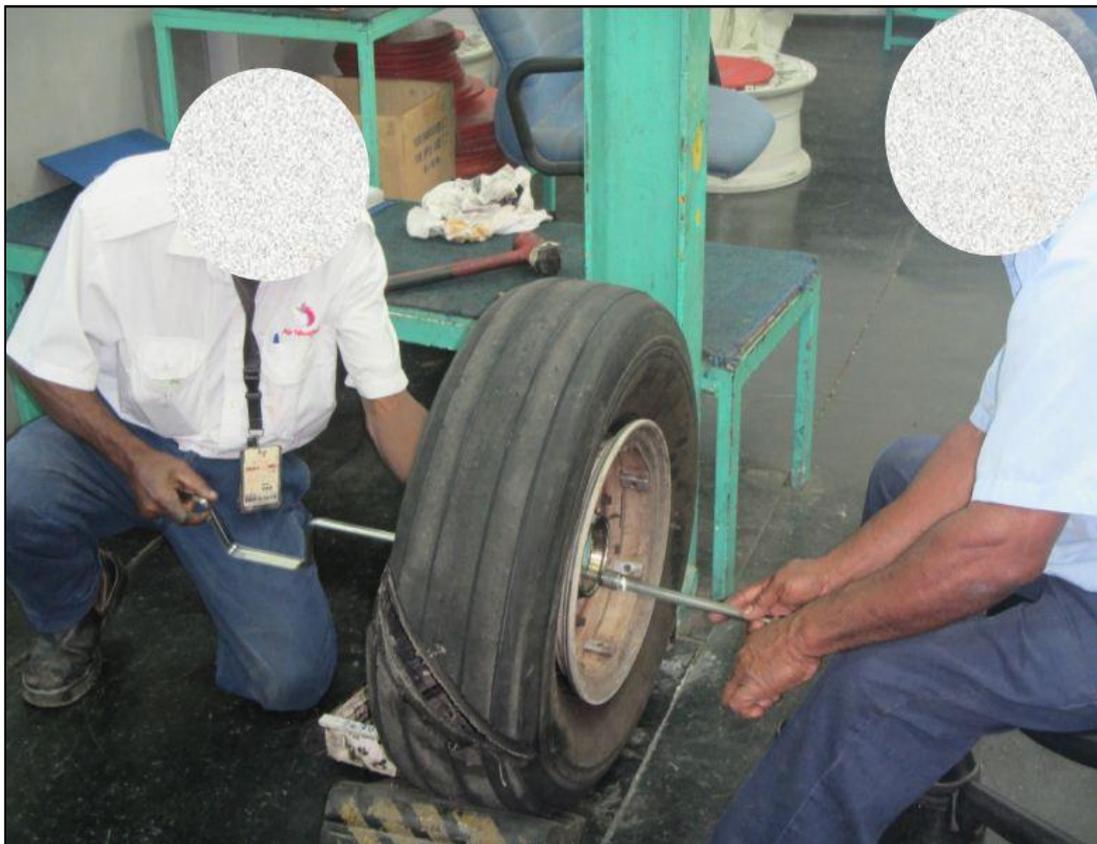
Figure 4: Wheel Assembly during dis-assembled under AIC supervision.

The left main landing gear number-2 wheel assembly was disassembled under AIC supervision and the tyre was brought to the AIC for further examination and analysis. The Air Niugini maintenance Non-destructive Testing (NDT) section was instructed to perform a Eddy Current Inspection and dye penetrant type testing on the wheel hub assembly s/n 2634, and provide a report to the AIC on their findings.
