PRELIMINARY REPORT

AIC 18-1003

P2-NTZ

NOSE WHEEL SEPARATION ON LANDING

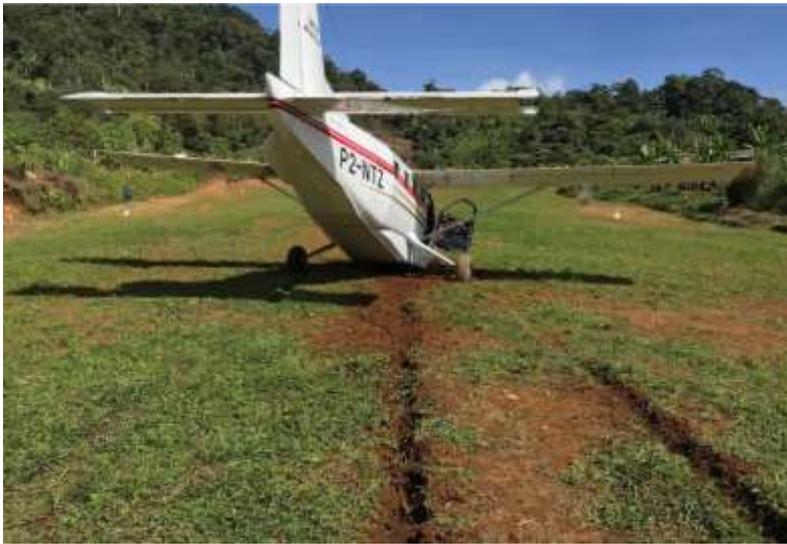
At about 23:25 UTC¹, during the landing roll, the aircraft's nose wheel sank into a soft patch on the strip surface. The aircraft came to an abrupt stop and the nose-wheel fork fractured on both sides of the oleo attachment plate resulting in the nose-wheel and nose-wheel fork assembly separating from the oleo. The pilots, the sole occupants, were not injured.

Figure 1: P2-NTZ at Mibu Airstrip showing wheel tracks in strip soft surface

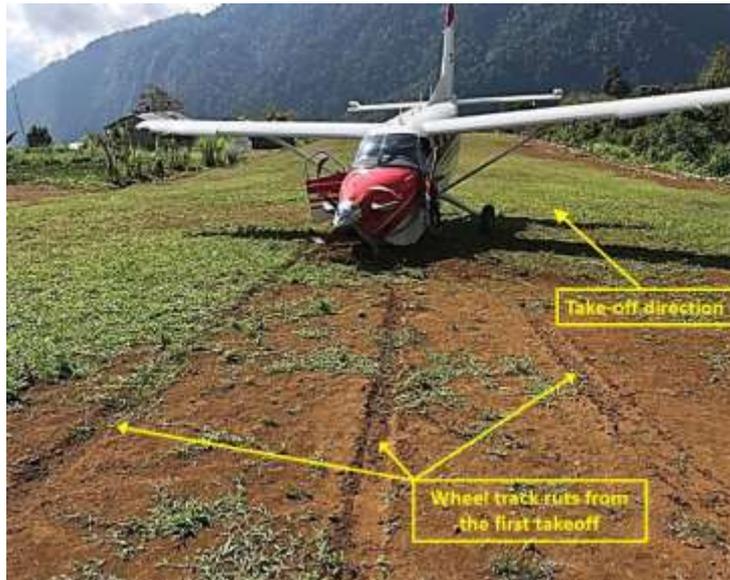
The nose of the aircraft dropped as the fork separated from the oleo and dug further into the soft ground until the bottom of the engine cowling was on the ground (See figure 2).

Figure 2: View of P2-NTZ showing the ruts in the soft strip surface from the first takeoff

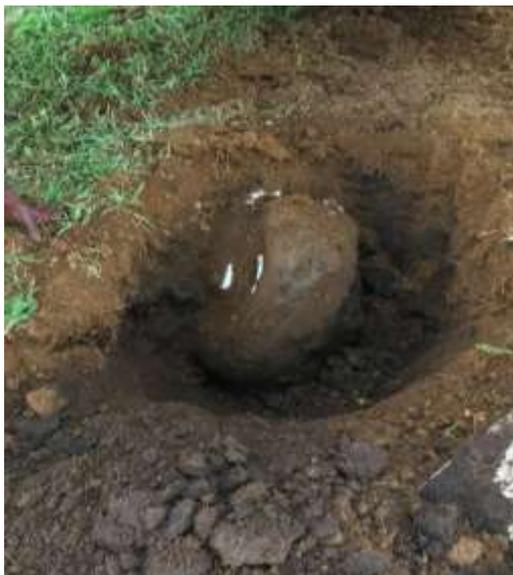
Figure 3: Nose wheel and fork assembly in bog hole Figure 4: Propeller assembly

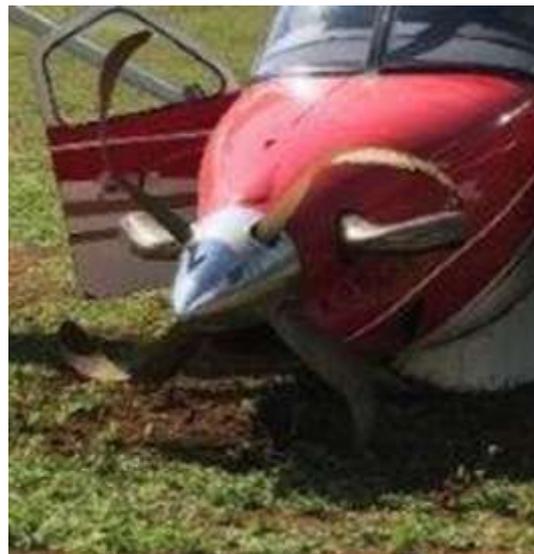
The PIC stated that he added power soon after touching down to maintain a 20kt speed up the 17% slope towards the end of the strip. The engine and propeller, under significant power, were substantially damaged as they impacted the ground.
