**ACCIDENT INVESTIGATION  
COMMISSION**

**PRELIMINARY AIRCRAFT ACCIDENT REPORT**

**P2-RUH  
BO 105  
7.5 KM SW TIMINI  
MOROBE PROVINCE  
PAPUA NEW GUINEA.**

**8 TH AUGUST 2011**

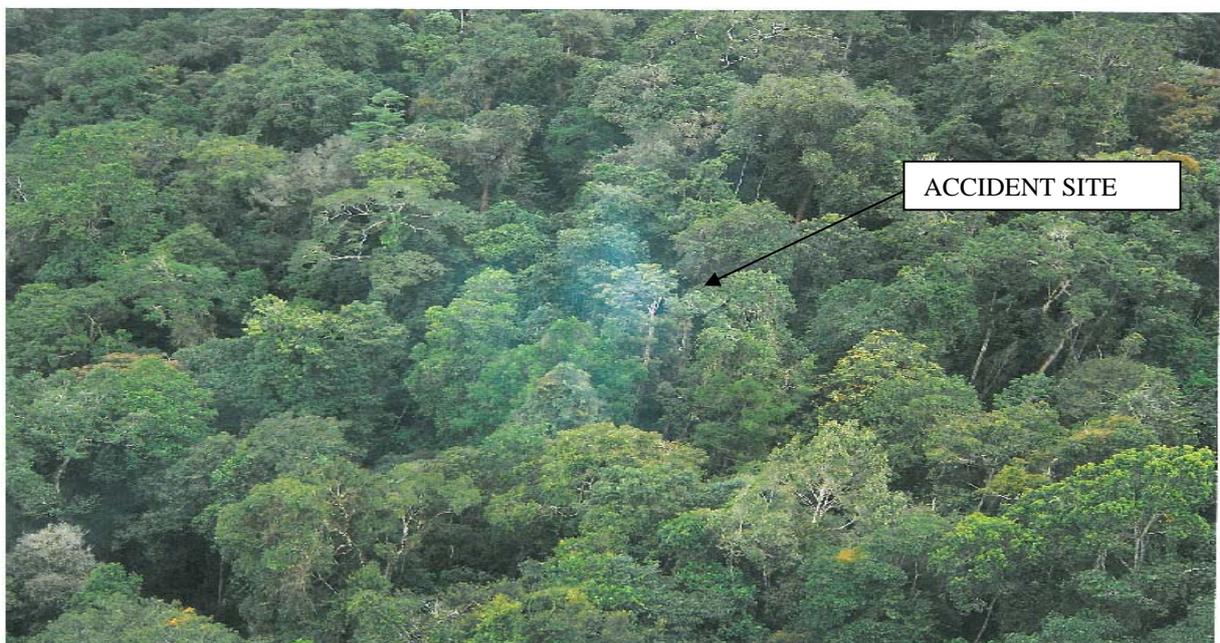
## GENERAL VIEW OF THE ACCIDENT SITE

A ground party search later determined that the accident was a high velocity event and that there had been no survivors.

Another aircraft operating in the same general area was dispatched for a search where the pilot saw thick smoke coming from bushlands on a steep mountain side. This was identified as the accident site.
