## **Safety recommendation: AIC 18-R04/18-1004**

**Addressed to: Air Niugini Limited**

**Investigation link: TC&I 18-1001 (AIC 18-1004)**

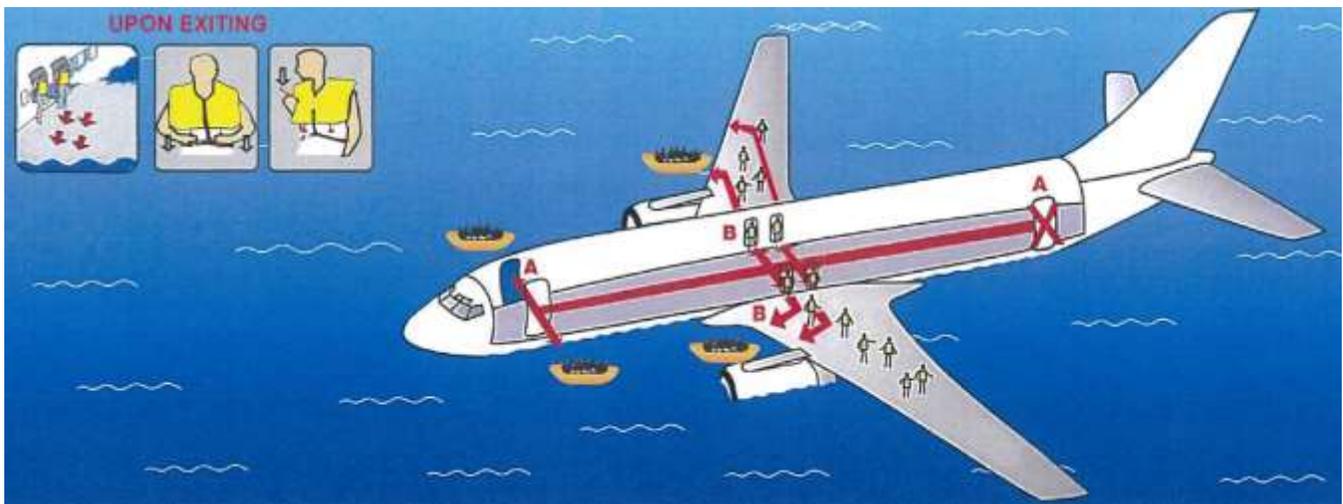
Figure 1: *Safety on Board Card* (Version PX3-11009 Rev.A)

The *Safety on Board Card* (passenger briefing card) for P2-PXC and P2-PXE incorrectly shows a path to the doors L1 and R1 with a life raft deployed from each door.

The PNG Accident Investigation Commission recommends that Air Niugini Limited should ensure that the *Safety on Board Card* (passenger briefing cards) for the Boeing 737-700 and -800 fleet accurately show the exits to be used in a water ditching accident, and the accurate depiction of which exits have life rafts deployed.

*The Safety on Board Card (Passenger Briefing Card) contains only primary information and other information is given in SEP manual for cabin crew reference purpose. Therefore, Air Niugini will amend Safety on Board Card to remove 1R life raft and evacuation path. Additionally, a foot note will be included stating that “Door 1R will only be used if door 1L is unusable during launching of Life rafts”. It will address the scenario where the entire cabin crew is unavailable and passengers will have to evacuate themselves.*

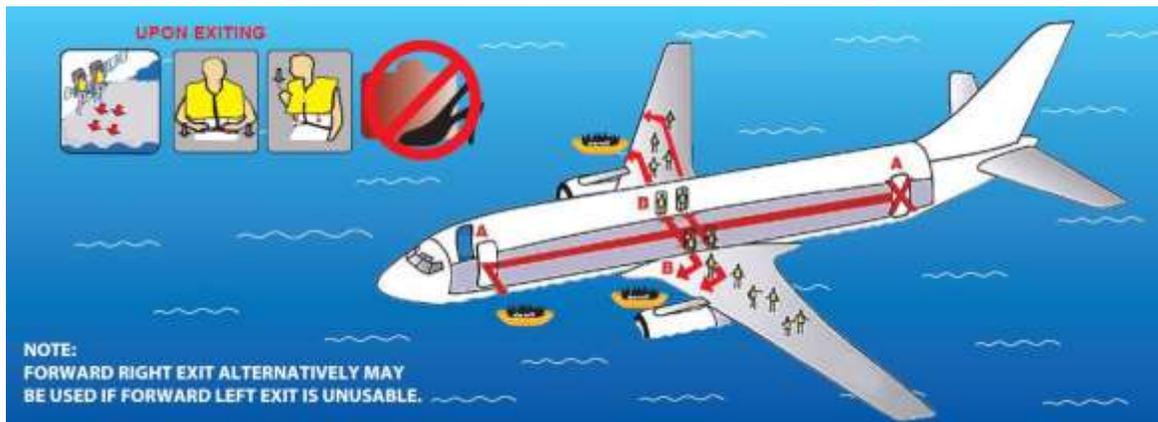
**Figure 2: Boeing 737-800 Safety on Board card (Version PX3-11009 Rev.B)**

On 30 November 2018, the PNG AIC received an updated response from Air Niugini Limited providing copies of the Boeing 737-800 and 737-700 Safety on Board cards. The cards clearly depict the correct door and raft deployment from door L1, and add a footnote to the diagram stating:

NOTE: FORWARD RIGHT EXIT ALTERNATIVELY MAY BE USED IF FORWARD LEFT EXIT IS UNUSABLE.
