Safety recommendation: AIC 19-R02/18-1004

Addressed to: Honeywell Aerospace

Investigation link: AIC 18-1004

On Friday 28th September 2018, a Boeing 737-8BK aircraft, registered P2-PXE, was being operated by Air Niugini Limited, on a scheduled passenger flight from Pohnpei to Chuuk, Federated States of Micronesia.

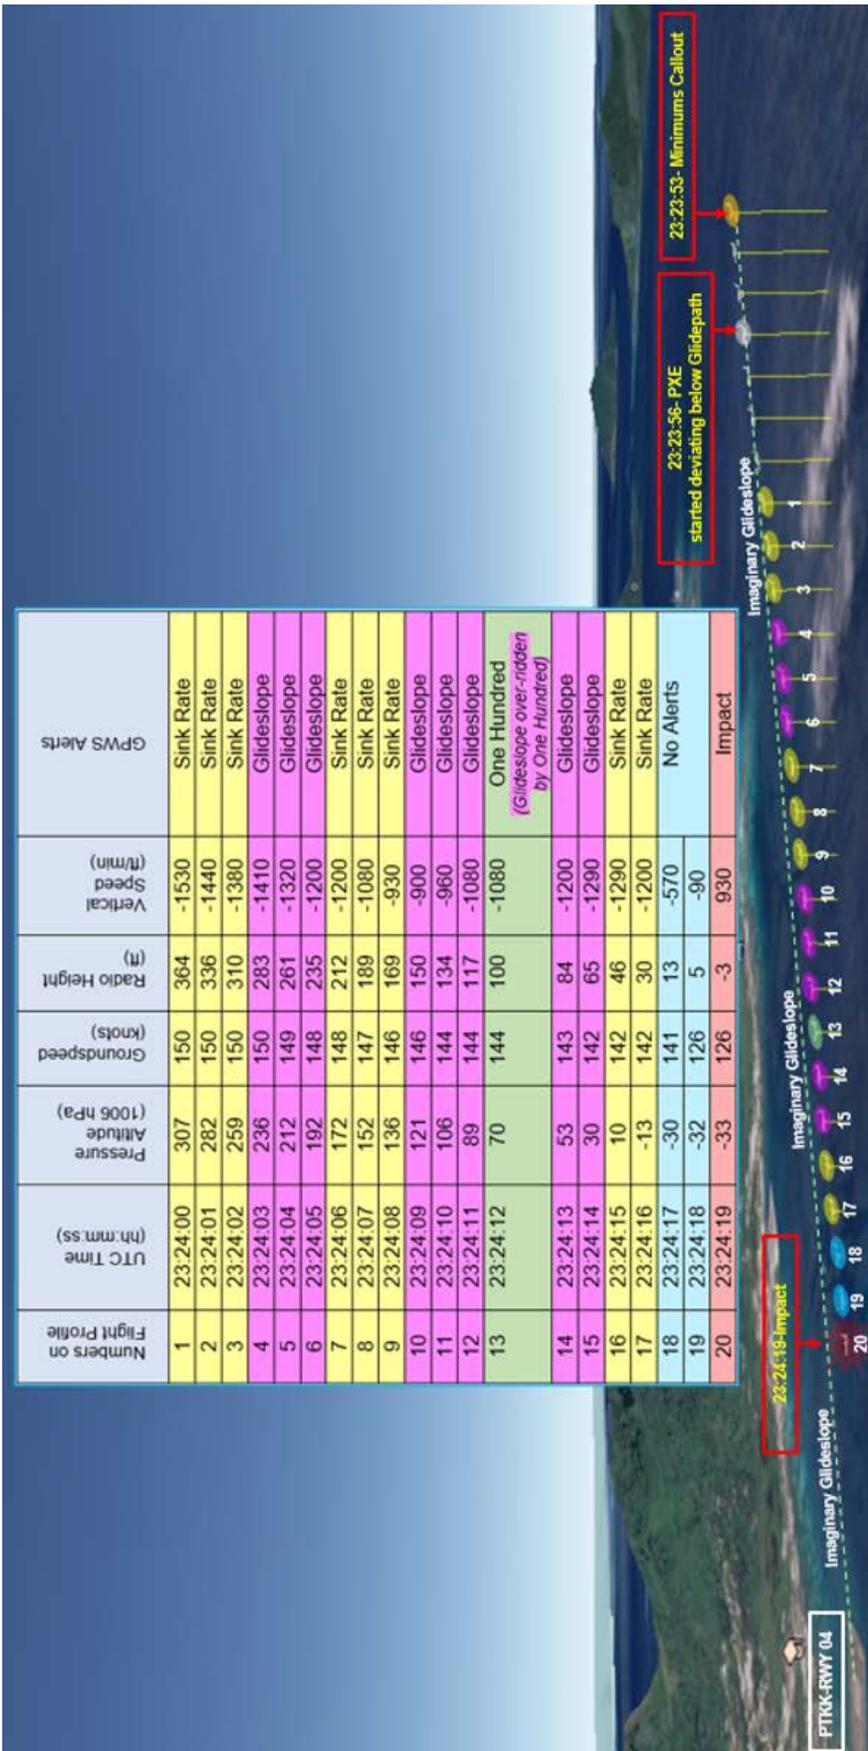
The aircraft was progressively flown below the glideslope, and from 23:24:00 to the time of impact at 23:24:19 the EGPWS issued eight *Glideslope*⁴ Alerts (aural alert), and nine *Sink rate*⁵ Alerts (aural alert). The first *Sink rate* Alert was issued at 23:24:00 when the aircraft was at a Radio Altitude of 367 ft with a vertical speed (rate of descent) of 1,616 ft per minute. The last *Sink rate* Alert occurred 2 seconds before impact at a Radio Altitude of 13 ft and a vertical speed (rate of descent) of 848 ft per minute. The Caution alerts (aural alerts) were ignored by the crew.

Figure 1: Glideslope and Sink rate aural Alerts graphic plotted using Derived Data (Revised graphic for clarity)

The PNG Accident Investigation Commission recommends that Honeywell Aerospace should ensure that the Honeywell EGPWS MK V Computer provides timely and continuous hard aural warning “*WHOO PULL UP*,” simultaneously with the stable visual display of **PULL UP** on the Primary Flight Display, which requires immediate action from the crew, when encountering an excessive Rate of Descent at very low Radio Altitude, similar to that encountered by the crew of P2-PXE as shown in Figure 1.

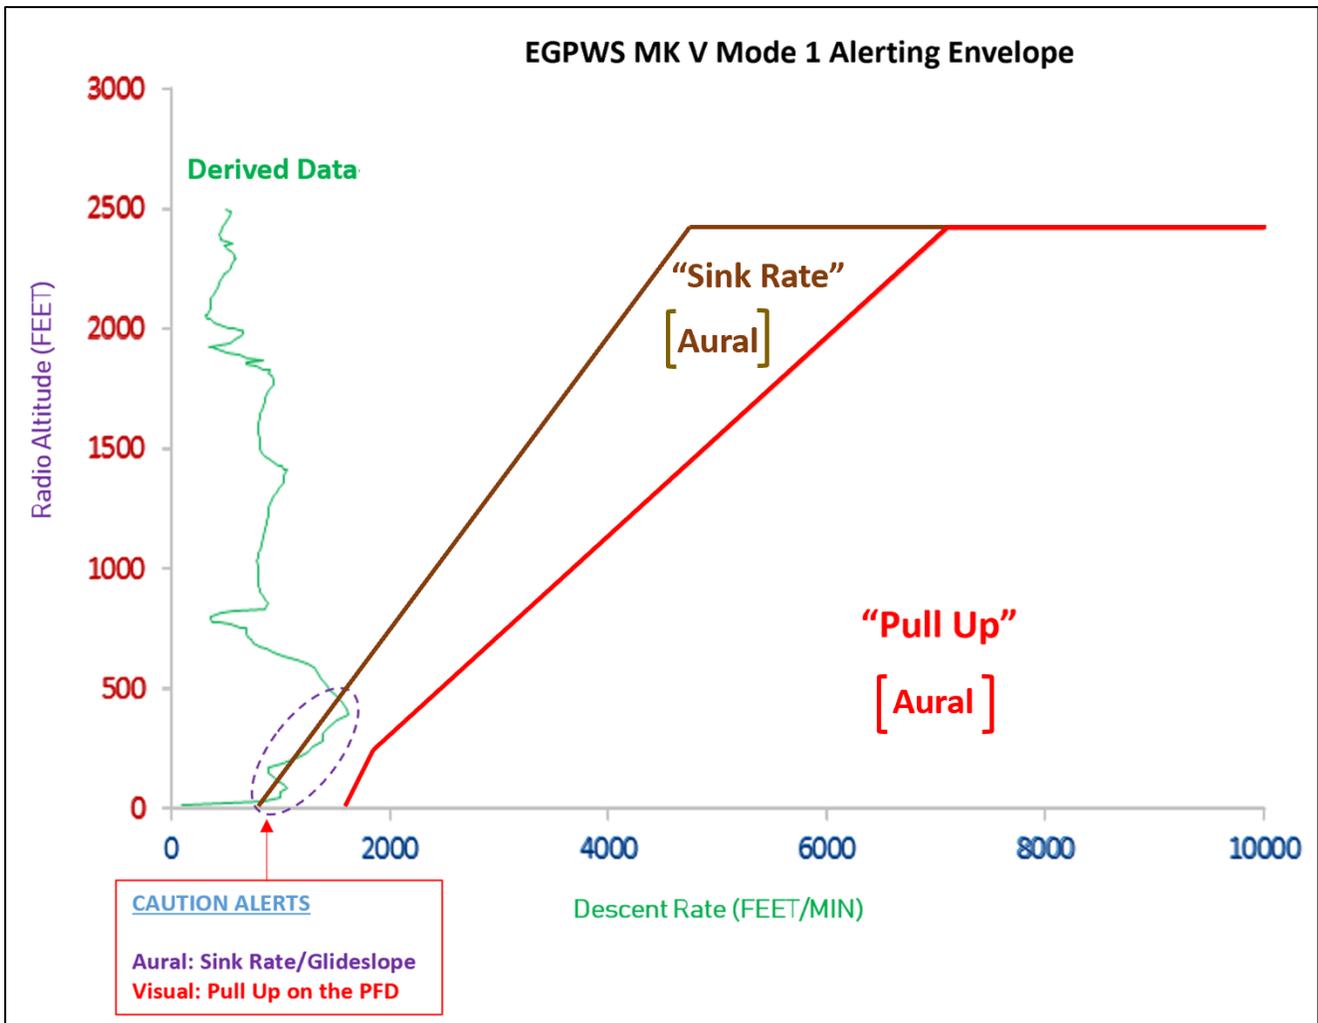
The investigation into this accident has found that the crew did not take any remedial action in response to the *Glideslope* and *Sink rate* Caution Alerts (aural alerts). The EGPWS issued these Caution Alerts (aural alerts) that included the words **PULL UP** appearing steady in red on the Primary Flight Display (*Electronic Flight Instrument System*) when the aircraft penetrated the Sink Rate Envelope of the *Honeywell EGPWS MK V Mode 1 Graph*. See Figure 2.

Figure 2: Derived Data plotted against Honeywell EGPWS MK V Mode 1 Graph

As per *DO-367 ‘Must Not Alert (Warning)’ requirement* region (as depicted in Figure 2), with the engine spool-up time and the time it will take to compensate for the loss of altitude for a positive rate of climb, there is insufficient time for pilots to react to an immediate time-critical situation if there is no ‘WARNING’ alert issued at low altitude after entering the *DO-367 ‘May Alert’ and ‘Must Alert’* regions. The rate of descent during the approach into Chuuk as shown in Figure 1, clearly shows that the crew were outside the safety margin.

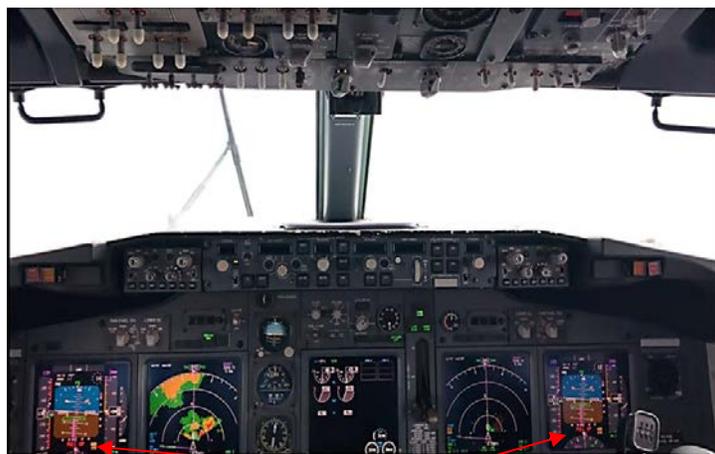
The investigation determined that the crew of P2-PXE were fixated on the task of landing the aircraft and did not notice the steady visual ‘PULL UP’ caution alert at the bottom of their Primary Flight Displays (PFD). Therefore, they (crew) did not take any positive action to arrest the high rate of descent and avoid landing in the lagoon. In fact, neither of the pilots were aware of the rapidly unfolding unsafe situation.

Figure 3: Image from PXE cockpit video⁹ showing steady **PULL UP** on PFD display

In the seconds leading up to this accident at Chuuk, the pilots missed an important change of indication on their PFDs. **Why?** Could it have been that there were so many steady indications that the steady **'PULL UP'** visual alert just blended into them? Could it have been that the crew did not hear an alert worth reacting to?

The pilots' fixation on the task of landing the aircraft could have been significantly diverted if there was an attention-getter hard aural **'WARNING'** alert rather than peripheral reliance on a steady visual **'PULL UP'** caution alert at the bottom of the PFD which was associated with the *'Sink Rate'* caution aural alert as provided by the LAMP Format 1 setting.

The AIC therefore believes the inclusion of a **flashing visual 'PULL UP' WARNING** on the PFDs rather than reliance upon peripheral steady visual caution alerts would be a significant enhancement in terms of attention getting alert capability.

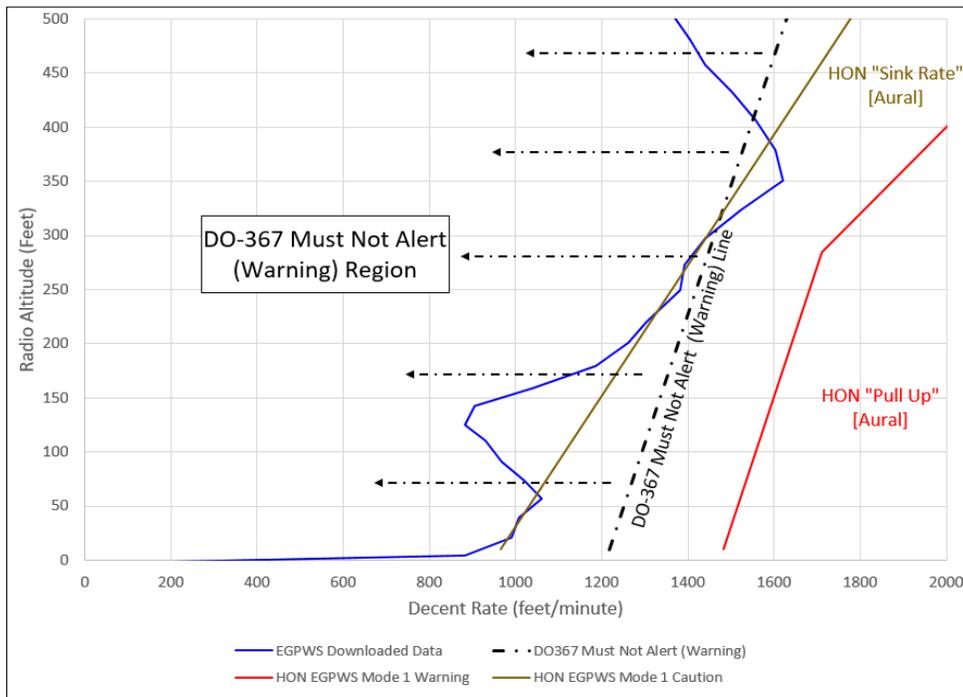
‘if the Warning curve were to be modified to exactly match the DO-367 “Must Not Alert” warning requirement, it would result in more nuisance “PULL UP” alerts being generated which would disturb the crew during normal operations and violate the requirements of the TSO-151d.’

Figure 3: Mode 1 Sink Rate Alert Curves with DO-367 “Must Not Alert (Warning)” Requirement¹¹

Figure 3 depicts the **HON “Pull Up” [Aural]** boundary of the HON EGPWS Mk V Mode 1 Warning.

- At 275 feet Radio Altitude and 1,750 feet/min rate of descent the time to impact would be 9.4 seconds.
- At 200 feet Radio Altitude and 1,650 feet/min rate of descent the time to impact would be 7.2 seconds.
- At 100 feet Radio Altitude and 1,750 feet/min rate of descent the time to impact would be 9.4 seconds.
- At 50 feet Radio Altitude and 1,500 feet/min rate of descent the time to impact would be 2.0 seconds.
