Safety recommendation: AIC 19-R04/18-1004

Addressed to: Air Niugini Limited

Investigation link: TC&I 18-1001 (AIC 18-1004)

On Friday 28 September 2018, a Boeing 737-8BK aircraft, registered P2-PXE, was being operated by Air Niugini Limited, on a scheduled passenger flight from Pohnpei to Chuuk, Federated States of Micronesia.

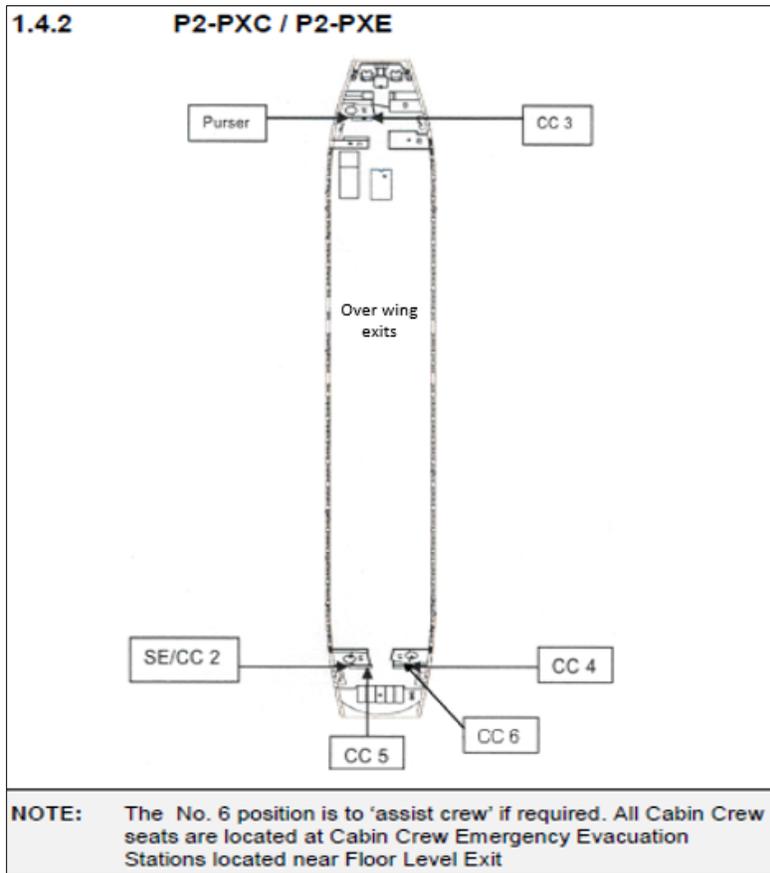
Figure 1: Cabin crew seating configuration Air Niugini Boeing 737-800 aircraft

Cabin Crew 1, 2, 3, 4, 5 & 6 were seated as shown in the diagram below. CC7 and CC8 were seated in business class seats 1A and 4D respectively.

Immediately after the ditching, cabin crew CC5 moved forward from her cabin crew station at the rear of the cabin to the over wing exit. Due to the passenger congestion caused by passengers standing in the aisles, her attempt to reach the over wing exits was slowed.

This flight did not have a full passenger load. There were numerous empty seats. In the event of a full capacity flight, the cabin crew would have had significant difficulty reaching the over wing exit.

The PNG Accident Investigation Commission recommends that Air Niugini Limited, should review its policy and procedures in the *Safety and Emergency Procedures Manual (SEPM)* in relation to all aircraft in the Air Niugini fleet to ensure:

- (a) a responsible and capable adult passenger is seated in the over wing exit row on all flights; and
- (b) the passenger(s) seated in the over wing exit row are fully briefed on the tasks required to deploy the emergency exit and assist in passenger evacuation.
