Safety recommendation: AIC 19-R05/18-1004

Addressed to: Air Niugini Limited

Date issued: 4 February 2019

Investigation link: TC&I 18-1001 (AIC 18-1004)

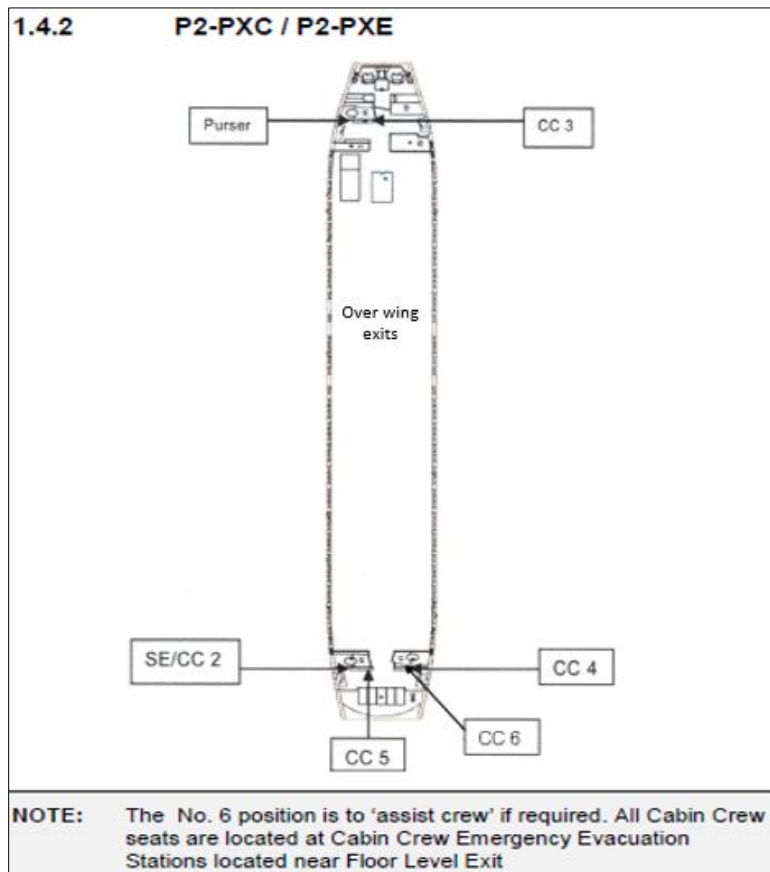
Figure 1: Cabin crew seating configuration Air Niugini Boeing 737-800 aircraft

Cabin Crew 1, 2, 3, 4, 5 & 6 were seated as shown in the diagram below. CC7 and CC8 were seated in business class seats 1A and 4D respectively.

The investigation found that the seating requirements for extra crew (more than six) had not been documented in any of the Air Niugini expositions/manuals.

Immediately after the ditching, cabin crew CC5 moved forward from her cabin crew station at the rear of the cabin to the over wing exit. Due to the passenger congestion caused by passengers standing in the aisles, her attempt to reach the over wing exits was slowed. This flight did not have a full passenger load. There were numerous empty seats. In the event of a full capacity flight, the cabin crew would have had significant difficulty reaching the over wing exit.

- Review its policy and procedures in the *Safety and Emergency Procedures Manual (SEPM)* and the *Airport Services manual (ASM)* in relation to all aircraft in the Air Niugini fleet to ensure a cabin crew member is seated in the over wing exit row on all flights.
