Safety recommendation: AIC 19-R07/18-1004

Addressed to: Air Niugini Limited

Investigation link: TC&I 18-1001 (AIC 18-1004)

On Friday 28 September 2018, a Boeing 737-8BK aircraft, registered P2-PXE, was being operated by Air Niugini Limited, on a scheduled passenger flight from Pohnpei to Chuuk, Federated States of Micronesia.

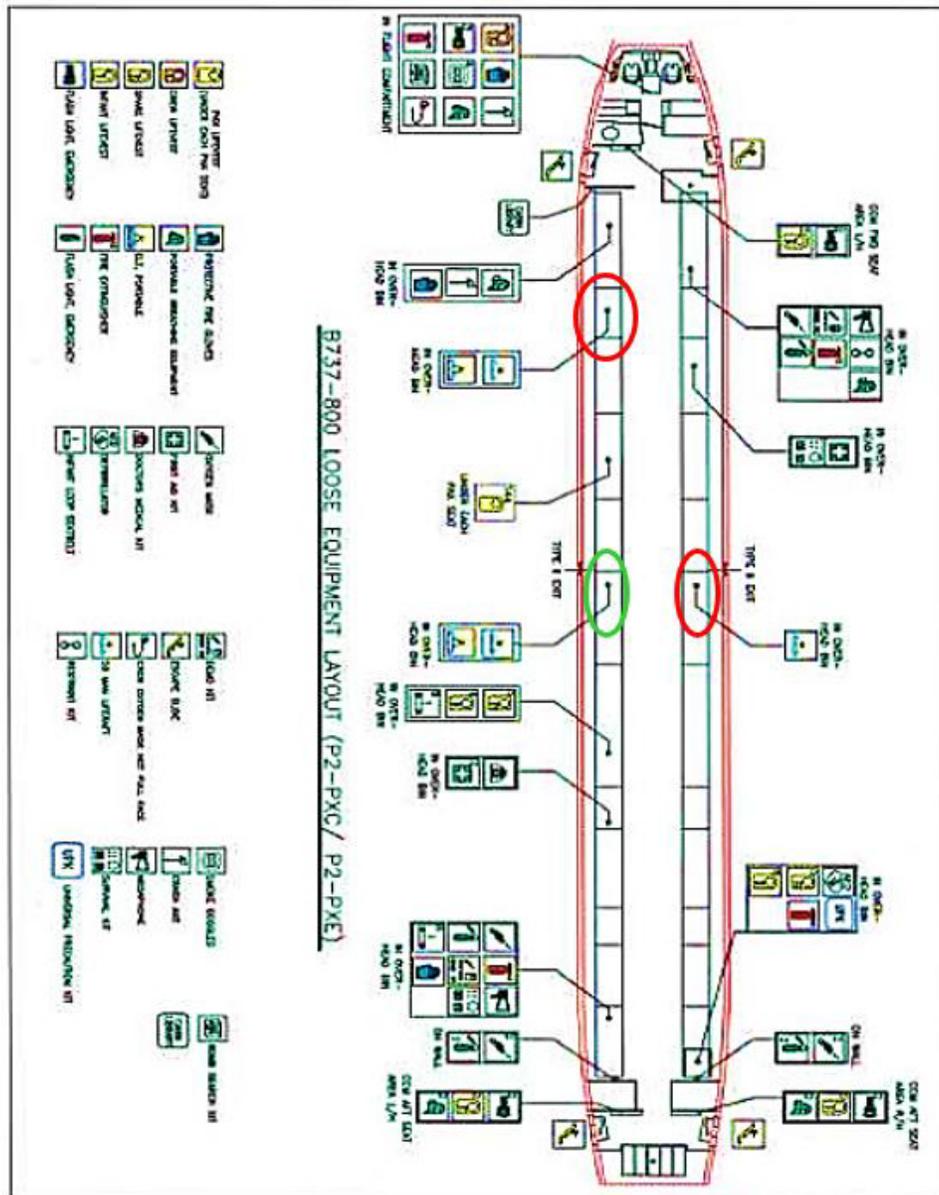
A review of the *Air Niugini Safety and Emergency Procedures Manual – Volume 6 (B737) Section 3.2.2 titled P2-PXC / P2-PXE – location of Emergency Equipment* shows an incorrect location of the life rafts.

The life raft in the Business Class area is depicted as stowed in the second left overhead locker (row 2). The Economy Class life rafts are depicted as being stowed in the left and right overhead lockers above the over-wing emergency exit rows 9 and 10.

Figure 1: Air Niugini Safety and Emergency Procedures Manual – Volume 6 (B737) Section 3.2.2 (Shows two incorrect life raft locations

and one correct life raft stowage location

).

The PNG Accident Investigation Commission recommends that Air Niugini Limited, should review the *Air Niugini Safety and Emergency Procedures Manual – Volume 6 (B737) Section 3.2.2 titled P2-PXC / P2-PXE – location of Emergency Equipment* to ensure the diagram clearly depicts the correct life raft stowage locations, and ensure all cabin crew are briefed on the correct location of the life rafts.

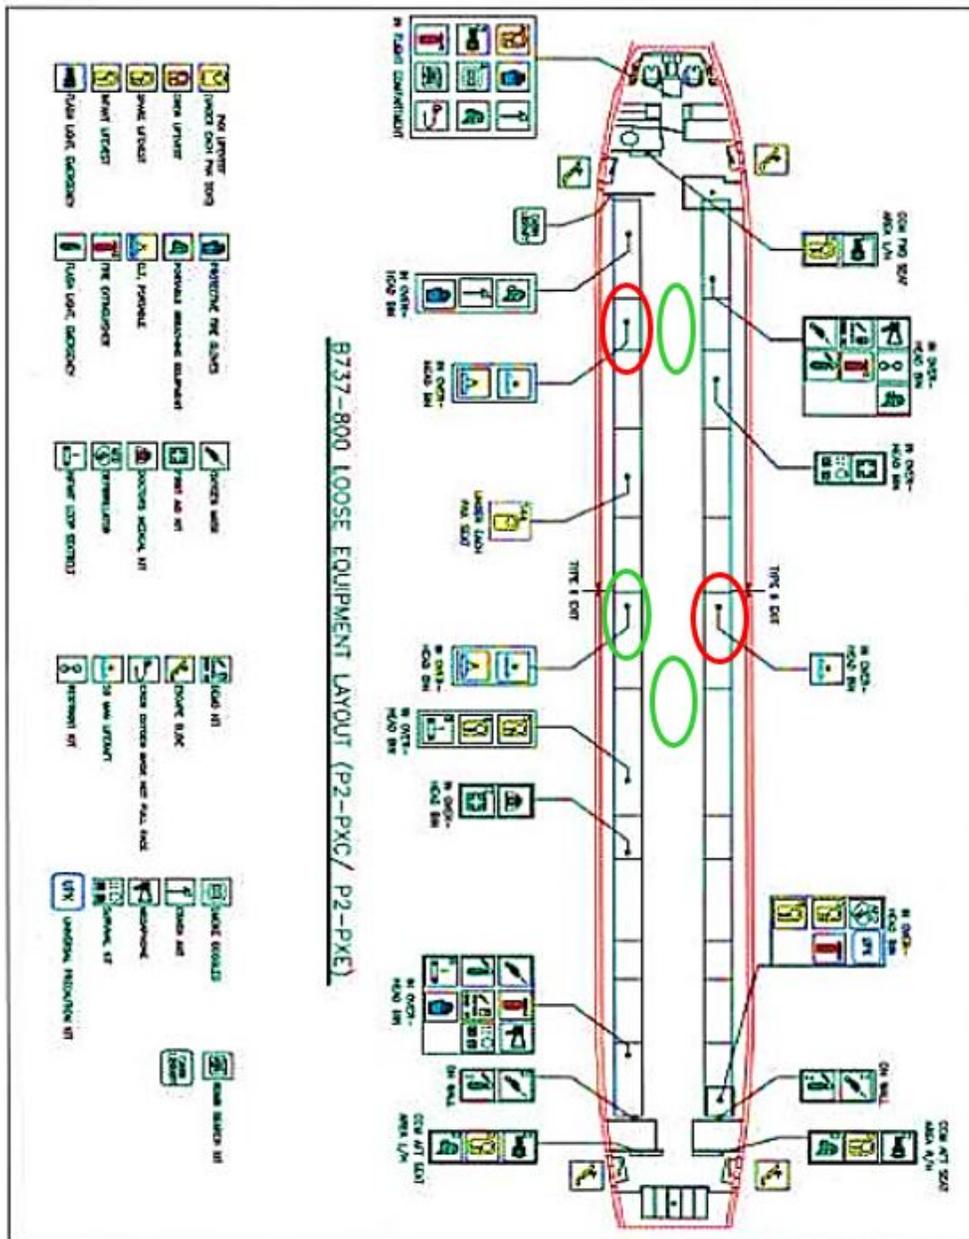
The actual life raft stowage locations on PXE and PXC are as follows:

- The Business Class life raft is stowed in the cabin ceiling between seat rows one and two.
- One Economy Class life raft is stowed in the ceiling between rows 12 and 14, behind the over wing exit row; and the other life raft is stowed in the left overhead locker above the exit rows 9 and 10.

Figure 2: Diagram modified from Air Niugini *Safety and Emergency Procedures Manual – Volume 6 (B737) Section 3.2.2.*

(Shows two incorrect life raft locations ○ as depicted in Figure 1 above, and the three correct life raft stowage location ○ as stowed on the aircraft).

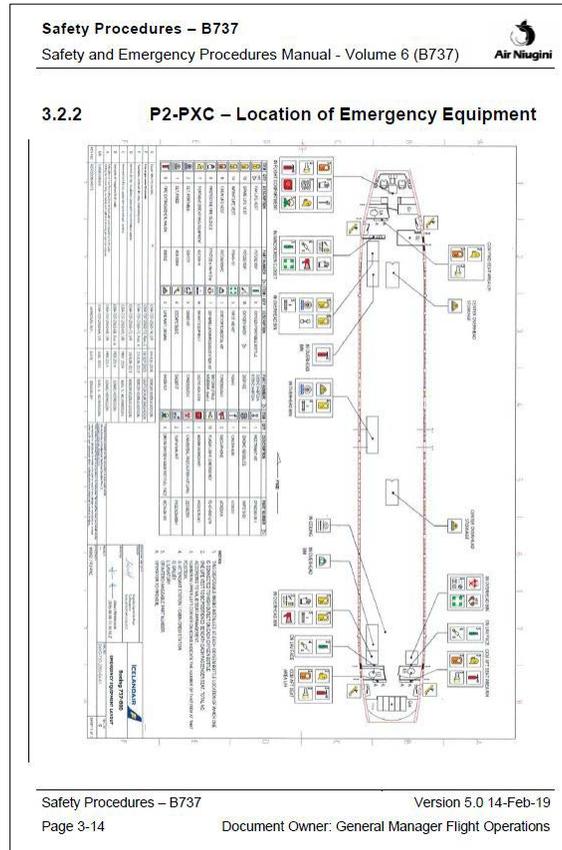
Figure 3: Diagram from Air Niugini amended *Safety and Emergency Procedures Manual – Volume 6 (B737) Section 3.2.2*. Amended 14 February 2019.

On 18 February 2019, Air Niugini Limited informed the PNG Accident Investigation Commission of its safety actions to address the safety deficiencies identified in *Safety Recommendation AIC 19-R07/18-1004*. Air Niugini also provided documentary evidence of the safety action taken, which included the amended depiction of the life raft locations.
