**Safety recommendation: AIC 19-R11/18-1004**

**Addressed to: Air Niugini Limited**

**Investigation link: AIC 18-1004**

On Friday 28 September 2018, a Boeing 737-8BK aircraft, registered P2-PXE, was being operated by Air Niugini Limited, on a scheduled passenger flight from Pohnpei to Chuuk, Federated States of Micronesia.

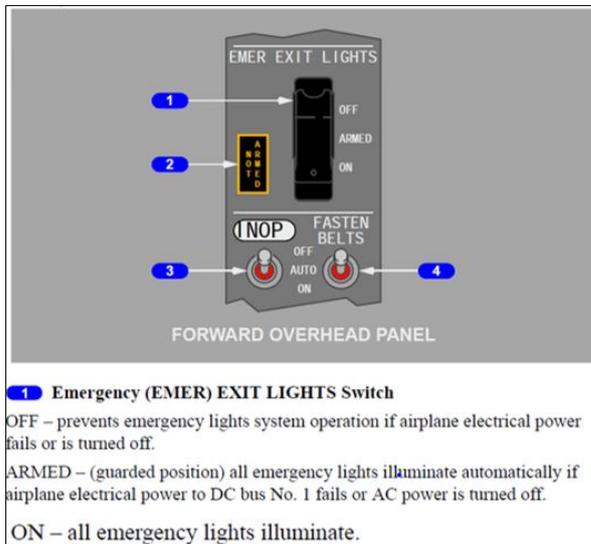
Figure 1: Cockpit Overhead Panel Emergency Light switch<sup>2</sup>

The internal and external emergency lighting did not illuminate following the impact. The reason(s) the armed emergency lights did not illuminate is yet to be determined.

While the emergency switch in the cockpit overhead panel was armed, the pilots did not over-ride the switch and activate (switch on) the emergency lighting during the evacuation.

The PNG Accident Investigation Commission recommends that Air Niugini Limited should, as a matter of urgency, ensure that the relevant Air Niugini manuals, including the *Quick Reference Handbook*, *Evacuation Checklist*, are amended to provide instructions and emergency procedures for the manual operation of the emergency lighting switch in the cockpit, and the switch located on the *Aft Attendant's Panel*, and that all pilots and Cabin Crew are instructed in their importance and use.

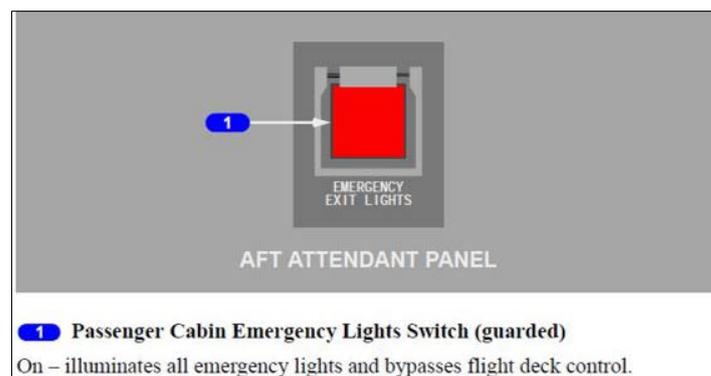
Figure 1: Aft Attendant Panel Emergency Light switch<sup>4</sup>

There is a *Passenger Cabin Emergency Lights Switch* at the *Aft Attendant Panel (Cabin crew station)*. When switched on (activated) that switch illuminates all emergency lights and bypasses the flight deck (cockpit) emergency light switch. The Cabin Crew did not activate the Aft Panel switch following the impact.

The investigation found that the relevant Air Niugini manuals including the *Quick Reference Handbook*, did not provide instructions or emergency procedure(s) for the manual operation of the emergency lighting switches located in the cockpit overhead panel, or on the *Aft Attendant's Panel*.
