Safety recommendation: AIC 19-R12/18-1004

Addressed to: Air Niugini Limited

Investigation link: AIC 18-1004

On Friday 28 September 2018, a Boeing 737-8BK aircraft, registered P2-PXE, was being operated by Air Niugini Limited, on a scheduled passenger flight from Pohnpei to Chuuk, Federated States of Micronesia.

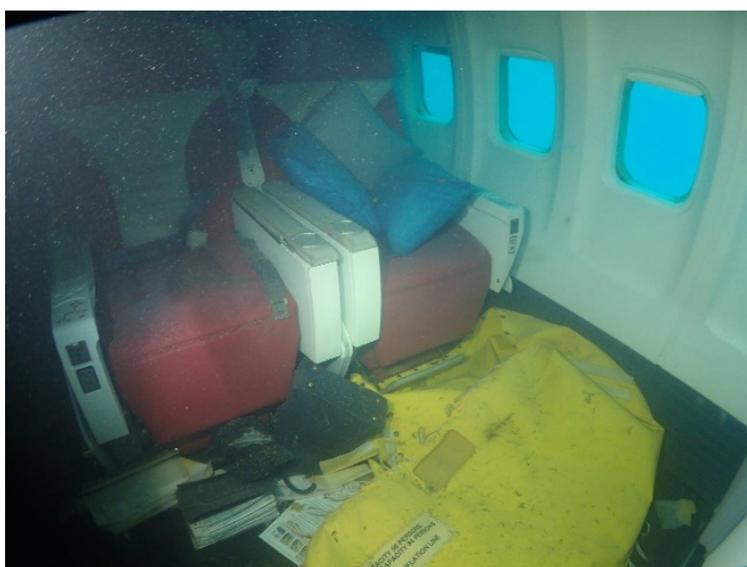
The investigation examined photographic evidence and found that two life rafts were in the water and one was on a seat in the over-wing exit row and had not been used because of the abundance of small rescue craft that came to the crash site. There was a 56-person life raft bag/cover laying on the floor in front of Business Class Seats 1A and 1B.

The investigation revealed that the Cabin Crew attempted to inflate the life raft before deploying it from the aircraft into the water.

The PNG Accident Investigation Commission recommends that Air Niugini Limited should, as a matter of urgency, ensure that the *Training Reference Manual* and all relevant Air Niugini manuals related to emergency evacuation are amended to ensure descriptors on drawings are clear and unmistakable, and that the *Training Reference Manual* and operational procedures clearly stress the requirement for life rafts to be deployed outside the aircraft before attempting inflation.

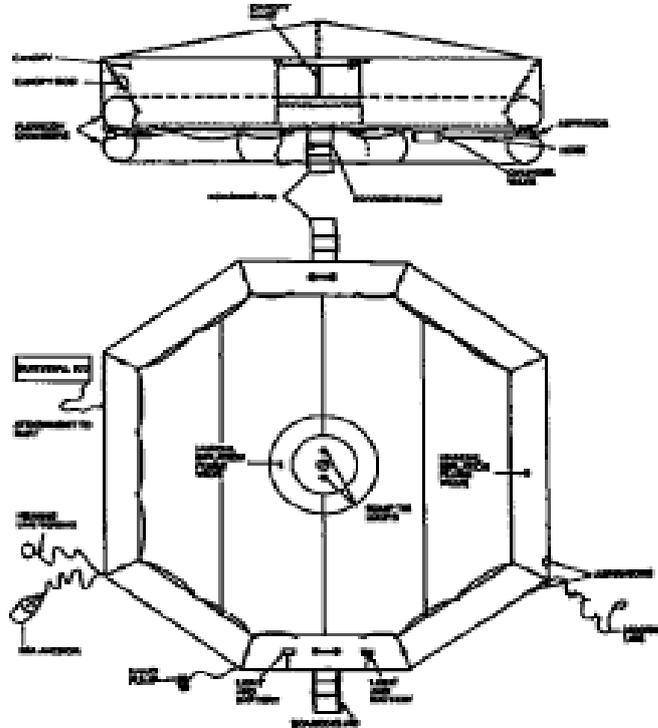
7.11.19.3 56 - Man Liferaft / 46 - Man Liferaft / 36 - Man Liferaft

Section 7.11.19.3 of the *Air Niugini Training Reference Manual* has diagrams of an inflated life raft (a side view and a plan view), but the captions describing the various parts of the life raft are very small font and blurred and therefore are unreadable, and provide no assistance to the user. (*See Appendix*)
