ACCIDENT INVESTIGATION COMMISSION
OFFICE OF THE CHIEF COMMISSIONER

Safety recommendation: AIC 19-R15

Addressed to: PNG National Airports Corporation

Date issued: 21st April 2019

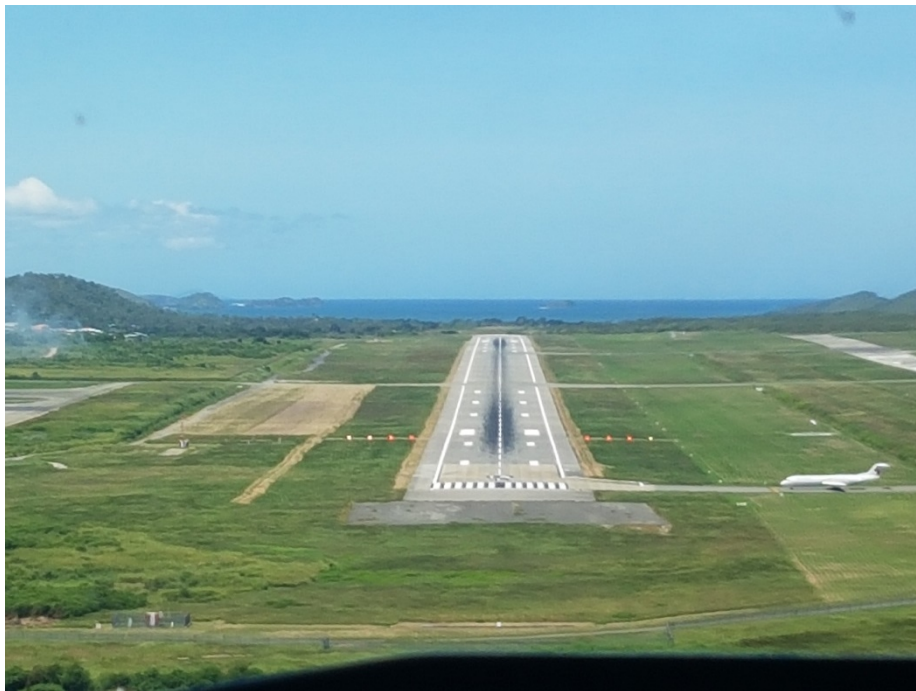
Figure 1: Jacksons International Airport Runway 14L showing PAPIs

The Runway 14L PAPI was showing two white lights and two red lights, indicating that the aircraft was on the correct profile for the 3 deg glideslope. That was confirmed by the cockpit instrument indications. However, the PAPI to the right of runway 14L was indicating three red lights and one white light indicating that the aircraft was slightly below the 3 deg glideslope.

The pilots said that they had previously observed a similar discrepancy when approaching to land on Runway 32R, the reciprocal runway.

The PNG Accident Investigation Commission recommends that the PNG National Airports Corporation should, as a matter of urgency, ensure that the Jacksons International Airport Runway 14L and 32R PAPIs are recalibrated.

The NAC rectification action included re-alignment of all PAPI boxes of runway 14L/32R to ICAO Standards. In it's response NAC said: "A 3-monthly maintenance inspection and calibration preventive maintenance has been developed for this critical operational equipment to ensure they are readily available and reliable.

The AIC notes that within 4 hours of receipt of AIC Safety Recommendation *AIC 19-R15* addressed to PNG National Airports Corporation, that the NAC took immediate action to rectify the PAPI discrepancy, with the recalibration work of the Runway 14L, right side PAPI commencing at 19:00 local on 21st April 2019 and completed by 21:00 local. The Runway 14L PAPIs were confirmed to be serviceable shortly after 08:32 local on 22nd April 2019. Both Runway 32R PAPIs were inspected on 24th April 2019, with realignment of all PAPI boxes completed to ICAO Standards.
