Safety recommendation: AIC 19-R17/18-1004

Addressed to: Federal Aviation Administration

Date issued: 20th May 2019

Investigation link: AIC 18-1004

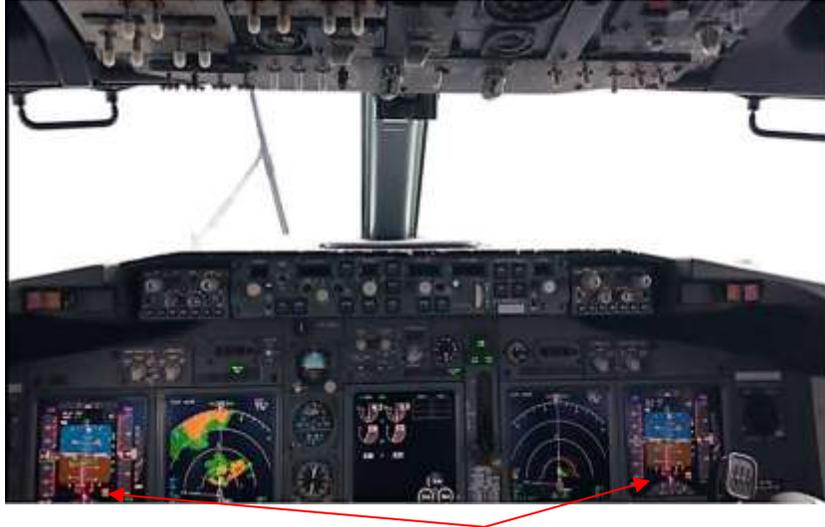
The investigation determined that the pilots of P2-PXE were fixated on the task of landing the aircraft and did not notice the steady visual **PULL UP** caution alert at the bottom of their Primary Flight Displays (PFD). Therefore, they (pilots) did not take any positive action to arrest the high rate of descent and avoid landing in the lagoon. In fact, neither of the pilots were aware of the rapidly unfolding unsafe situation.

The investigation into this accident found that although there were numerous cues to the unsafe situation, the Honeywell EGPWS MK V Mode 1 did not provide sufficient aural WARNING alert that required immediate action by the pilots, at very low altitude, with excessively high rate of descent.

Figure 1: Image from PXE cockpit video⁸ showing **PULL UP** on PFD display

A recommendation was issued to Honeywell Aerospace to ensure that the Honeywell EGPWS MK V Computer provides timely and continuous hard aural **warning** “*WHOOP WHOOP PULL UP,*” simultaneously with the visual display of **PULL UP** on the Primary Flight Displays, which would require immediate action from the crew, when encountering an excessive Rate of Descent at very low Radio Altitude, similar to that encountered by the crew of P2-PXE as shown in Figure 1. (Refer to recommendation *AIC 19-R02/18-1004* to Honeywell Aerospace) on the 31st January 2019.

The PNG Accident Investigation Commission recommends that the Federal Aviation Administration should re-evaluate TSO’s 151b and 151d and DO-367 related to EGPWS warnings and cautions, and ensure that the Honeywell EGPWS MK V Computer provides a **timely warning** in the form of a continuous **flashing** visual display of ‘**PULL UP**’ at the bottom of the Primary Flight Displays, as an absolute minimum standard. A **flashing** visual display ‘**PULL UP**’ warning, accompanying an aural ‘SINK RATE’, would require immediate action from the flight crew when encountering an excessive Rate of Descent at very low Radio Altitude, similar to that flown by the crew of P2-PXE.

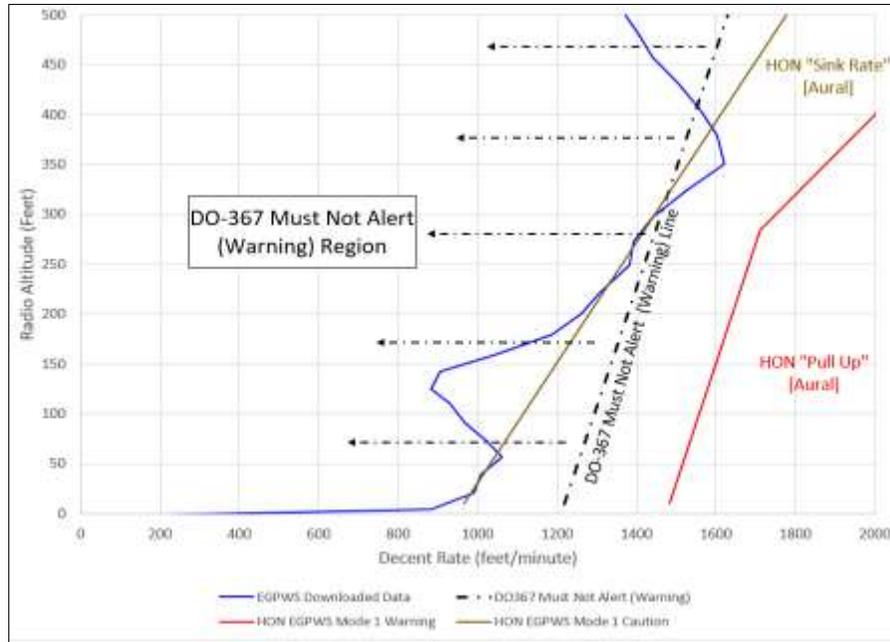
The *Honeywell EGPWS Mk V Computer* was certified by the FAA, in accordance *TSO-151b*. However, *TSO-C151b* did not contain clear and precise requirements for caution and warning alerting curves as set out in the newer *TSO-C151d* and *DO-367 (MOPS)*.

Furthermore, the minimum operational standards set out in *DO-367 (MOPS)* as depicted in **Figure 1** below shows the *DO-367 ‘Must Not Alert’ (Warning) Region*, plotted against the *Honeywell EGPWS Mode 1 Alerting Envelope*. It is precisely in this region, at very low altitude and excessively high rate of descent that PXE was flown.

Figure 2. Mode 1 Sink Rate Alert Curves with *DO-367 ‘Must Not Alert (Warning)’* requirement¹⁰
