**Safety recommendation: AIC 19-R18/18-1004**

**Addressed to: Jeppesen**

**Investigation link: AIC 18-1004**

On Friday 28 September 2018, a Boeing 737-8BK aircraft, registered P2-PXE, was being operated by Air Niugini Limited, on a scheduled passenger flight from Pohnpei to Chuuk, Federated States of Micronesia.

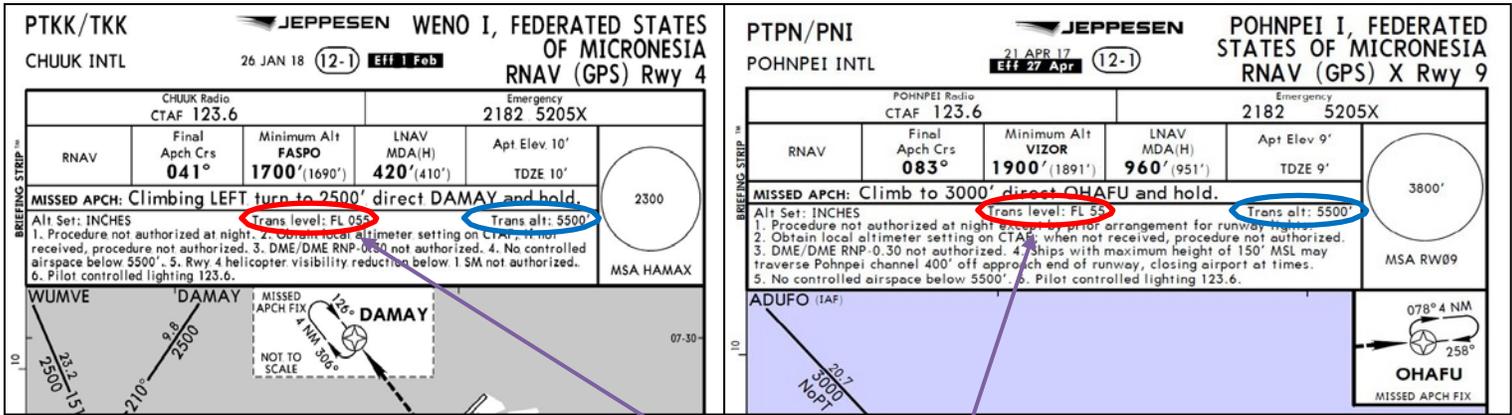
The investigation found that the terminology used to indicate the *Transition Level*<sup>7</sup> on the approach chart as shown in Figure 1 was not consistent.

On the Chuuk RNAV (GPS) Rwy 04 chart, Jeppesen indicates the Transition Level as **Trans: FL 055** and as **Trans: FL 55** on the Pohnpei RNAV (GPS) X Rwy 09 as depicted in Figure 1, although both are referring to the same thing (Trans alt: 5500’, see Figure 1).

**Figure 1: Jeppesen (Chuuk International & Pohnpei International) charts showing the inconsistent terminology used to indicate *Trans level: FL 055* and *Trans level: FL 55*.**

Furthermore, the inconsistent use of terminology(s) can bring confusion and risk of comprehension errors when briefing the instrument approach plate, thus inducing the risks of pilot input errors.

The PNG Accident Investigation Commission recommends that Jeppesen should ensure that standard terminology is used on both (Chuuk RNAV (GPS) Rwy 04 and Pohnpei RNAV (GPS) X Rwy 09) instrument approach charts. Jeppesen should also ensure that terminologies and the layout used on all Jeppesen Instrument approach charts are consistent and standardised.

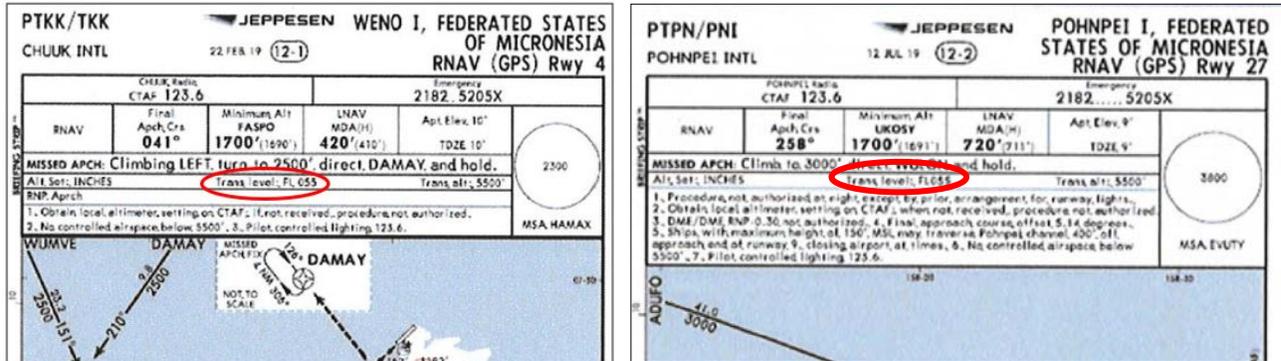
**Figure 2: Jeppesen (Chuuk and Pohnpei Airport) charts showing the amended terminology used to indicate *Trans level: FL 055*. Example of change promulgated on the full suite of charts.**

*In reply to Section 4.2.17 Recommendation number AIC 19-R18/18-1004 Jeppesen has updated for consistency the charts for PTPN, PTRO, PTSA airports per the AIC finding so that all transition levels read FL055. The revised charts were released with this correction on 12 July 2019.*
