**FINAL REPORT**

**AIC 16-1004**

**PACIFIC AEROSPACE PAC 750XL**

**TOUCHDOWN OFF HARD SURFACE OF STRIP  
SUBSEQUENT LOSS OF CONTROL**

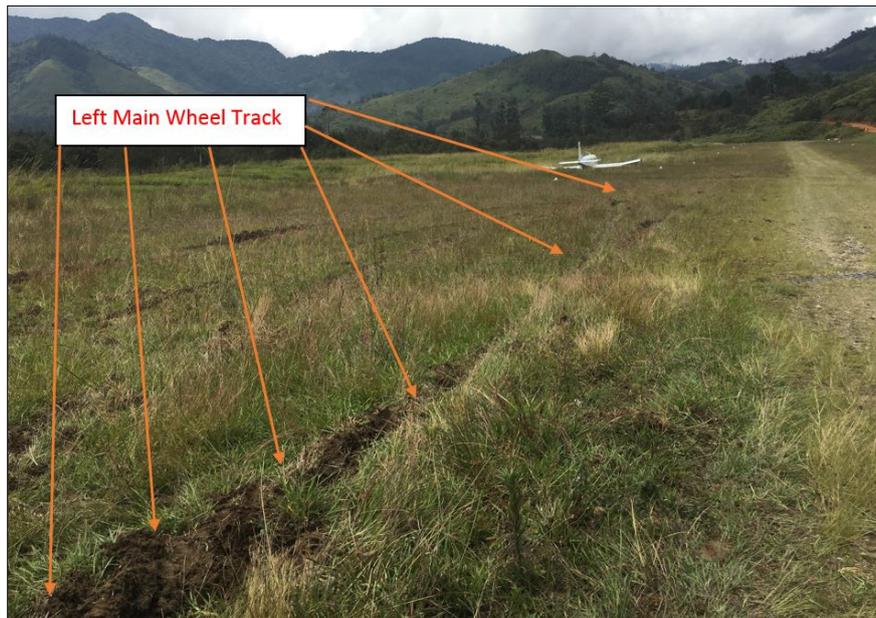
**Figure 2: Evidence of the start of runoff**

Because of many years of lack of airstrip maintenance, and heavy rainfall, water runoff had shifted a lot of soil, including airstrip gravel down the runway, and deposited it on the grassed area along the south-western side of the strip. During heavy rain, those parts of the airstrip became extremely soft. Much of the gravel on the centre of the strip had been washed away, exposing stones. The drain that ran across the southern length of the strip was blocked, causing the rain water to flow along the edges of the strip's gravel surface.

The nose-wheel and the right main wheel touched down on the gravel area of the strip. The left main wheel touched down on the grassy area about 1 metre left of the gravel surface of the strip. The left main wheel sank into the soft ground, and the aircraft continued along the soft grass, with that wheel dragging through the grassed muddy side of the airstrip.

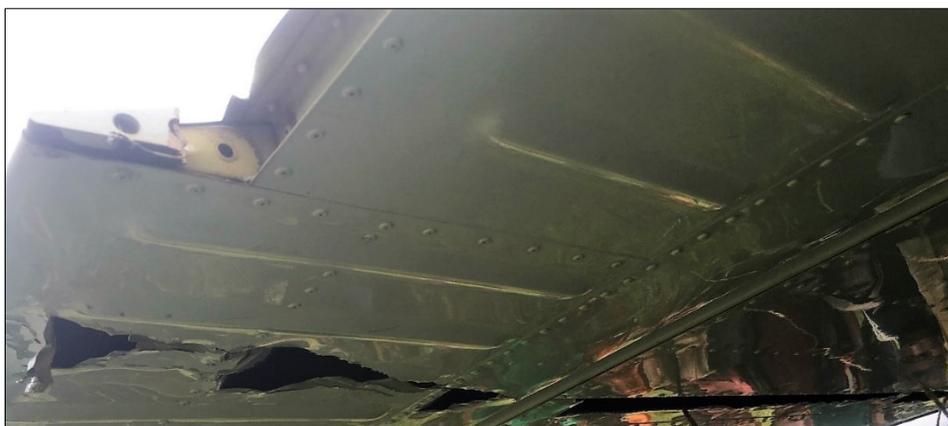
**Figure 3: Damaged left wing lower skins**

The left wing lower surface was damaged by the steel star-picket fence posts, puncturing the left main fuel tank, and fuel leaked from that tank. The left aileron trim tab fractured. There were a number of tears in the left wing's lower surface skins. There was no apparent structural damage.

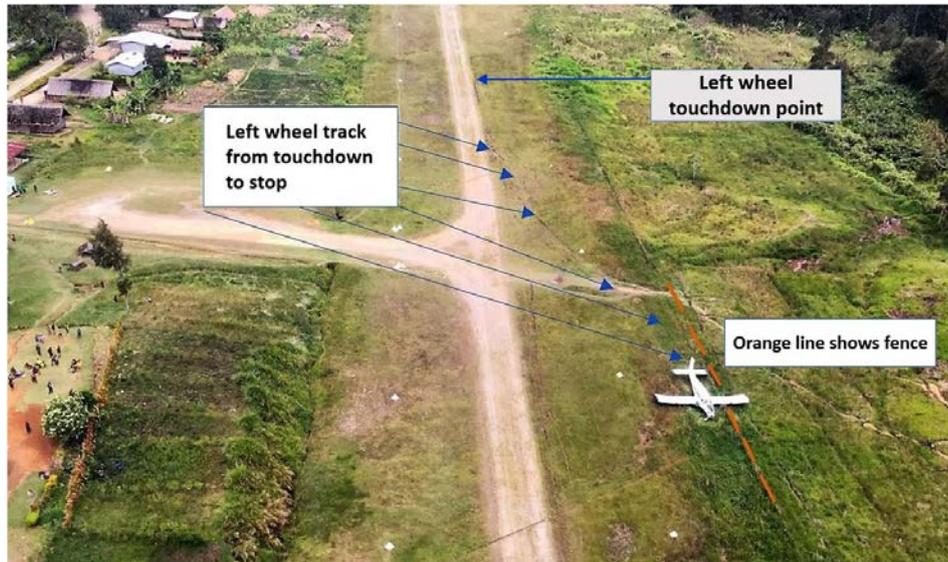
**Figure 4: Aircraft track after touchdown**

When the pilot applied reverse thrust the aircraft veered to the left and then turned left sharply, diverging further through the extremely soft grass covered surface towards a fence. The pilot reported applying reverse thrust and kicking the brakes and right rudder to turn the aircraft right. The left wing's lower surface impacted a fence before the aircraft stopped. The pilot shut down the engine, and evacuated the passenger.
