FINAL REPORT

AIC 12-1004

P2-MHC

Cesna Aircraft Company U206G

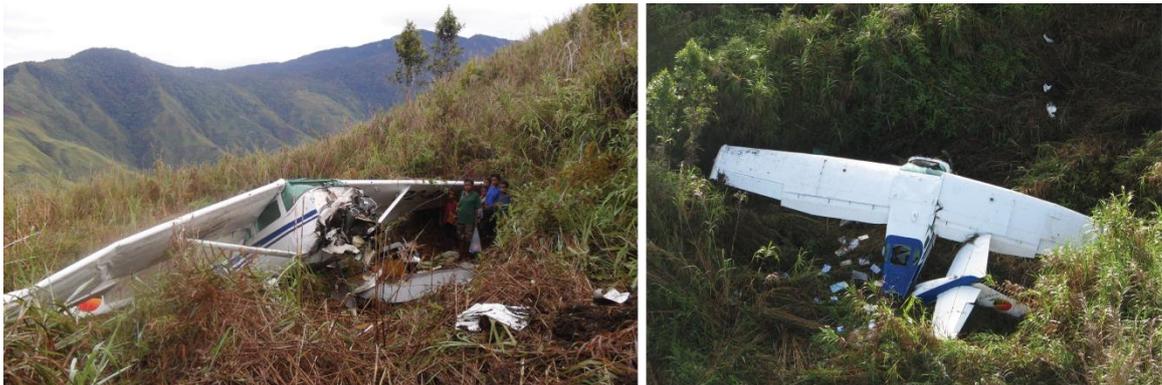
Figure 2: Cessna U206G, P2-MHC wreckage

The aircraft was substantially damaged by impact forces. There was no fire.

The tail section of the fuselage and the empennage were broken and bent upwards (Figures 2 and 4). This indicates that at the time of impact, the tail section’s centre of gravity was below the aircraft’s centre of gravity, and that the aircraft must therefore have impacted the ground in a nose-up attitude.

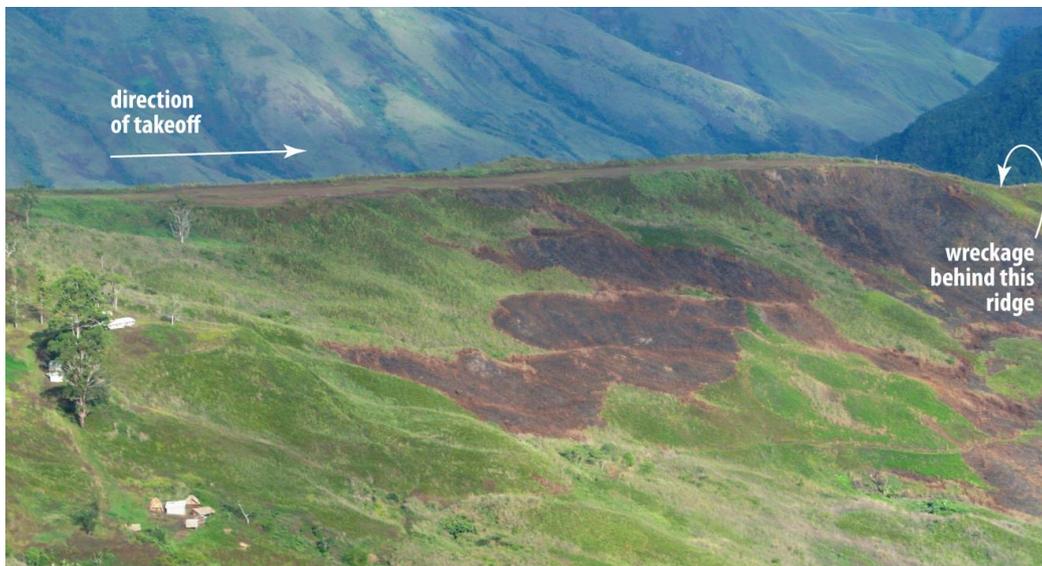
Figure 3: Guari airstrip viewed from the south east

The pilot described the runway as being in ‘quite bad condition’, with small bushes growing on it and with tall cane grass just beyond the threshold of runway 12.

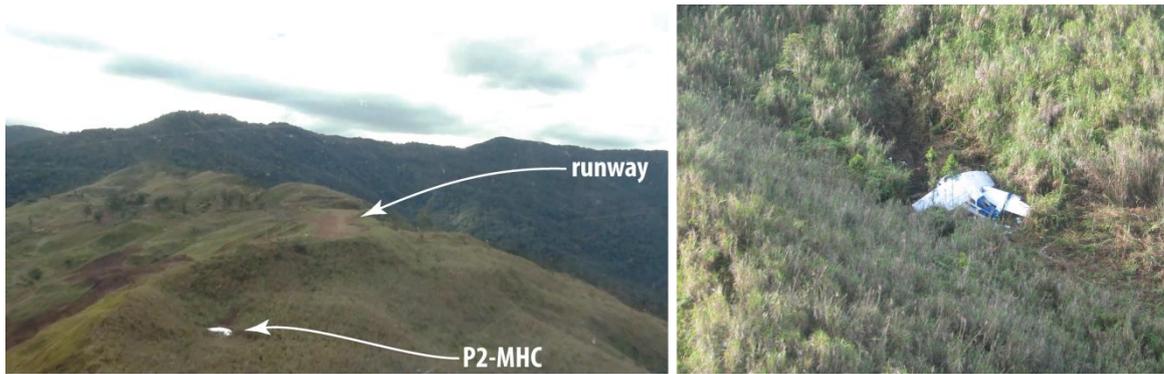
Figure 4: Accident site and wreckage of P2-MHC

The aircraft impacted the ground at the base of a steep bank that was an extension of the ridge on top of which the runway was situated (Figure 4). The impact occurred short of the threshold of runway 12, and below the level of the runway. With the exception of the engine and propeller that separated from the fuselage, the wreckage was confined to the general

The tail section of the aircraft had broken upwards off the fuselage. The investigation determined that the centre of gravity of this section must therefore have been below the aircraft's centre of gravity when the aircraft struck the ground. This indicates that the aircraft was nose-high when the tail section broke off and is consistent with the pilot raising the nose in an attempt to minimise the impact.

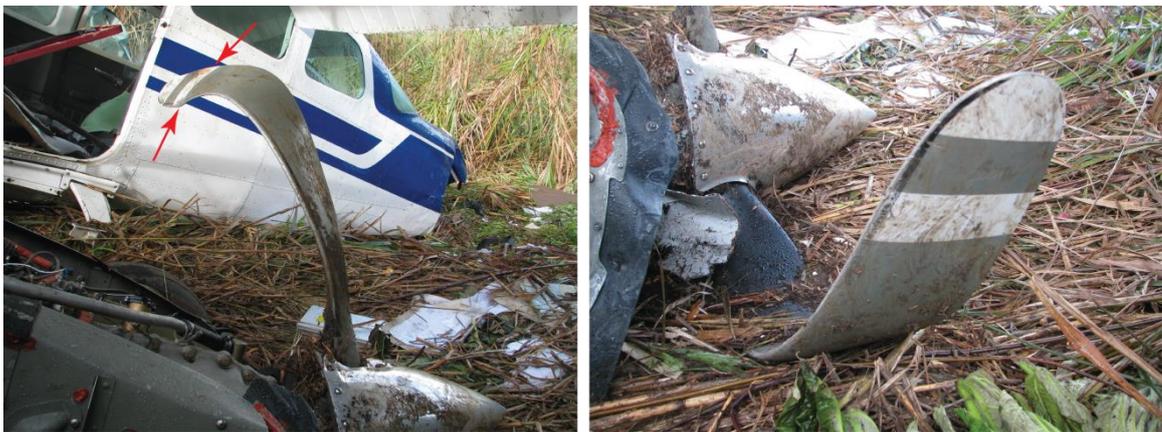
Figure 5: P2-MHC propeller blades

The nature of the chord-wise twisting of the propeller blades (Figure 5) and the bending of one of the blades (marked by red arrows in Figure 5) indicate that the propeller was rotating when the impact occurred and that it was not being driven at high power. This may mean either that the propeller was turning because the engine was producing low to moderate power, or that the propeller was wind-milling and was not being driven by the engine at all. Neither scenario can be eliminated on the basis of the bending of the propeller blades.

The way in which the propeller blades were twisted indicates that the propeller was rotating when the impact occurred. It was not possible to determine whether this was at a low engine power setting or because it was wind-milling.

8. The aircraft was destroyed by impact forces.
9. There was no evidence of pre- or post-impact fire.
10. Propeller blade damage and twist was consistent with the propeller turning because the engine was producing low to moderate power, or that the propeller was wind-milling and was not being driven by the engine.
