FINAL REPORT

AIC 16-1003

Hard landing

N8841X

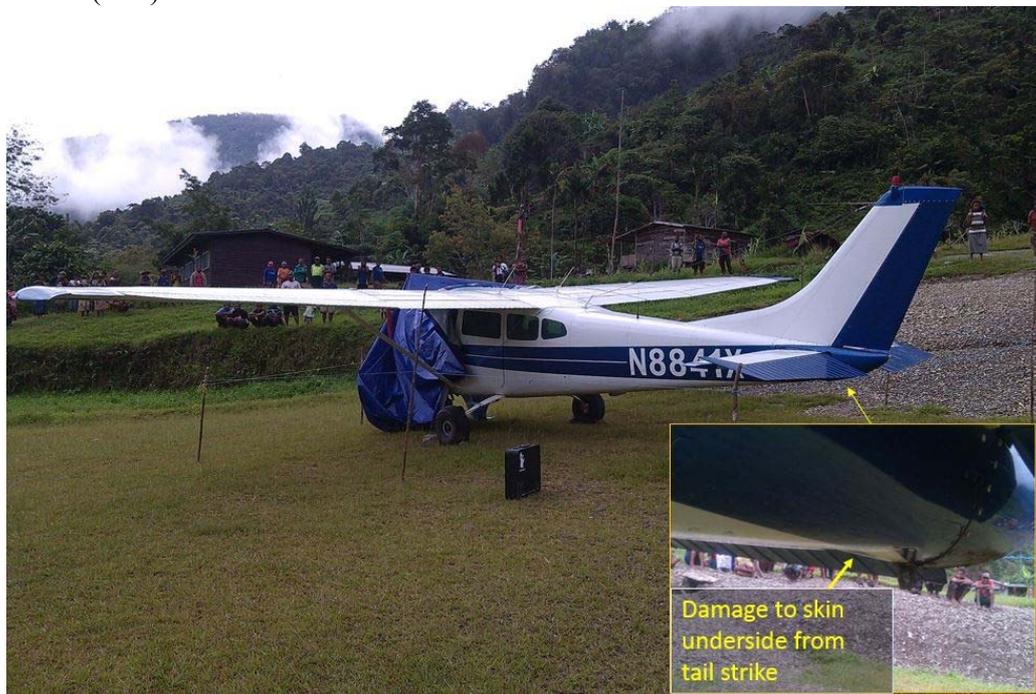
Figure 3: Aircraft at Tumolbil after accident

The AIC investigators arrived at the scene at 03:00 on 26 June 2016. The on-site inspection of the aircraft, revealed a dent about 10 cm in diameter on the airframe across the bottom of the tail (Figure 3). All the primary controls were found to be operating freely through their full extent and in the correct sense. The elevator trim wheel was quite stiff, but could still be moved with a bit of effort, and through its full extent in both directions. However, the rudder trim wheel, appeared to be slightly off its designed position. Several attempts were made to rotate it, but it failed to rotate past 30 degrees (Figure 4). When viewed closely using a borescope through its indicator window, the rudder trim knob appeared to be significantly displaced. The engine firewall and the bulkhead assembly tunnel behind the firewall were substantially damaged. That damage compromised the integrity of the trim cables.

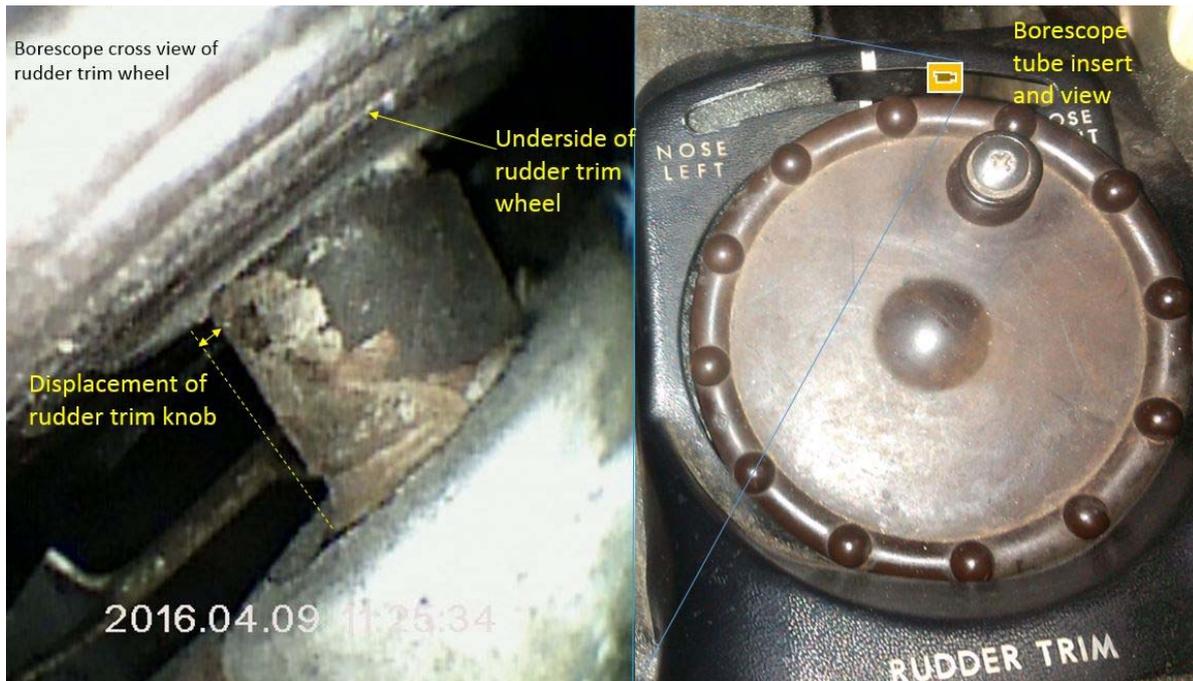
Figure 4: Rudder trim analysis
