**FINAL REPORT  
AIC 18-1001**

**Lynden Air Cargo and Air Niugini Limited  
N403LC and P2-PXE  
Lockheed Hercules L-382 and Boeing 737-800  
Collision during taxiing  
Parking Bay 23 and Bay 22, Jacksons International Airport  
National Capital District  
PAPUA NEW GUINEA  
12 May 2018**

# Taxiing collision — Lockheed Hercules L-382 and Boeing 737-800

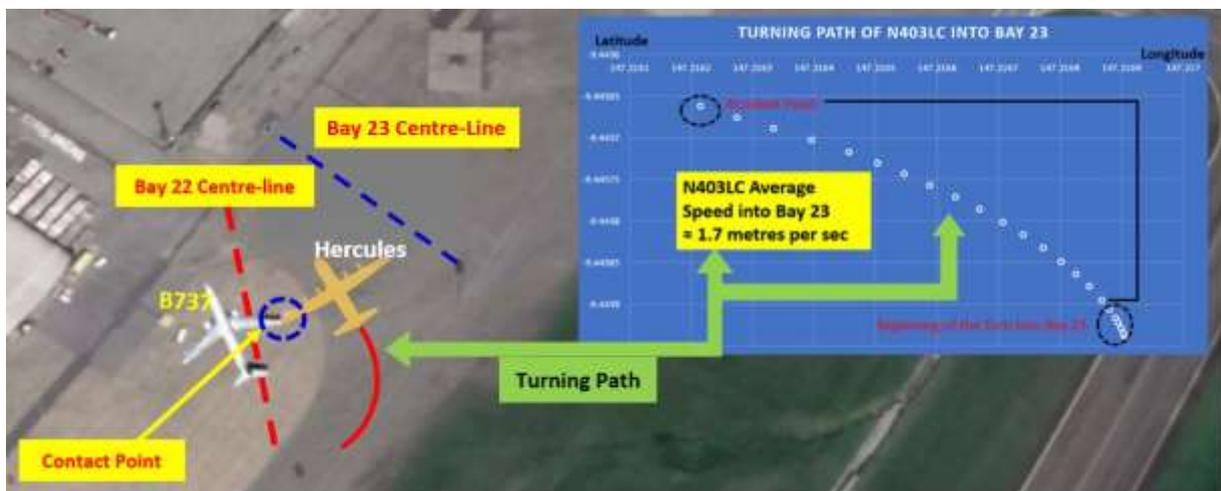
Figure 3: Depiction of aircraft on the parking bays

The investigation determined the speed of the Hercules was 3.3 knots (1.7 metres/second). (Figure 3)

The Boeing 737 wingspan is 34.1 metres and the Hercules wingspan 40 metres. The Bay 22 centreline was not parallel to the Bay 23 centreline.

That provided less distance between the lines as aircraft moved further along the lines. Bay 23 was suitable for Boeing 747 aircraft with a wingspan of 64 metres. The distance between the parking Bay centrelines abeam the right wing-root of the parked Boeing 737 was 46.2 metres.

The investigation found that the centreline of the Boeing 737 fuselage adjacent to the wing root was 6.5 metres to the left of the Bay 22 centreline. The nosewheel of the Hercules was 15.7 metres left of the Bay 23 centreline.

The investigation found that the PIC did not taxi via the Bay 23 centreline, but was 15.7 metres to the left of the line. Bay 23 is designed for Boeing 747 parking which provides for a wingspan 24 metres longer than the Hercules. If the Hercules had been taxiing on the Bay 23 centreline and if the parked Boeing 737 was on the Bay 22 centreline there would still have been a safety margin of 8 metres between the wing tips.

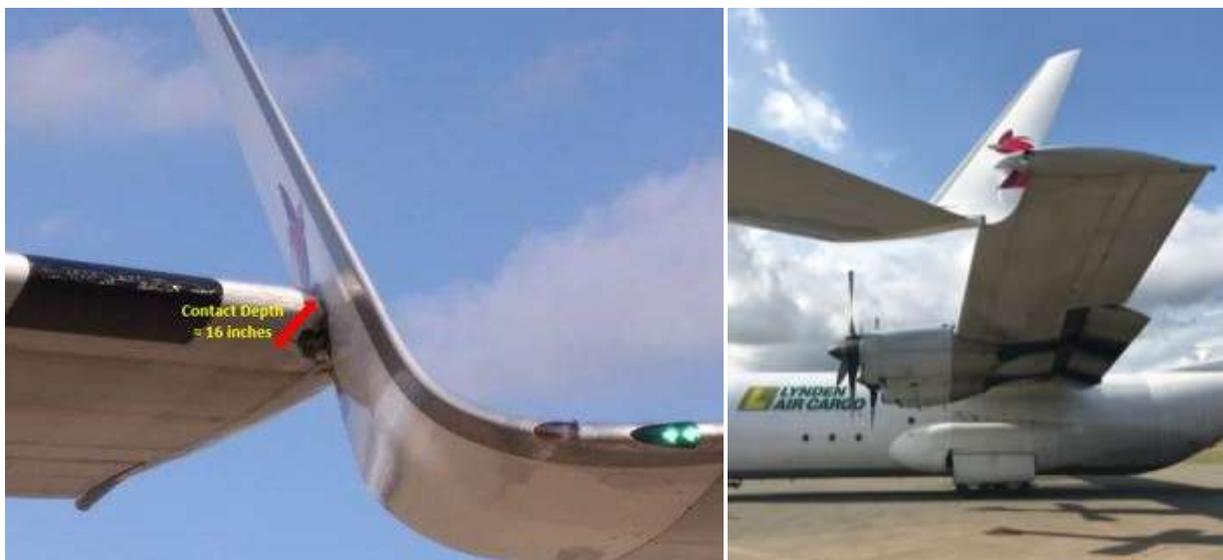
**Figure 4: Damage to both aircraft**

The leading edge of the left wing of the Hercules impacted the right winglet of the Boeing 737 causing significant damage to both aircraft. The Hercules leading edge penetrated the Boeing 737 blended winglet to a depth of 40.64 mm (16 inches).

The damage to the B737's "upward-swept extension to the airplane wings" termed blended winglet was significant requiring replacement. The damage to the Hercules wing was listed by the Operator's Maintenance Organisation as structure requiring major repair. Therefore, it was categorized as an accident.

The Hercules Operator's Maintenance Organisation provided details of the repairs to the Hercules wing. The log stated: *Aircraft structure that requires major repair*. The repairs included replacement of the upper forward wing tip fitting, rib and leading edge.
