FINAL REPORT

AIC 12-1006

Undershoot; landed in water

P2-SBA

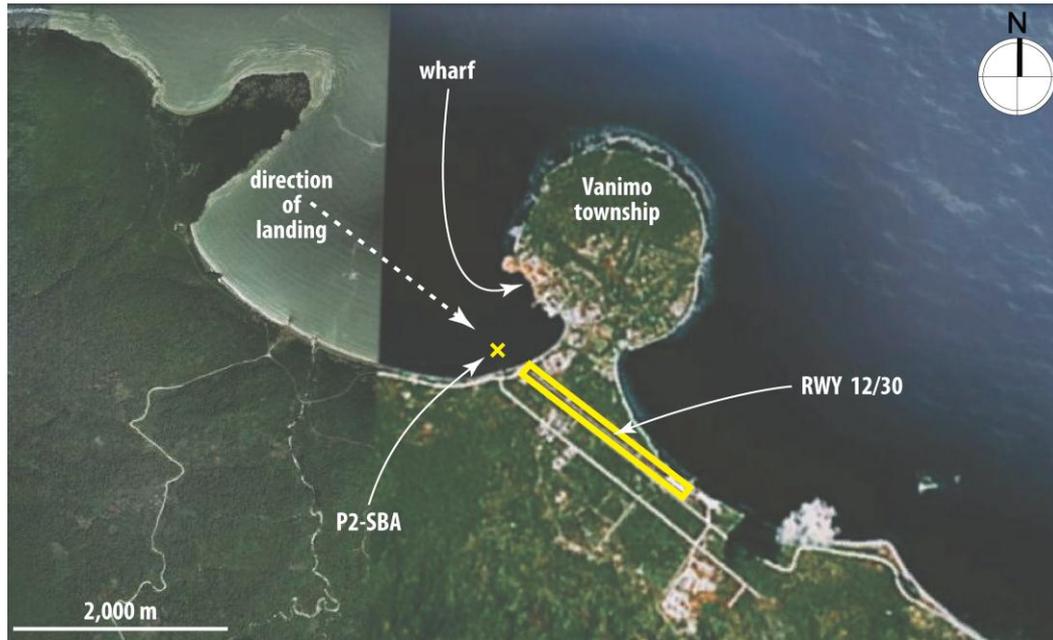
Figure 2: Vanimo Airport and location of the accident

On 11 June 2012, the PNG AIC was informed about a Britten Norman BN-2T aircraft that struck the water about 40 metres short of the threshold of runway 12 at Vanimo Airport, Sundaun Province. The aircraft settled into the water. None of the occupants were injured.

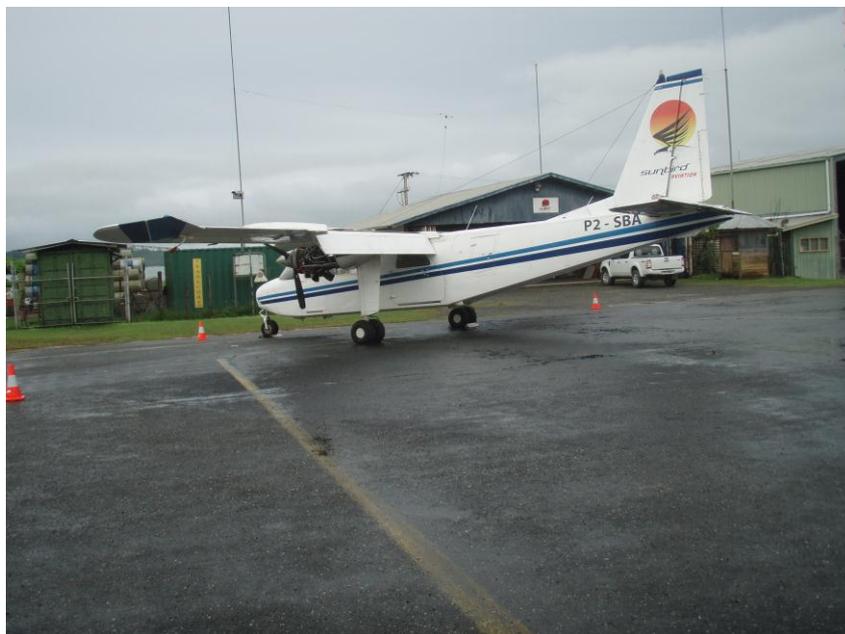
Figure 3: P2-SBA after recovery from the water

There was no significant impact damage to the airframe or engines. However, the aircraft was substantially damaged due to sea water ingestion in the engines and airframe.
