FINAL REPORT
SERIOUS INCIDENT INVESTIGATION
AIC 17-2002

P2-502

CASA CN235-100M

Landed on closed runway

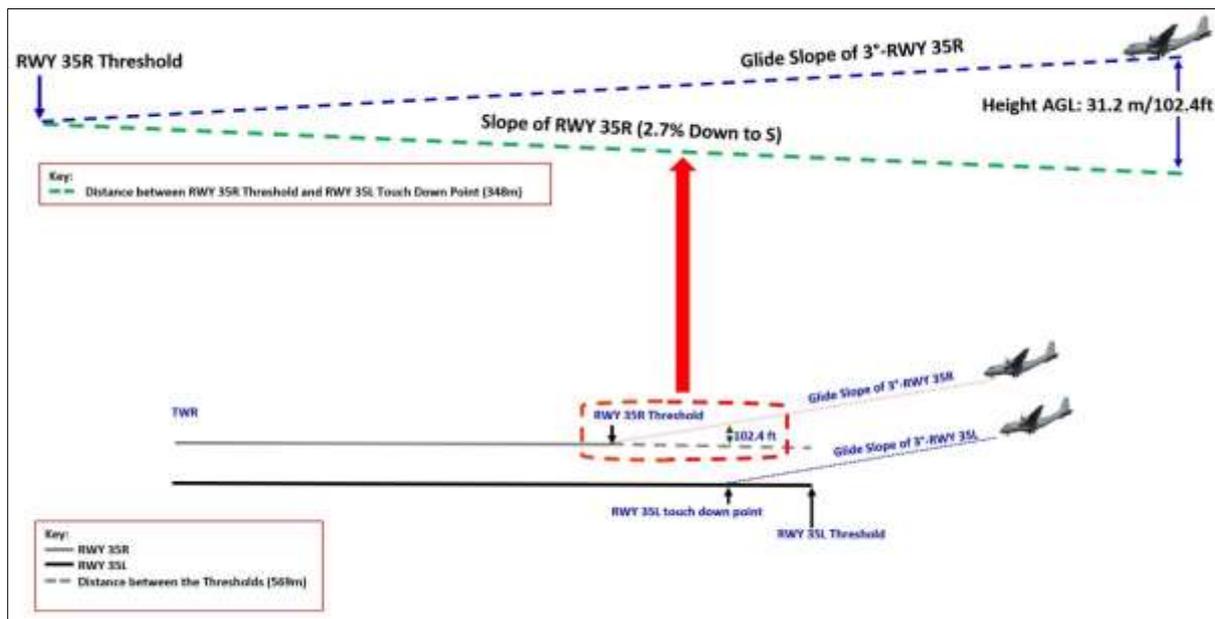
Figure 3: Diagram of glideslope relationship to the runways at Goroka Airport

“...when just before the cone markers (abeam taxiway ‘D’) he lifted the plane slightly and landed going past the cone markers and onto the freshly sealed portion of the Runway 35Left”.

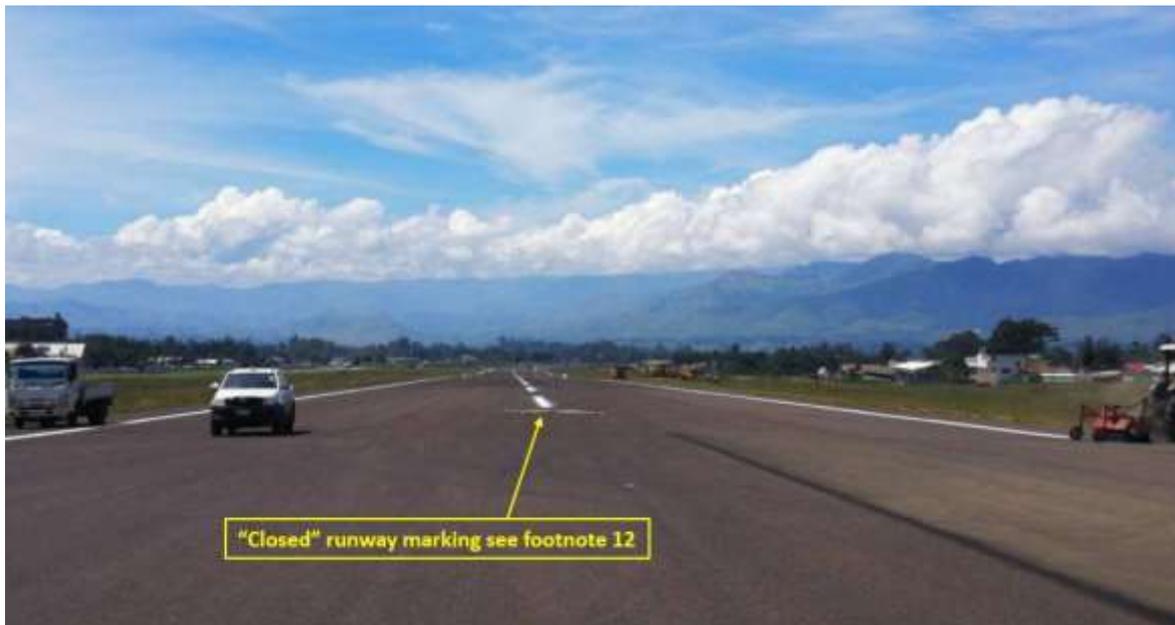
Figure 4¹³. Runway works in progress viewed from runway 17 Right.

There were no runway closure markings, nor was there any taxiway closure marking as required by Annex 14 (see Attachment C), and in accordance with the *MOWP* required by *PNG CAR Part 139*.

The runway was not marked in accordance with the *ICAO Annex 14* requirements and the approved *Method of Works Plan*. That was also a contributing factor that led to the potentially unsafe landing on the closed Goroka runway during construction works.

¹³ Picture taken subsequent to the landing, and after remedial safety action was taken by NAC to mark the closed runway in accordance with the approved Method of Works Plan.

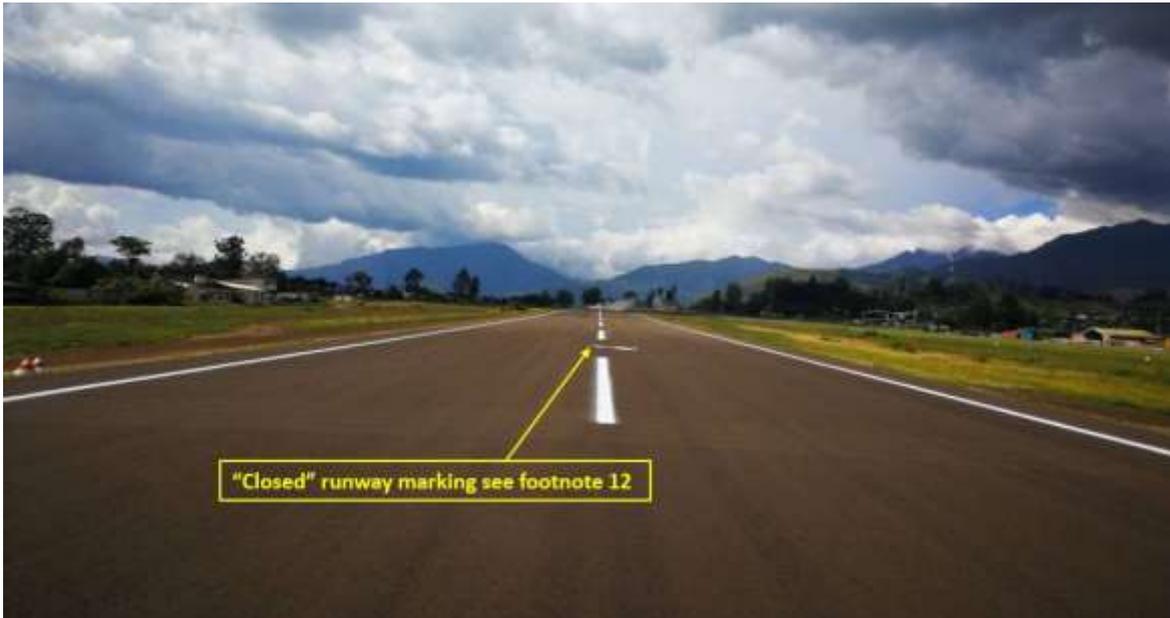
Figure 5. Runway 35 Left viewed from the landing point.

Eagle 502 touched down a quarter of the way along the newly paved runway 35 Left. There was runway construction work in progress (WIP). The construction workers were monitoring the Goroka tower radio frequency. They heard the after-landing radio communications between Eagle 502 and the tower controller, when the PIC realised his error and the controller gave Eagle 502 the back-tracking taxi clearance.
