**FINAL REPORT
AIC 18-1002**

**Air Vanuatu Operations Limited
YJ-AV71**

ATR 72-500

Loss of directional control during landing roll

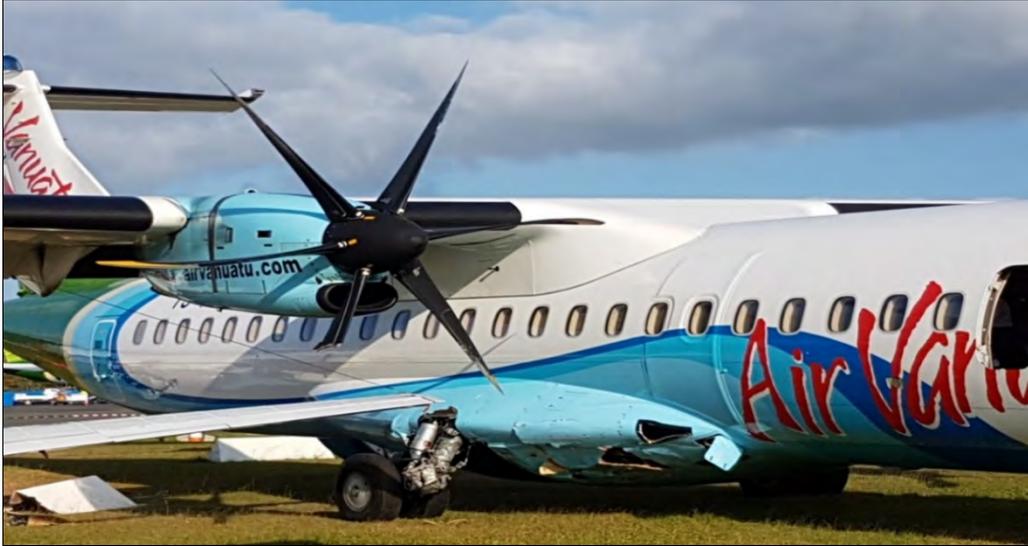
The ATR sustained significant damage to the right side of the *fuselage, propeller assembly, right-main landing gear nacelle* and *nose landing gear door* structure. The *No. 2 engine* was substantially damaged (see *Section 1.6.1.4*).

Figure 3: AV71 Right fuselage impact damage

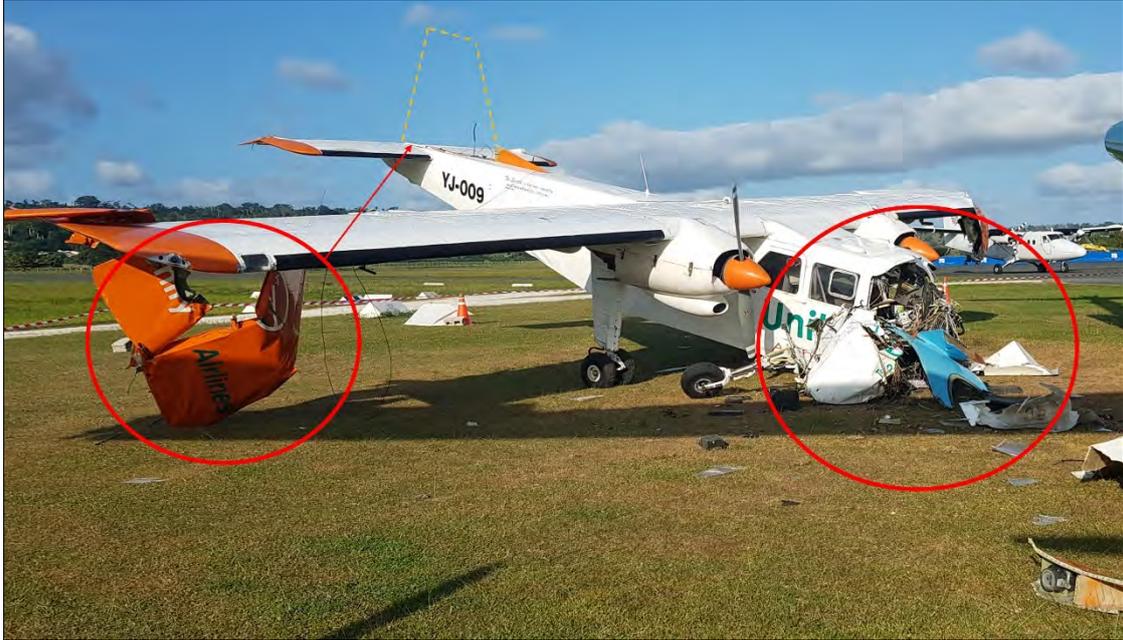
The outboard section of the left wing (YJ-OO9) was substantially damaged and the rudder and vertical stabiliser were sheared off the aircraft (see Figure 5).

Figure 5: BN-2 Islander, YJ-009 destroyed by the starboard-side of AV71

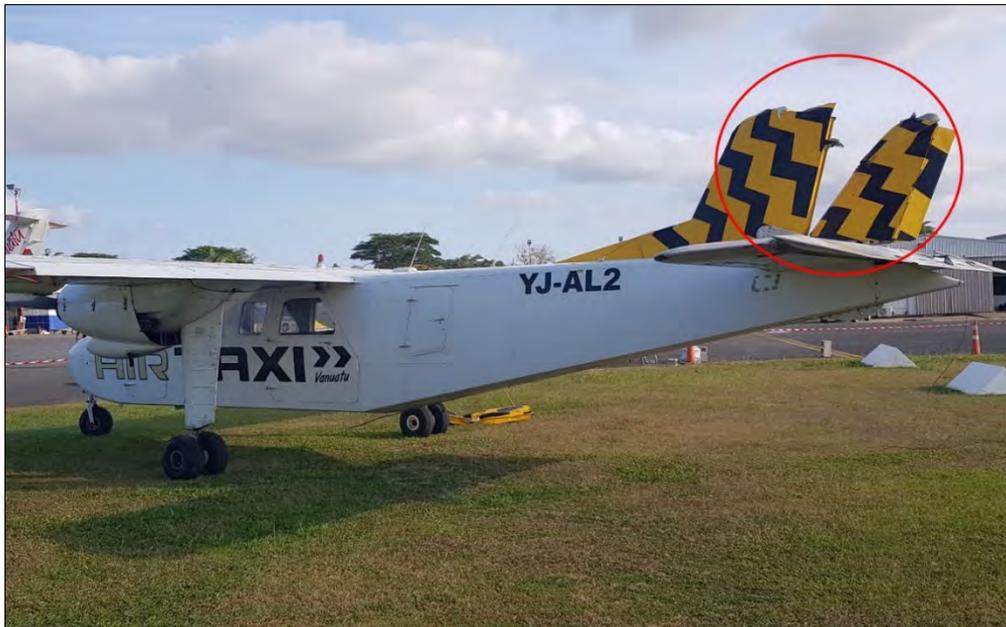
YJ-AL2, also sustained vertical stabiliser and rudder damage from impact with the left side of AV71. The upper hinge of the rudder was dislodged (*see Figure 6*).

Figure 6: BN-2 Islander damaged by the left side of AV71

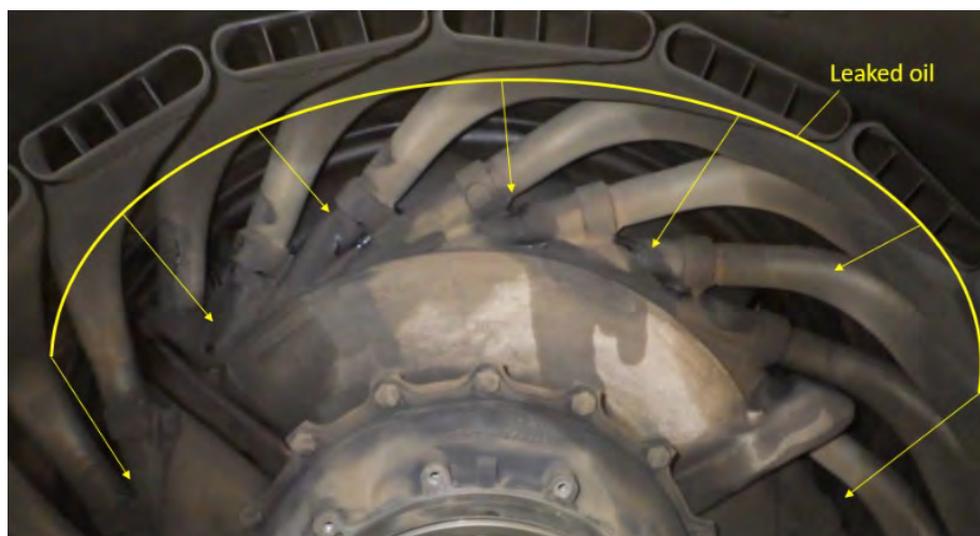
When the *combustion chamber* was removed, evidence of an internal oil leak was observed.

Figure 9: Evidence of oil leak

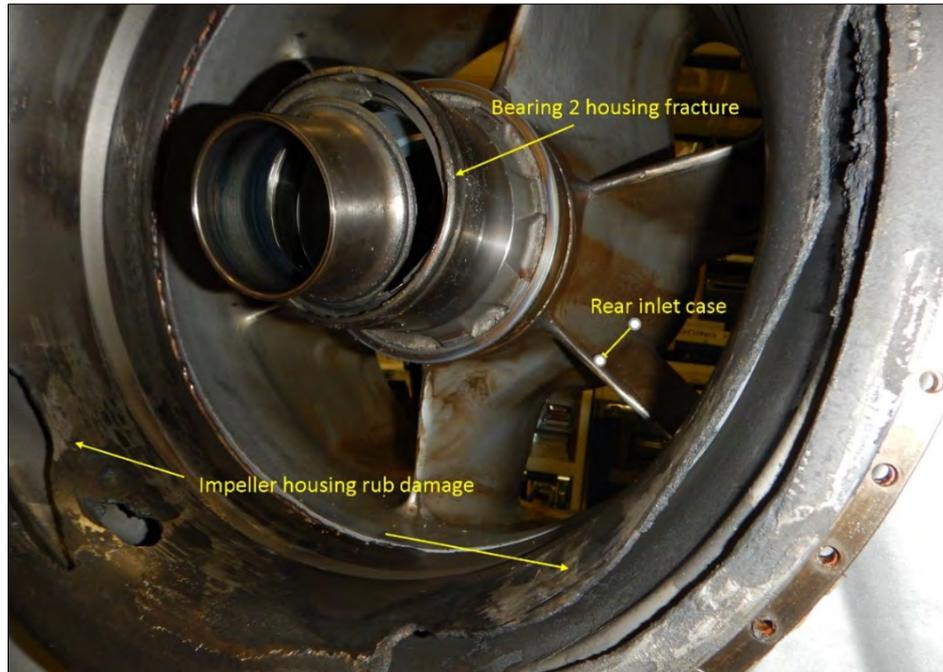
When the *rear inlet case* was removed, evidence of rubbing at the *impeller shroud housing* and three large perforation areas was observed (see *Figure 10*). The *No. 2 bearing housing* was circumferentially fractured adjacent to the *No. 2 bearing outer race* location as a result of rubbing against the *low-pressure impeller blade profile*, the *bore*, and *forward face* (see *Figure 10 & 11*). These indicated that the *low-pressure impeller* moved forward into its *low-pressure impeller housing*. Engine oil and rubbing marks were observed on the back face of the *impeller* (see *Figure 12*).

Figure 10: Rear inlet case and impeller housing

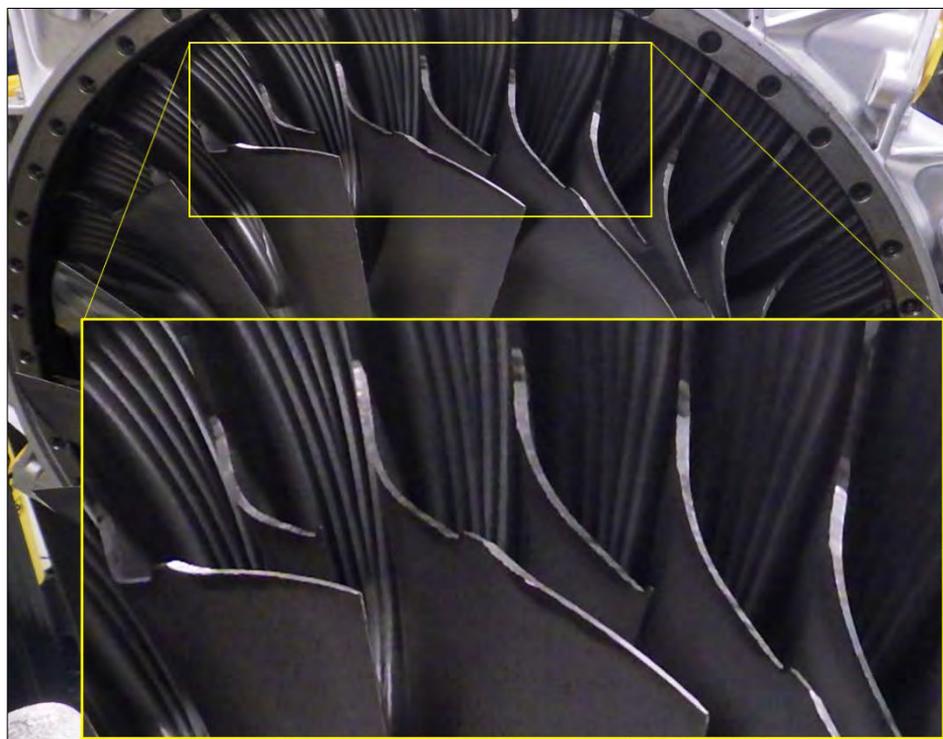
Figure 11: Low-Pressure Impeller blade wear

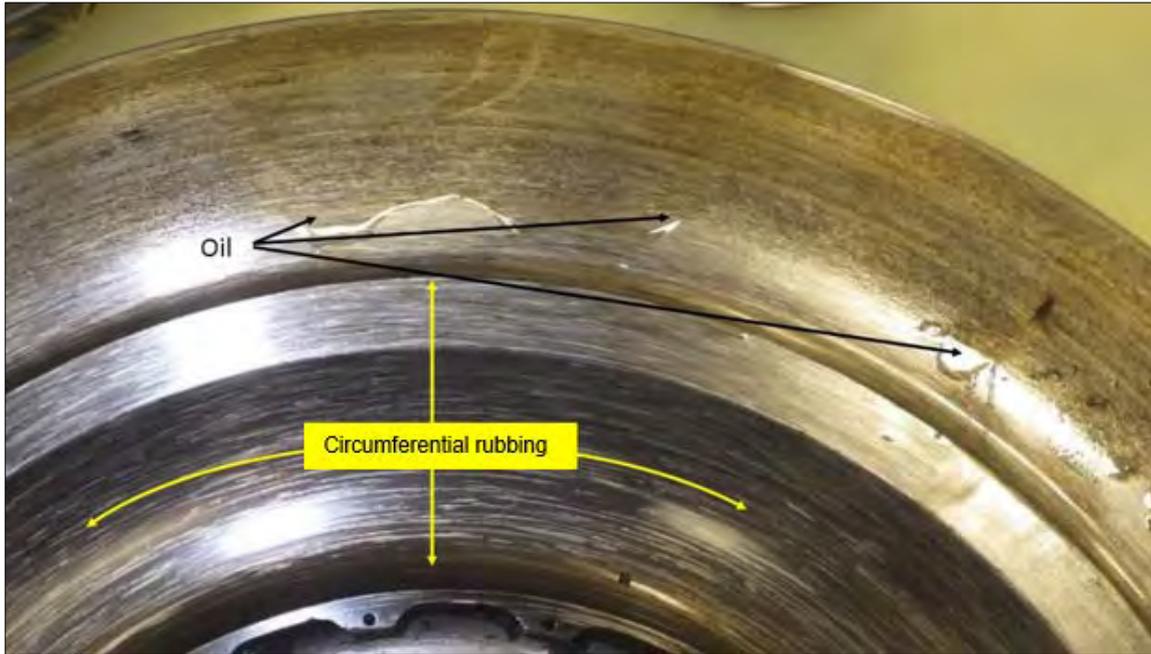
Figure 12: Impeller back surface

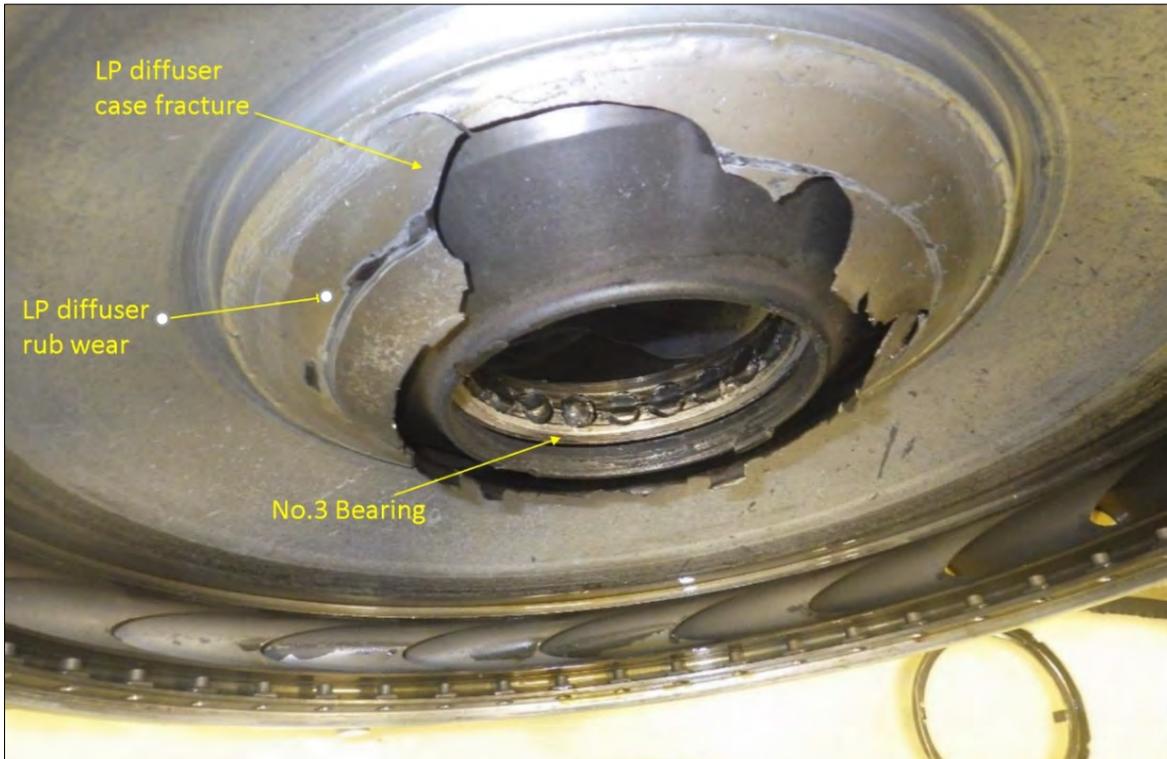
When the *diffuser case* was removed and examined, fractures were observed at several locations. Circumferential rubbing marks were also noticed on the *low-pressure diffuser*, which were consistent with *low-pressure impeller contact* (see *Figure 13*).

Figure 13: Low-Pressure diffuser case

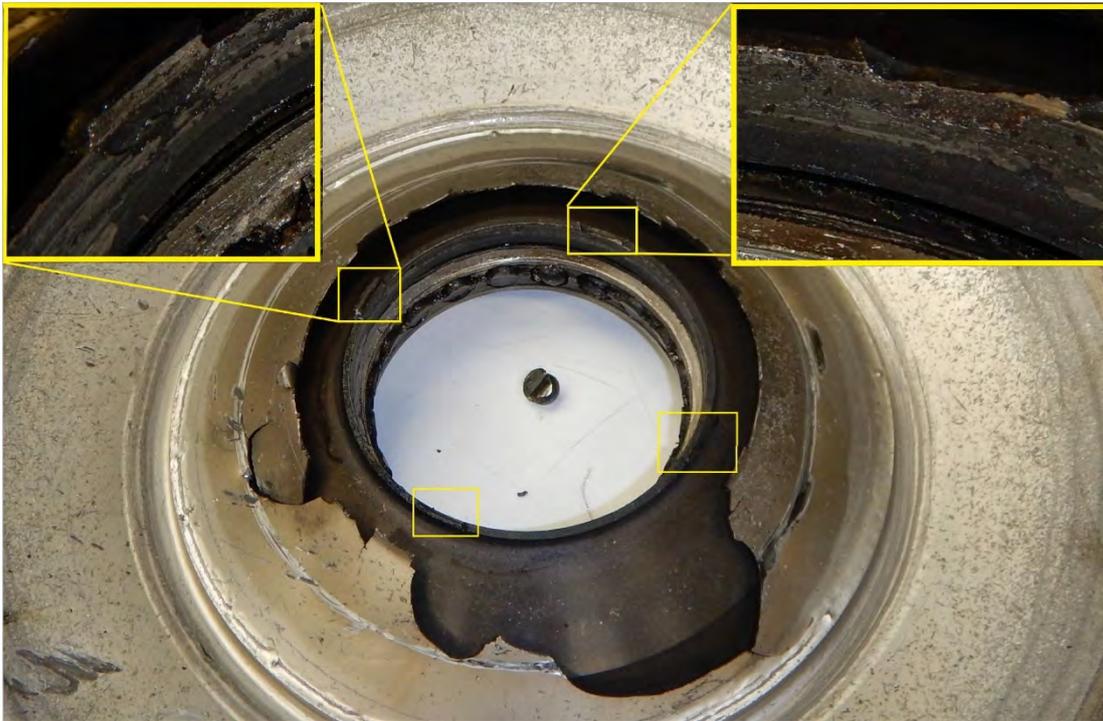
The *low-pressure diffuser case* had four fracture surfaces at the *No. 3 bearing stator seal web*. Three of fracture surfaces were completely obliterated during the event. One could only be observed through the microscope and showed fractographic features.

Figure 14: Low-Pressure diffuser case fracture surfaces stator seal web

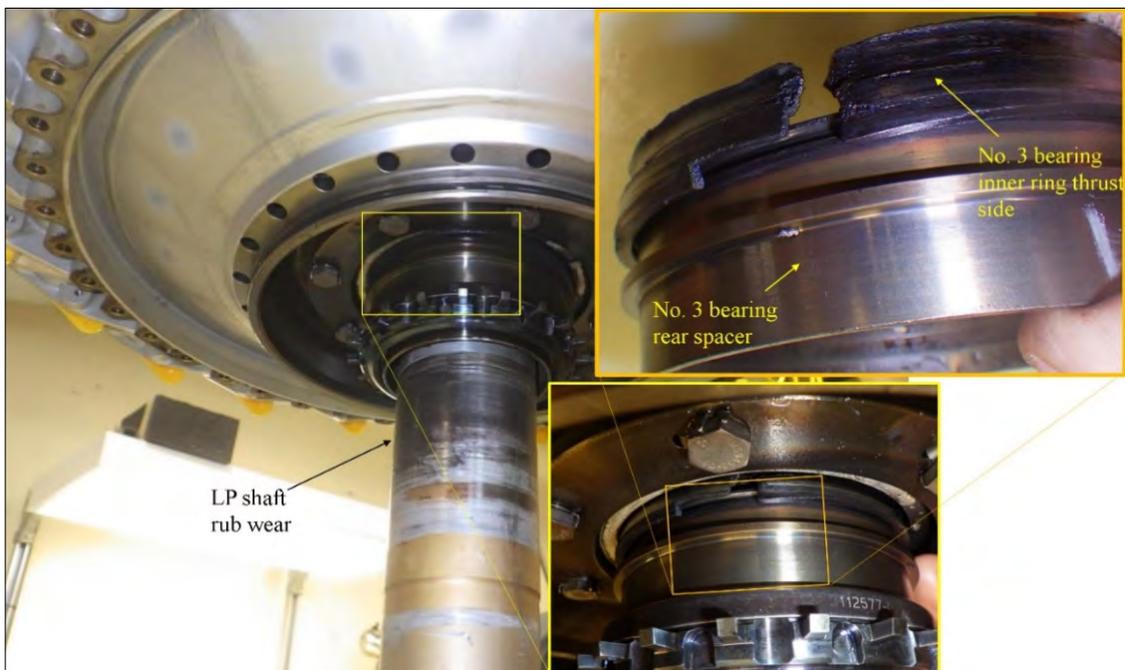
Rubbing wear was observed on the *low-pressure shaft* outside diameter at the *high-pressure impeller seal* area. The *No. 3 bearing inner race* was found fractured. The *No. 3 bearing rear spacer* was found underneath the *No. 3 bearing inner race* (see Figure 15).

Figure 15: No. 3 bearing inner ring & rear spacer

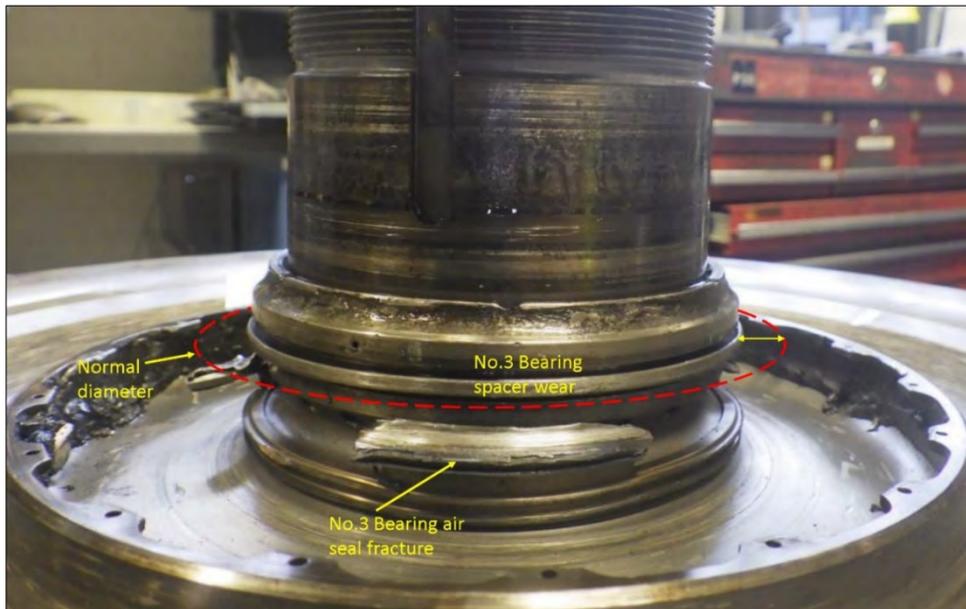
Wear marks were observed on the outer diameter of the *No. 3 bearing spacer (fwd)*. Fractures were observed on the *No. 3 bearing air seal* at several locations (see *Figure 16*).

Figure 16: No. 3 bearing spacer and air seal

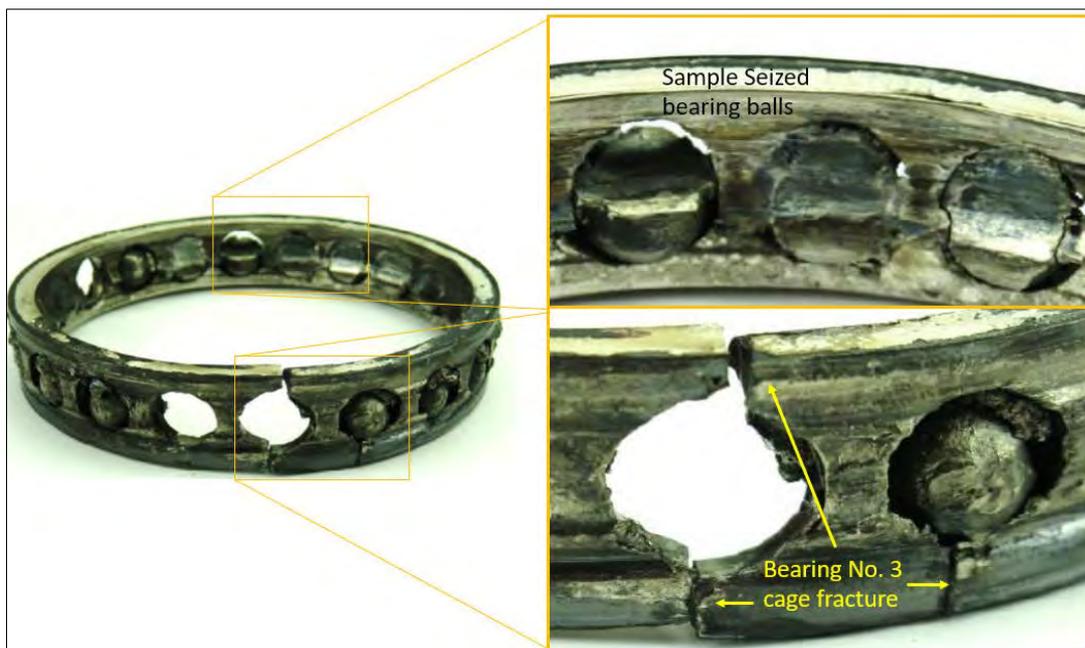
All the *No. 3 bearing balls* were seized inside the cage and showed heavy wear from rubbing against the *No. 3 bearing inner ring* thrust side. Rubbing wear was also observed on the *bearing cage*. The *bearing cage* was fractured at three locations, but did not show evidence characteristic of a ball bearing primary distress (see *Figure 17*).

Figure 17: No. 3 Bearing cage

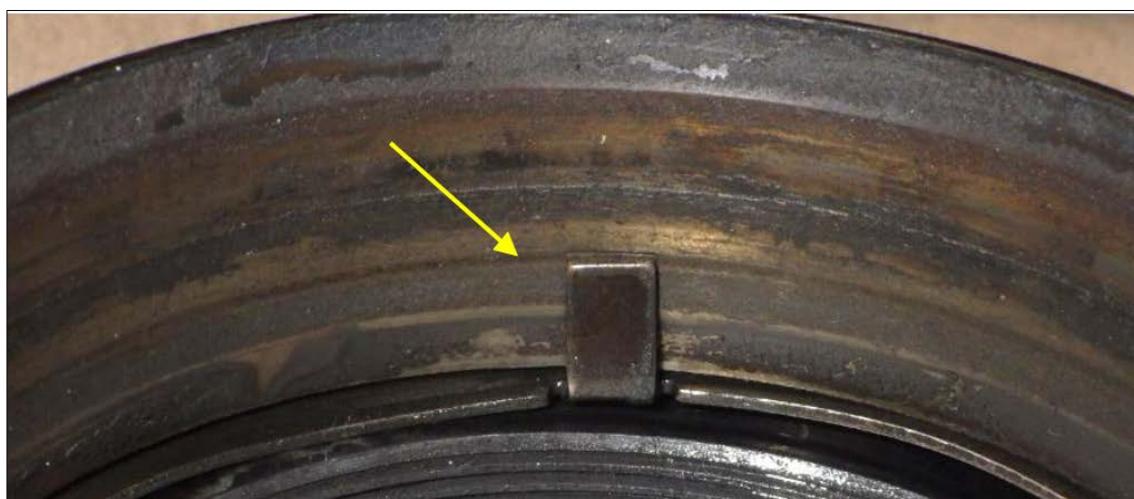
During the examination the *pulse pick-up runner*, the *key washer* and the *No. 3 bearing rear spacer* were mated together by the technician to identify the source of the circumferential wear observed at the inner diameter of the *No. 3 bearing rear spacer*. The *tang* of the *key washer* was believed to have induced the wear at the inner diameter of the *No. 3 bearing rear spacer* (see *Figure 18*).

Figure 18: No. 3 bearing rear spacer wear induced by the tang of the key washer

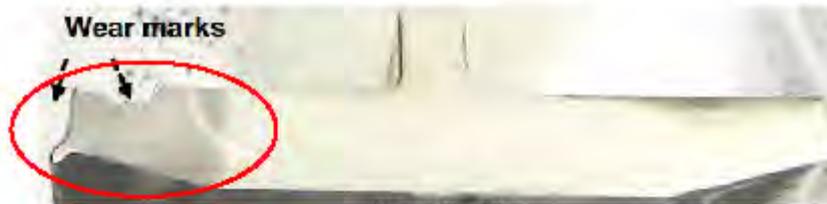
Photo No. 53

- 3.2 Magnified views of the cross section through the No. 3 bearing rear spacer showed the discoloration adjacent to the wear marks (red oval, Photo No. 53). The microstructure in the material and their relative hardness vary into the material. The material of the spacer hardened in the portion that was heated by friction transforming the tempered martensite into a re-hardened slightly tempered martensite and into an untempered as white martensite (Photos No. 54 to 58). The original microstructure in the non-affected zone revealed martensite as per drawing requirement. The hardness observed in the non-affected zone is as per drawing requirement. The hardness of the No. 3 bearing spacer becomes harder on the section that was heated.

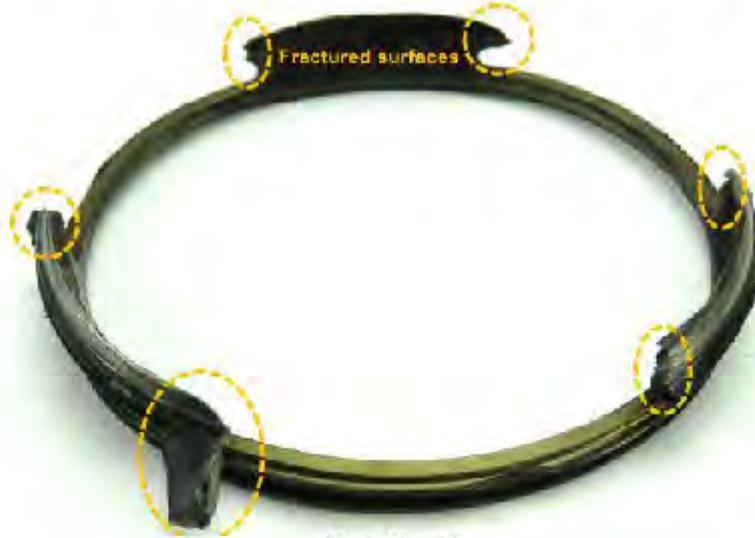
Photo No. 59

3.3 Visual examination of the No. 3 bearing air seal showed 6 fracture surfaces (yellow ovals, Photo No. 59). Magnified view of the fracture surfaces showed the extent of the damage on each of them. Almost all of the fractographic features have been obliterated by rubbing during the event (Photos No. 60 to 63).

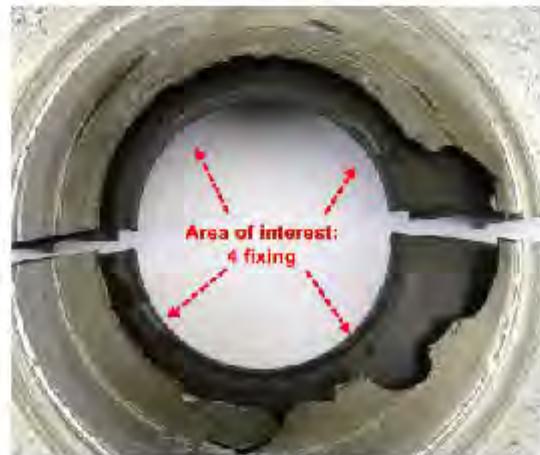
Photo No. 69

- 3.6 General views of the LP diffuser case showing the four fracture surfaces (Photo No. 69) at the No. 3 bearing stator seal web. Magnified view of the 4 fracture surfaces of interest showed that only one fracture surface revealed fractographic features (Photo No. 70). The other 3 fracture surfaces were completely obliterated during the event (Photos No. 71 to 73).

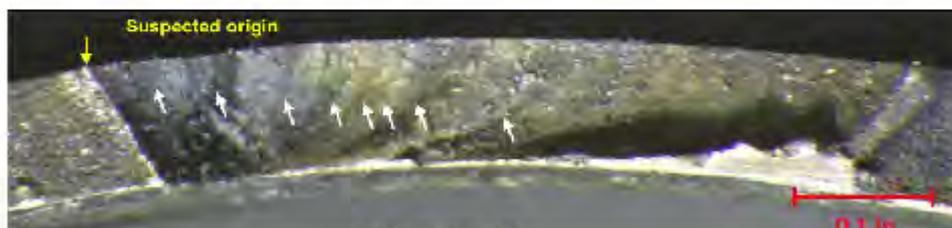
Photo No. 74

- 3.7 Magnified view of the LP diffuser case fracture surface No. 1 showed semi-elliptic crack progression marks (white arrows) indicative of fatigue crack propagation originating from the external surface of the fixing (yellow arrow, Photo No. 74).

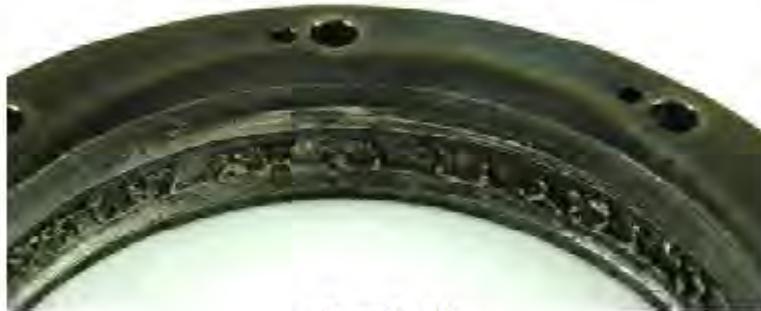
Photo No. 80

3.10 Visual examination of the No. 3 bearing outer ring showed transferred material on the raceway and discoloration on the flange most likely due to high temperature exposure (Photo No. 80). No evidence of crack was observed on the No. 3 bearing outer ring. Magnified view of the cross section taken through the outer race showing the microstructure modification due to high temperature exposure and rapid cooling near the track. The micro hardness measured in the modified microstructure is higher than the original tempered martensite (Photos No. 81 to 85). The transition zone exhibited the lowest hardness measured.

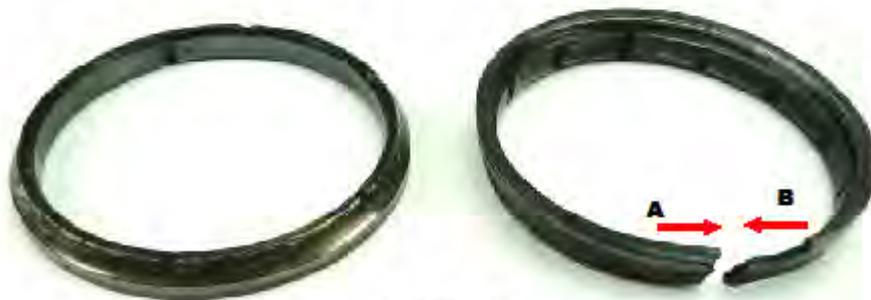
Photo No. 87

- 3.12 Visual examination of the No. 3 bearing inner rings showed damage on the raceway and discoloration most likely due to high temperature exposure. The No. 3 bearing inner ring thrust side was fractured and distorted next to the fracture (Photo No. 87). Magnified view of the fracture surfaces on the No. 3 bearing inner race thrust side showed overload fracture characteristic. Missing material (yellow ovals) and groove (red arrows) were noticeable on the inner diameter of the No. 3 bearing inner ring thrust side shoulder (Photos No. 88 to 89).

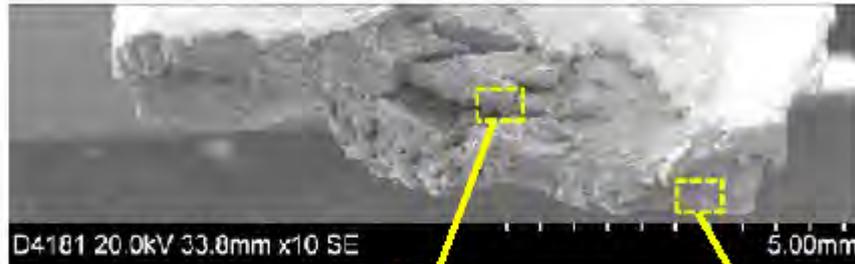
Photo No. 91

- 3.14 SEM view of the fracture surface of the inner ring (Photo No. 91) showing that the surface is mostly covered by splattered material covering the microfractographic features (Photo No. 92). A small section exhibited dimples characteristic of an overload fracture (Photo No. 93).

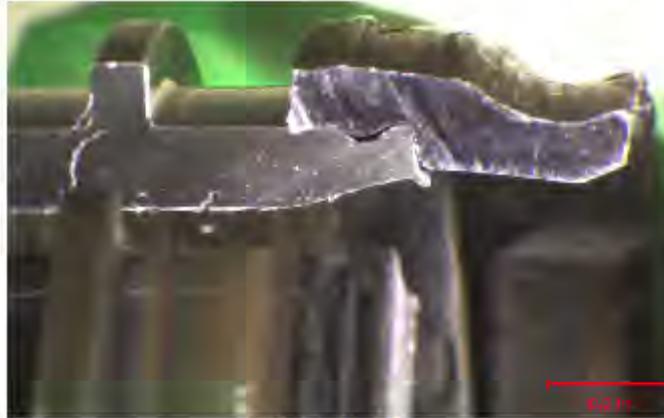
Photo No. 94

- 3.15 Cross section of the No. 3 bearing rear spacer and the No. 3 bearing inner ring thrust side showing that the grooving and the missing material on the No. 3 bearing inner ring thrust side interlocks with the wear pattern observed which is confirming interaction between the two components in operation (Photo No. 94).

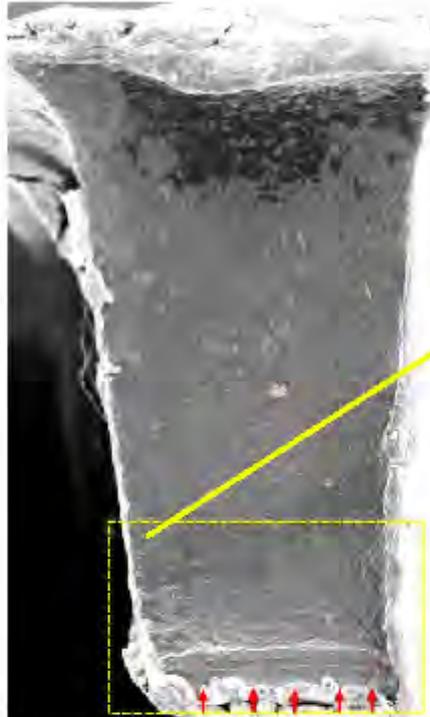
Photo No. 103

- 3.18 SEM magnified view of a No. 3 bearing cage fracture surface showing progression marks (white arrows) suggesting fatigue crack propagation initiated at the surface at the internal diameter of the cage (red arrows) and propagated toward the external diameter (Photos No. 103 to 105).
