AIC 17-1003

**PAPUA NEW GUINEA
ACCIDENT INVESTIGATION COMMISSION
ACCIDENT INVESTIGATION REPORT**

Government Aircraft Factory (GAF) Nomad N22C

Wheels-up landing

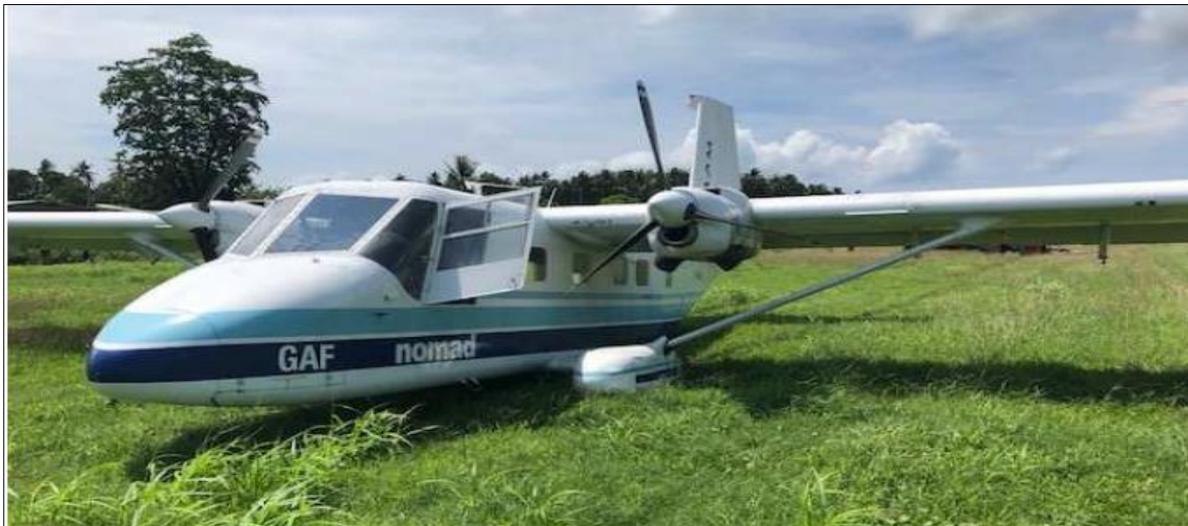
The pilot reported that when doing the pre-landing checks the landing gear failed to extend. He attempted to deploy the landing gear using the emergency system, actuated by a manual pump. The handle of the manual pump broke after three to four pumps. The pilot decided to perform a landing in the grassy flight strip, about 32 metres to the right of the sealed runway centerline. The pilot-in-command (PIC) was the sole occupant and was not injured.

Figure 1: VH-ATO landing wheels-up in the grassy flight strip

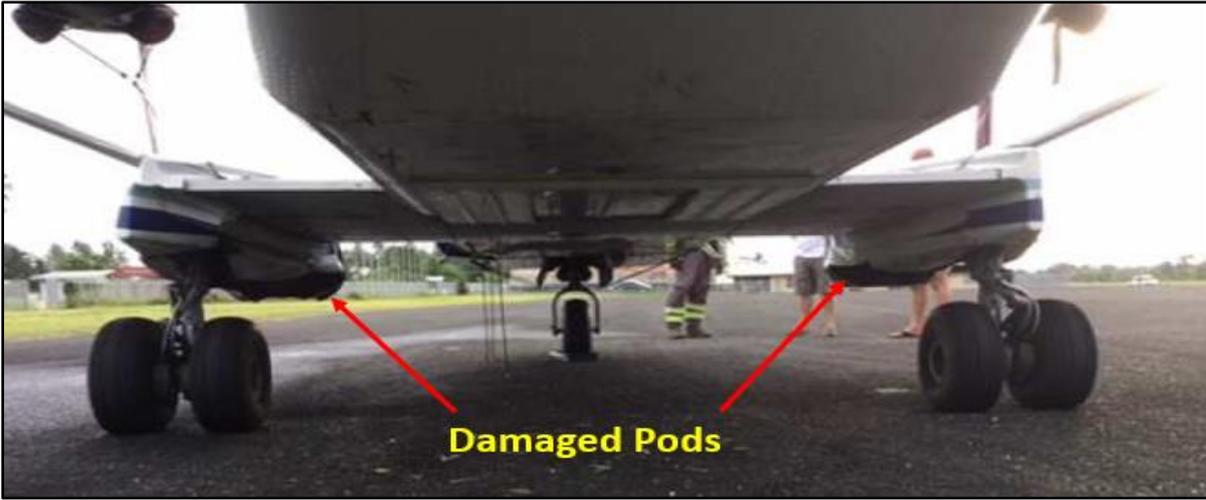
During the ground impact, the main landing gear pods sustained significant damage. The lower attachment points of both wings' struts came into contact with the landing-gear pods and tore the pods' side skins, which resulted in the pods' doors separating from the pods. No visual structural damage was evident on the wing struts or the attachments at the pods.

Figure 2: Damaged pods of the main landing gear

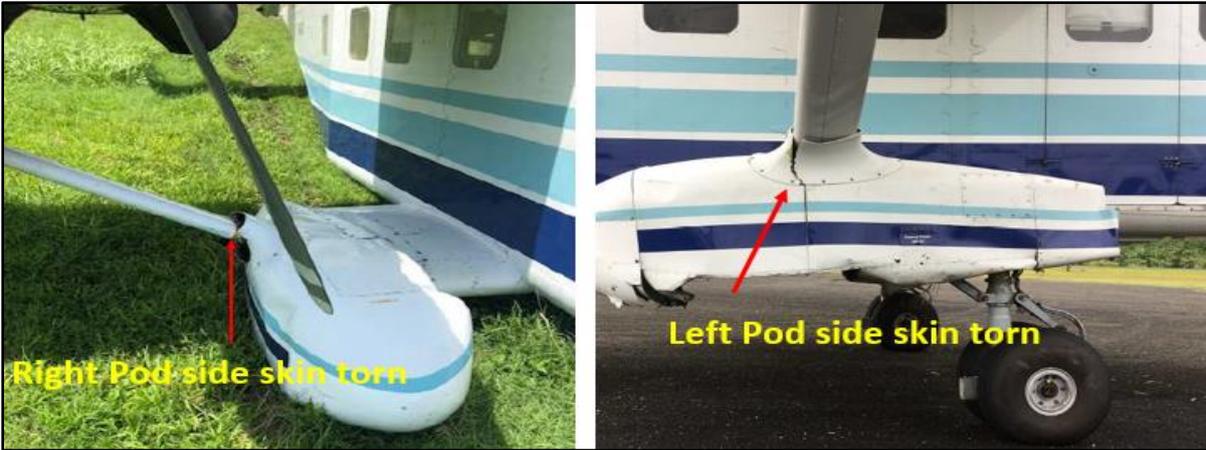
Figure 3: Right pod side skin torn

Figure 4: Left pod side skin torn

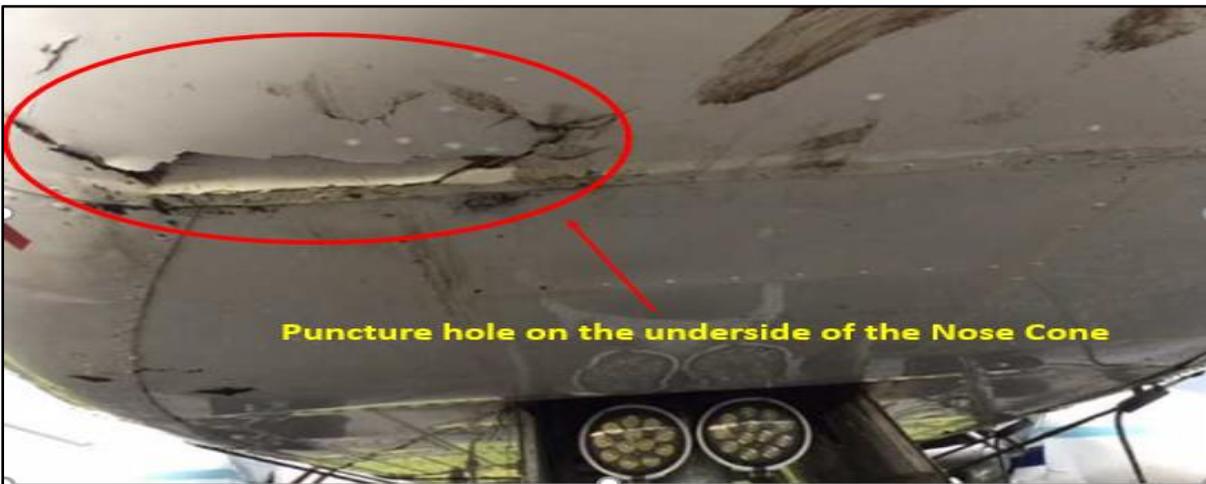
The nose landing gear and its doors were not damaged. The nose cone had a puncture hole/tear on the underside, approximately 4 inches long.

Figure 5: Puncture hole on the underside of the Nose Cone

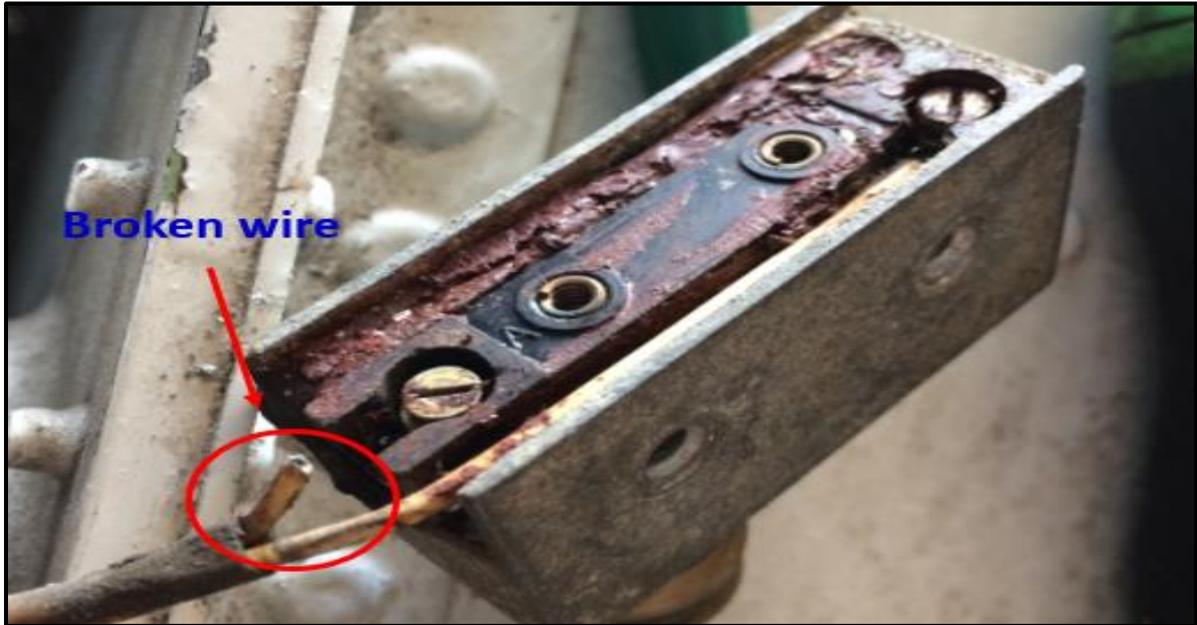
In the presence of the AIC investigators at Port Moresby, the landing gear and its systems were examined by the engineers from Air Gold Coast. The defect causing the failure of the landing gear to extend was found to be a broken wire on the up-lock switch on the right-main landing gear. That caused the motor to lock up.

Figure 7: Broken Wire on the up-lock switch of the right landing gear

The landing gear system was examined including the electrical wiring. The wire to the up-lock switch on the right land gear had fractured and separated, rendering the normal landing gear extension system inoperative.

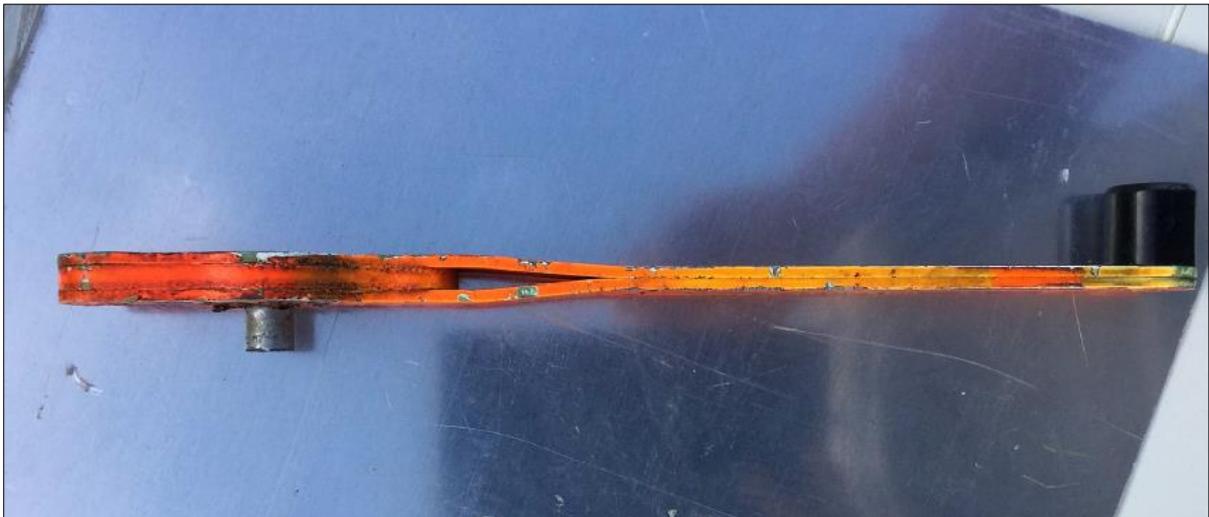
Figure 8: Broken Handle of the Emergency gear extension

After three or four pumps of the manual landing gear extension handle it fractured. The pilot reported that he had to apply a large force on the pump handle during those initial pump actions. The investigation determined that because the log motor had locked up, large resistance on the small 3/8 drive was experienced, and the handle drive failed.

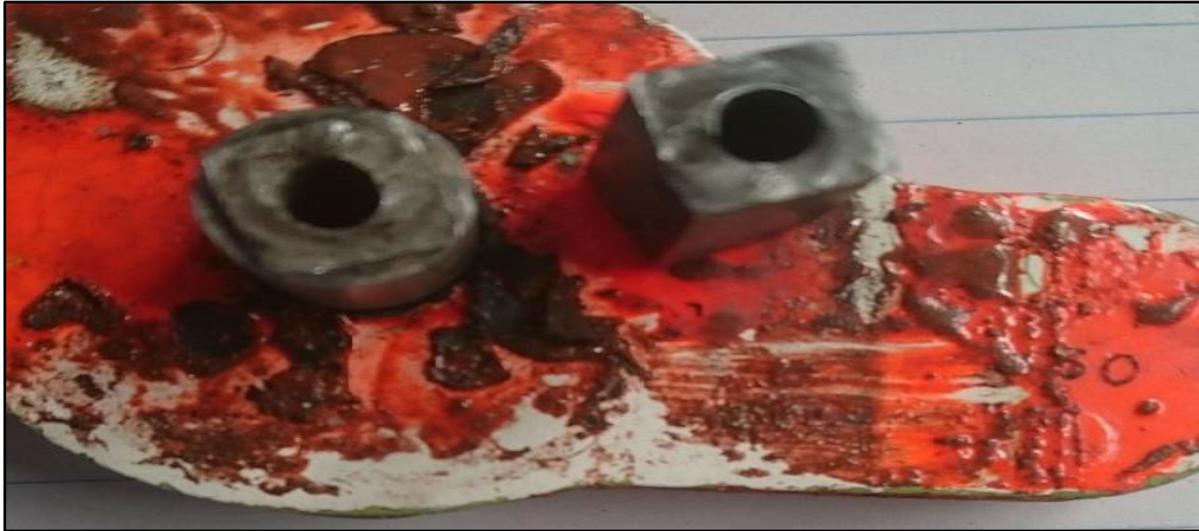
Figure 9: Failed drive

The manual extension handle drive was inspected, and it showed no evidence of corrosion or fatigue cracking. The servicing history of the component was also analysed, and that confirmed that the component was serviceable prior to the flight.

Excessive force due to the resistance of the locked-up landing gear extension motor during the pumping to extend the gear manually, likely contributed to the overload failure of the handle.
