**FINAL REPORT**

**AIC 12-1005**

**PAPUA NEW GUINEA  
ACCIDENT INVESTIGATION COMMISSION  
SHORT SUMMARY REPORT**

**Runway excursion**

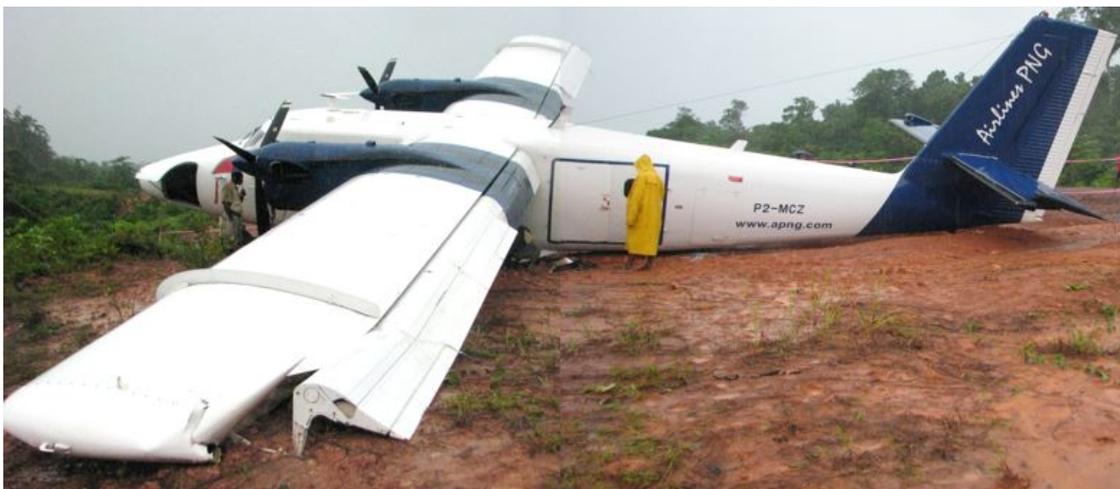
**Figure 1: P2-MCZ at the crash site**

That partially dislodged the landing gear from the airframe causing the left wing to impact the ground. The aircraft came to rest about 5 m from the edge of the airstrip (Figure 1). The PIC shut down the engines while the copilot assisted the passengers from aircraft through the right rear cabin door.

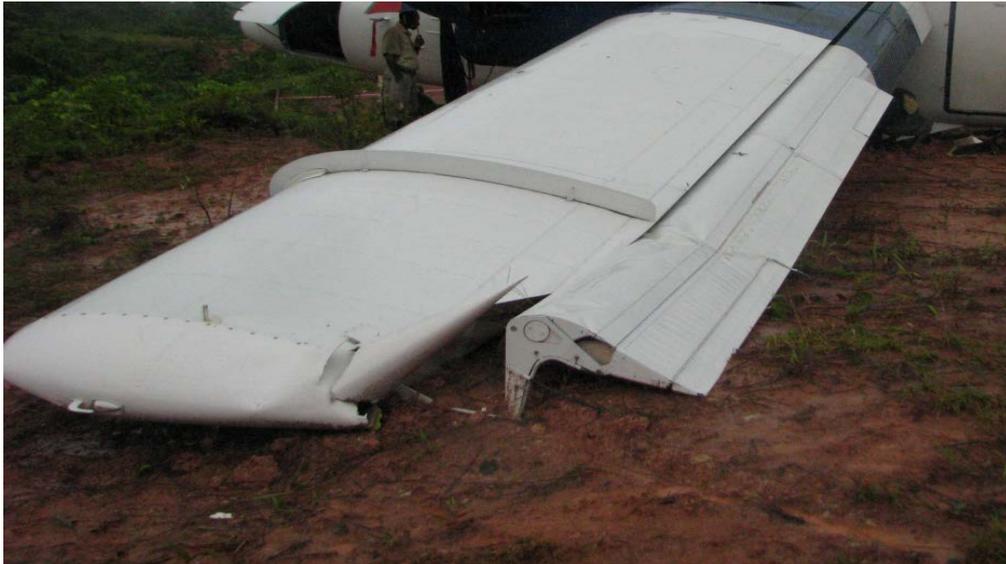
The aircraft was substantially damaged. The left main wheel was torn from the left main landing gear assembly which also separated from the airframe. Damage to the fuselage, left wing and control surfaces was substantial (See Figure 3).

**Figure 3: View of damaged aircraft from the left wing.**
