FINAL REPORT

AIC 14-1005

HeviLift Ltd

DHC-6-300

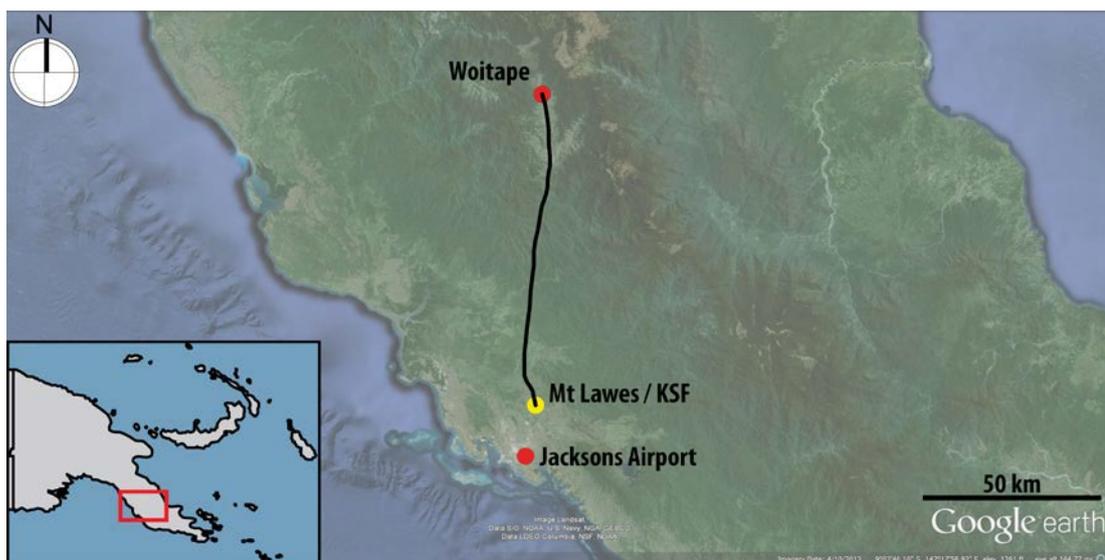
Figure 1: Track of KSF from Waitape to Mt Lawes

The ADS-B data was received using PNG Airservices' ground-based equipment. The track in Figure 1 was derived from this information plotted on Google Earth™ by PNG Airservices Ltd and provided to the PNG AIC by PNG Airservices Ltd.

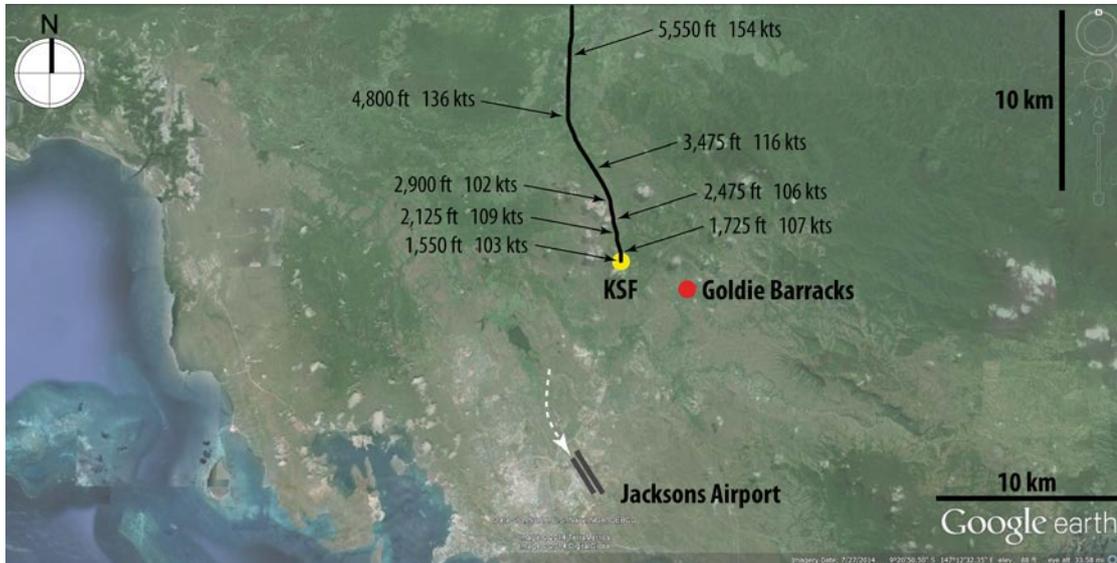
Figure 2: Final part of the track taken by KSF; the dotted white arrow shows the approximate path to be flown from a left base position onto runway 14 right

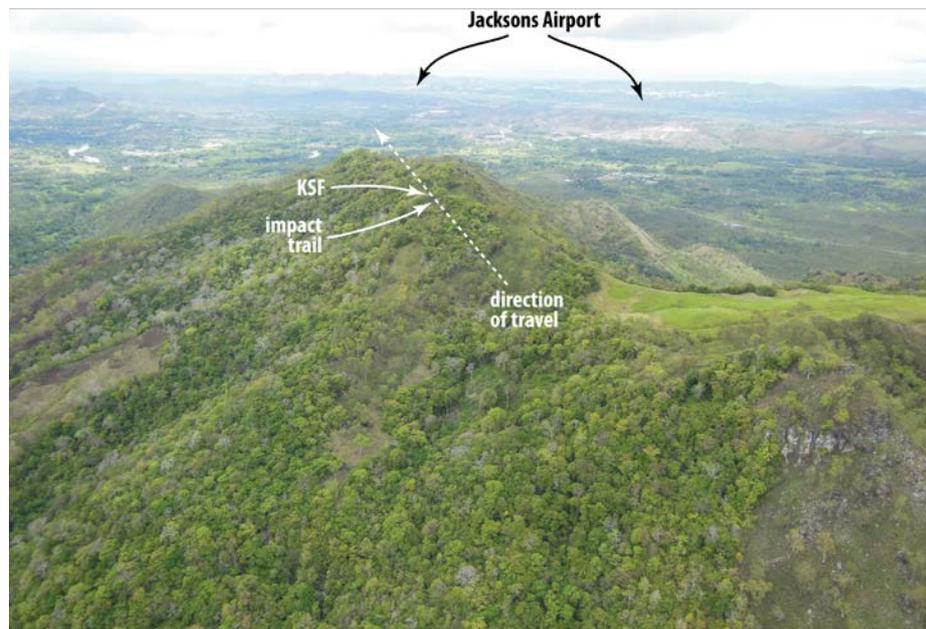
The aircraft impacted Mt Lawes, just below the summit on the northern side, tracking 176° magnetic.

Figure 3: KSF accident site on Mt Lawes, with Jacksons Airport in the distance

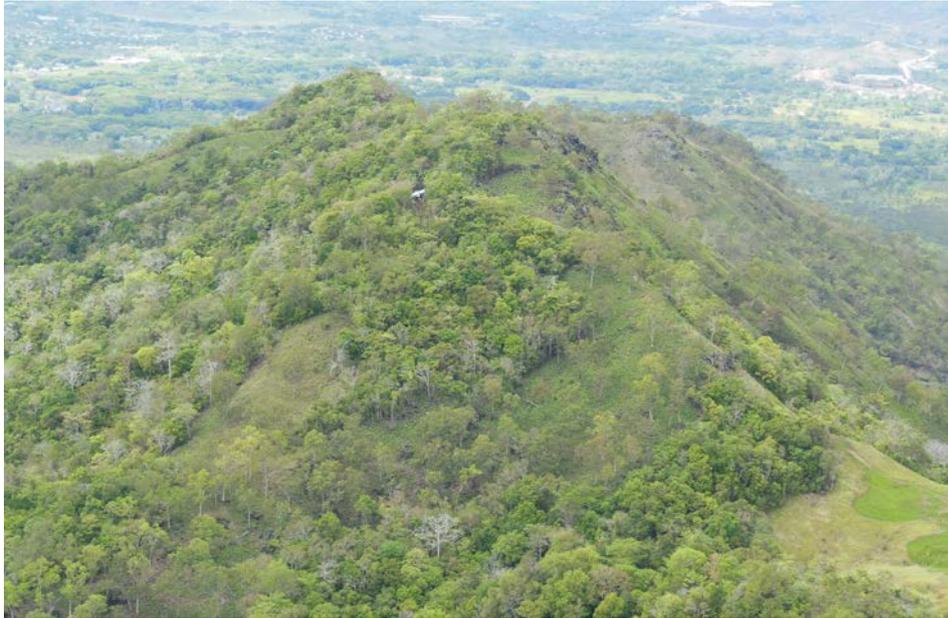
Figure 4: KSF accident site on Mt Lawes

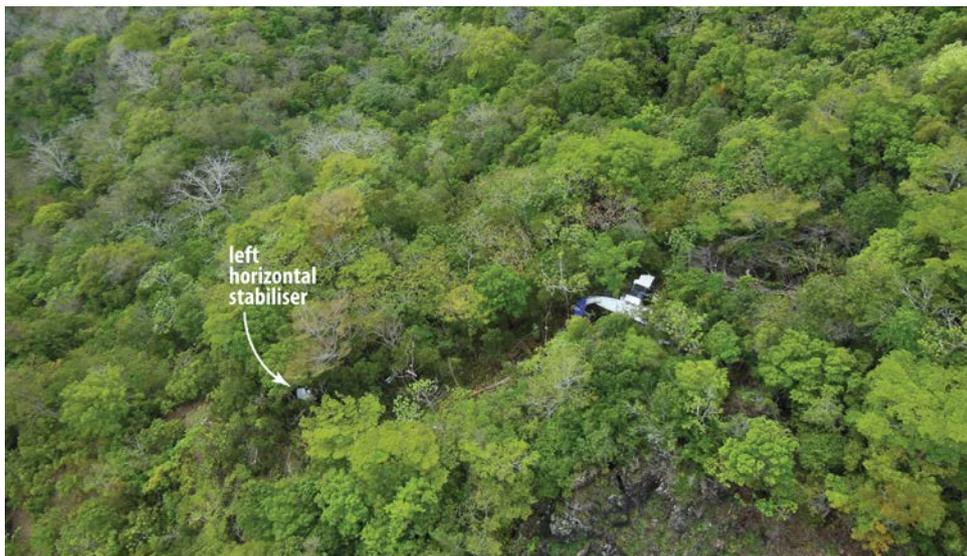
The impact sequence left a trail approximately 100 m long in the vegetation.

Figure 5: Wreckage of KSF and impact trail

Before coming to rest on the steep slope, the aircraft turned approximately 45 degrees to the right, causing the tail section to twist through 90 degrees and the front of the aircraft to strike the side of the mountain. The cockpit was crushed during the impact. The left horizontal stabiliser, visible in Figure 5 to the left of the impact trail, detached from the tail.

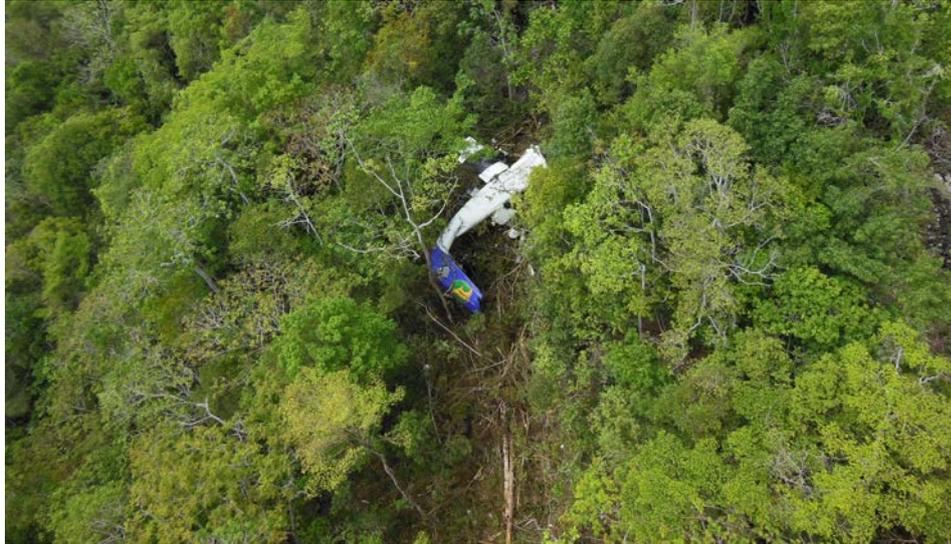
Figure 6: Wreckage of KSF and impact trail

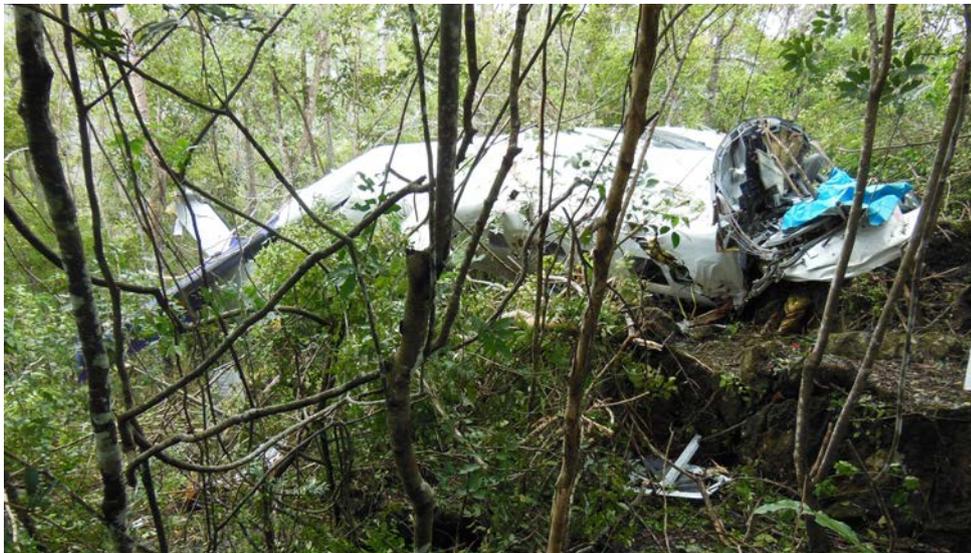
Figure 7: Wreckage of KSF

The right wing separated from the fuselage and was found inverted on the right side of the aircraft. The right engine was situated on the ground beneath the main wreckage (the rear part of the main wreckage remained elevated, see Figure 8).

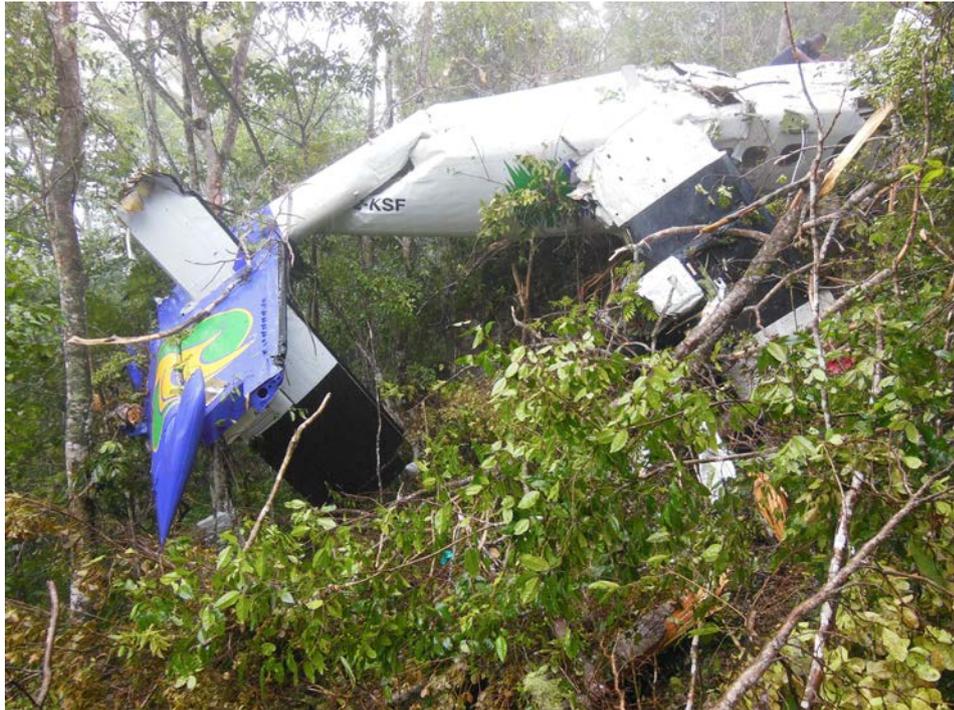
Figure 8: Wreckage of KSF showing empennage hanging
