AIC 17-1002

P2-ANK

de Havilland Dash 8-202

Burst tyre at 20,000 feet during climb

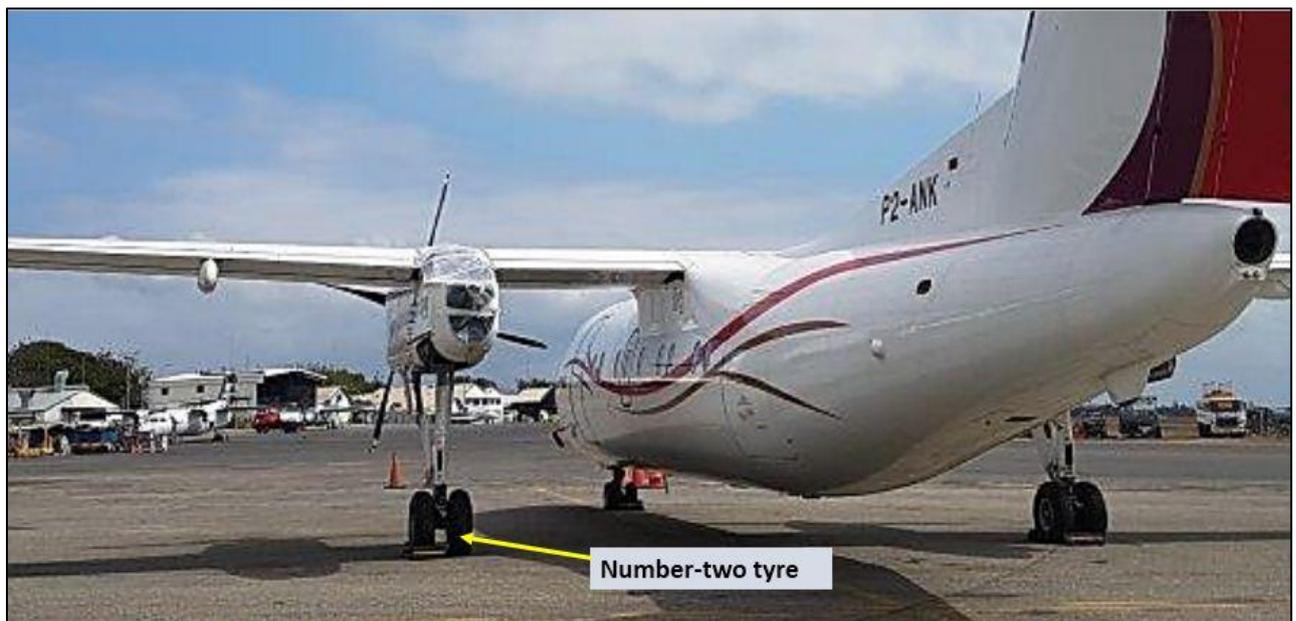
Further inspection found that the left main landing gear number-two tyre was deflated and damaged. It was apparent that when the tyre blew out in the wheel well, it caused substantial damage to the main structure on the inside of the nacelle. It was then the crew realised that the bang sound they heard was the tyre exploding in flight at 20,000 ft.

Figure 2. View showing location of the number-two tyre

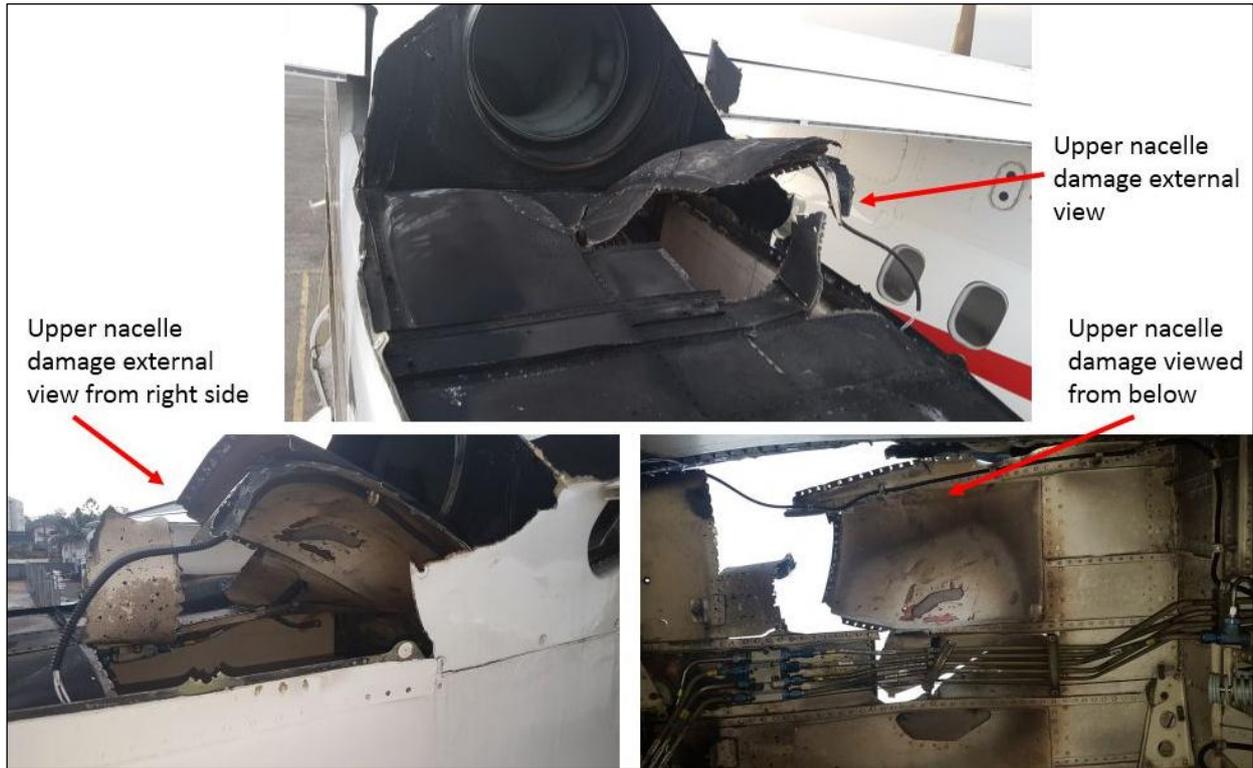
The PIC reported that it was at that moment they realized that everyone on the tarmac was looking at the aircraft, particularly the left side. It wasn't until the passengers and the crew disembarked, that the crew were advised by the engineers that panels were missing aft of the left exhaust nacelle.

Figure 3: Damage area left nacelle

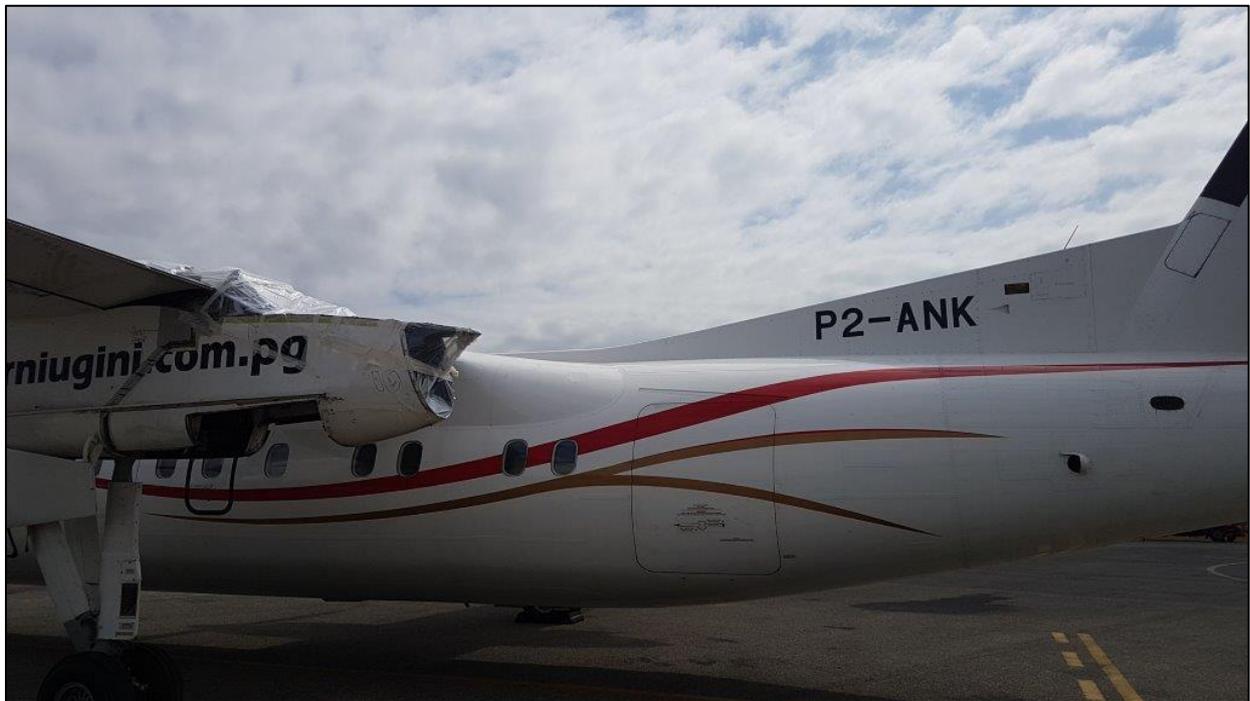
Figure 4. Damaged left nacelle (Wrapped in plastic for protection)

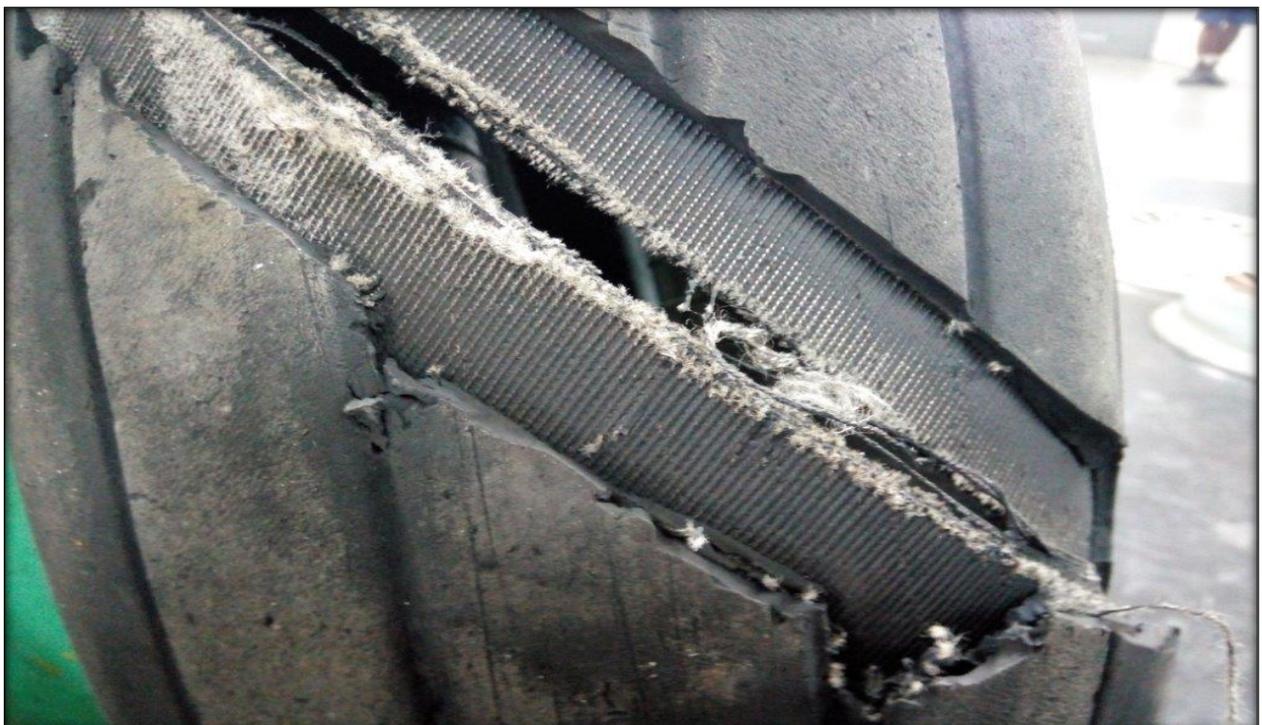
Figure 6: Damage number-two left main wheel tyre

It is likely that the FOD damage occurred when a jagged rock impacted the non-serial sidewall of the number-two tyre during the landing at Bulolo on 3 August 2017. The aircraft returned to Jacksons safely, but the damage was not found during post-and pre-flight inspections. During the subsequent flight after departure from Jacksons on 4 August, the casing plies in the impacted area fractured, propagating from the serial side sidewall along the cord direction to tread area and the non-serial side sidewall. It is likely that the significantly damaged and weakened casing of the tyre, and the differential of the atmospheric pressure compared with the pressure within the tyre, caused the tyre to blow out, resulting in substantial damage to the left nacelle.

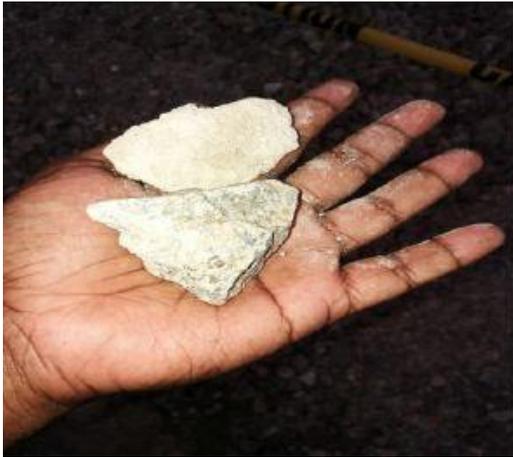
Figure 8: Jagged edge rocks found at the Bulolo strip.

The investigation determined that *Licensee* had neglected its primary responsibility of properly maintaining the airstrip, to allow for safe landings and take-offs of aircraft, in particular LinkPNG aircraft. It is likely that this neglect contributed to the cause of the tyre blow out.

Due to weather erosion over time, and the lack of maintenance by the *Licensee*, large jagged rocks had become exposed on the surface of the Bulolo strip.

On 25 October 2017, the Civil Aviation Safety Authority of PNG informed the AIC that the Bulolo Aerodrome, *Civil Aviation Rule Part 139, Aerodrome Operating Certificate (ADOC)* had lapsed and Bulolo Aerodrome was not certificated. However, moves were underway for its certification. At the time of finalising this investigation report 4 January 2018, the Bulolo ADOC had not been renewed by CASA PNG.

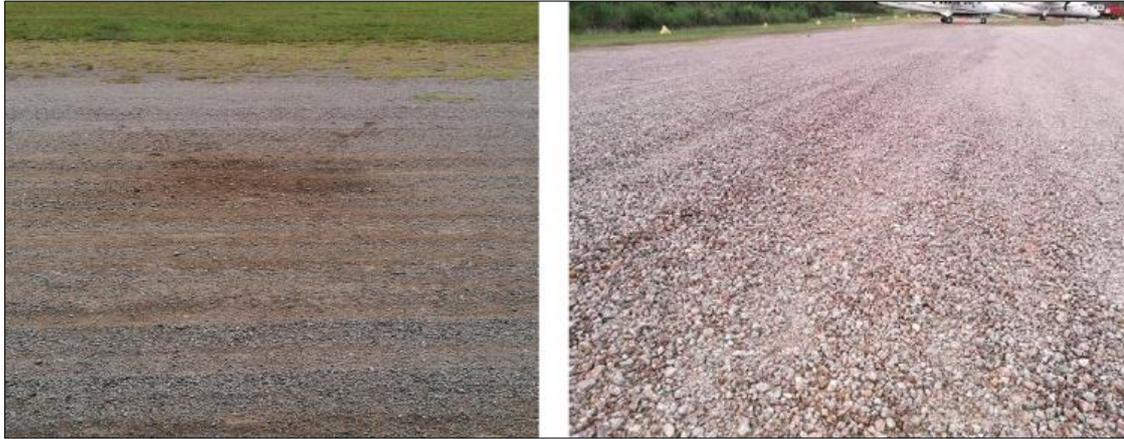
The report was comprehensive, describing the airstrip surface. The airstrip has a slope 0.8° down to the northwest. The report stated that in September 2016, three quarters of the runway was compacted with coarse gravel. Subsequent continuous exposure to the weather elements had eroded the gravel surface, exposing large embedded stones at several locations along the runway. Depressions in several areas along the runway were also evident during the inspection.

Figure 10: Bulolo Airstrip Surface
Source: LinkPNG- Facility Inspection Report

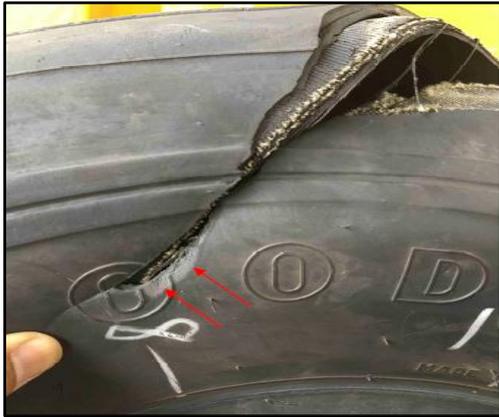
The manufacturer found evidence of hard-impact damage on the tyre wall and that the casing fracture was caused by FOD⁹. The analysis revealed that the side wall of the tyre had been impacted by a hard object at serial side sidewall¹⁰ locations. After the casing plies at the impacted serial sidewall area severed, the fractured casing plies propagated along the cord direction to the tread area, and the non-serial¹¹ side sidewall.

Figure 11: Impact area
Source: Tyre manufacturer's report

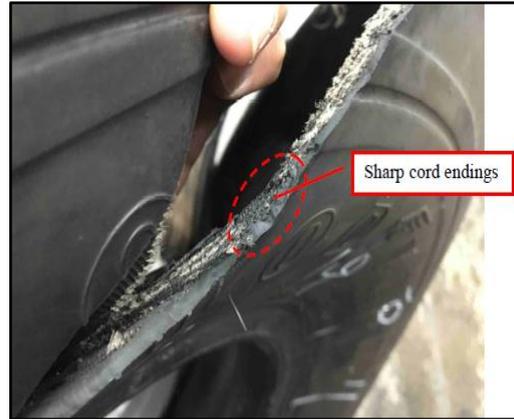
- The casing fractured along the casing-ply cord direction, across the tread area. The fractured area was between the serial side sidewall and the non-serial side sidewall.
- There was an impacted sign at serial side sidewall, see Figure 3
- The cord endings at impact area were sharp. That indicated that the casing plies suddenly broke due to hard impact, see Figure 4.

Figure 12: Fractured tyre showing sharp cord endings
Source: Tyre manufacturer's report
