AIC 11-1006

**PAPUA NEW GUINEA
ACCIDENT INVESTIGATION COMMISSION
SHORT SUMMARY REPORT**

P2-LAE

Uncontained Engine Failure and Collision with Terrain

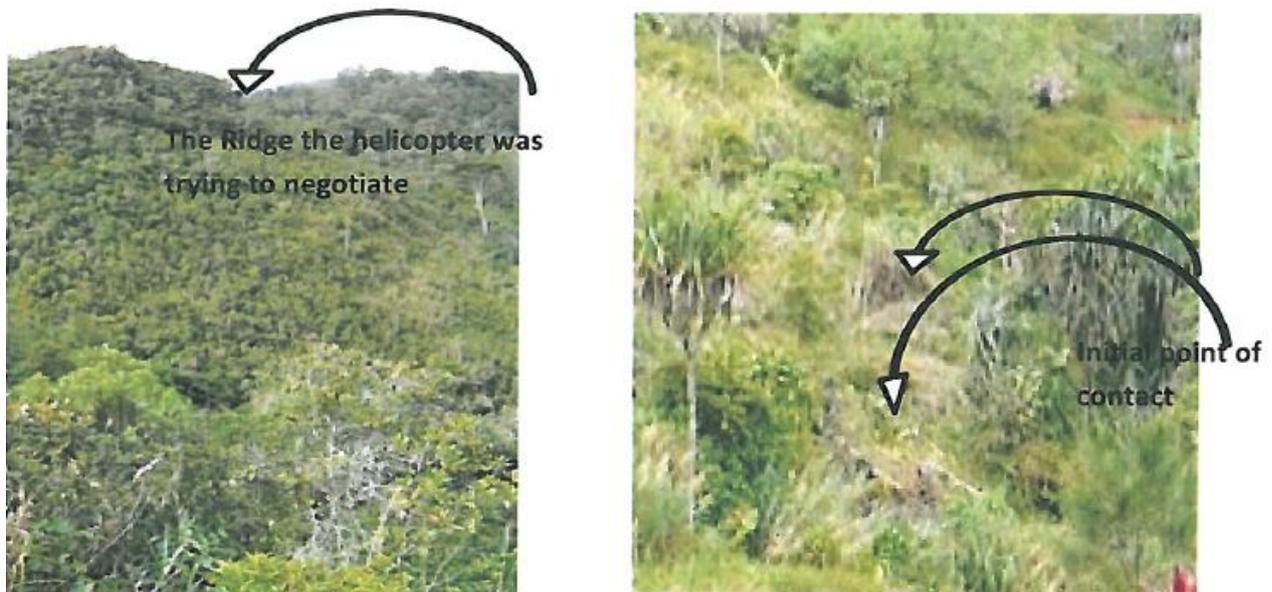
Figure 1: Impact location

The investigation found that the impact marks left by the main rotor indicated that rotor speed was very low, and possible rotor stall may have caused the sudden roll inverted. Local villagers recalled hearing the engine ‘crying’ (still operating) followed by an explosion, evidence of the number-2 engine, self-destructing. An on-board fire extinguisher was used with the help of the local villagers in an unsuccessful attempt to extinguish the fire.

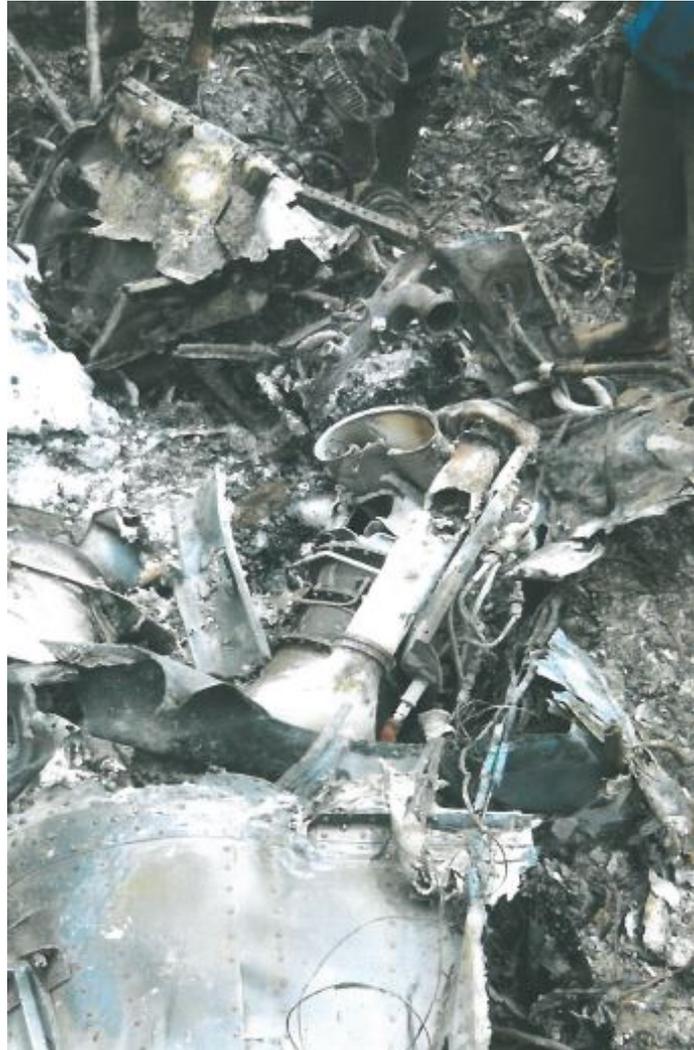
The intense post-impact fuel-fed fire destroyed the helicopter.

Figure 2: Cockpit and engine destroyed by the fire
