**PAPUA NEW GUINEA  
ACCIDENT INVESTIGATION COMMISSION  
SHORT SUMMARY REPORT**

**P2-IHP**

**Agusta Bell B212**

**Engine failure**

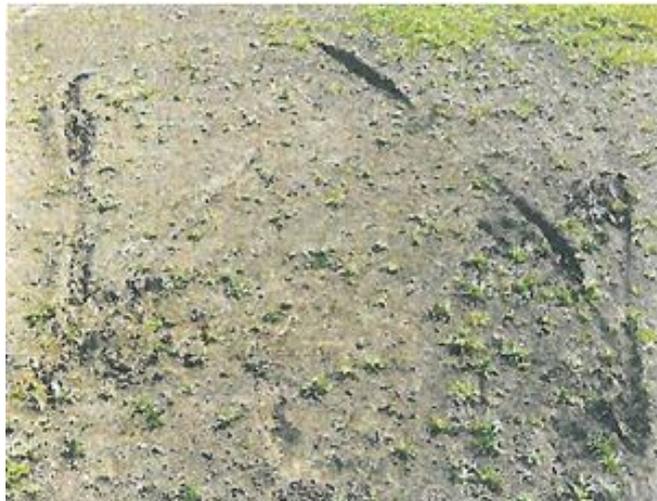
The school ground surface was wet and muddy causing the helicopter skids to sink rather than skid along the surface on landing and with the thirteen passengers on board and the single engine approach. The landing was heavy causing significant stress/pressure on the skids.

**Figure 2: Heavy landing imprint made by landing gear skids**

Early in the investigation it was thought that the landing gear skids may have been damaged with the rear skids yielding caused by the heavy landing. Engineering inspections at the accident site in accordance with the *Airworthiness Limitations Manual (1. Hard Landing page 6-1)*, with measurements taken with weight “ON” and “OFF”, revealed that there was no damage and the measurements were within the recommended manufacturers’ specifications. However, a subsequent inspection after the helicopter had been flown to a maintenance facility revealed cracks on the landing gear mount surface, and worn bushes and rubber damper on the skid to fuselage mount points.

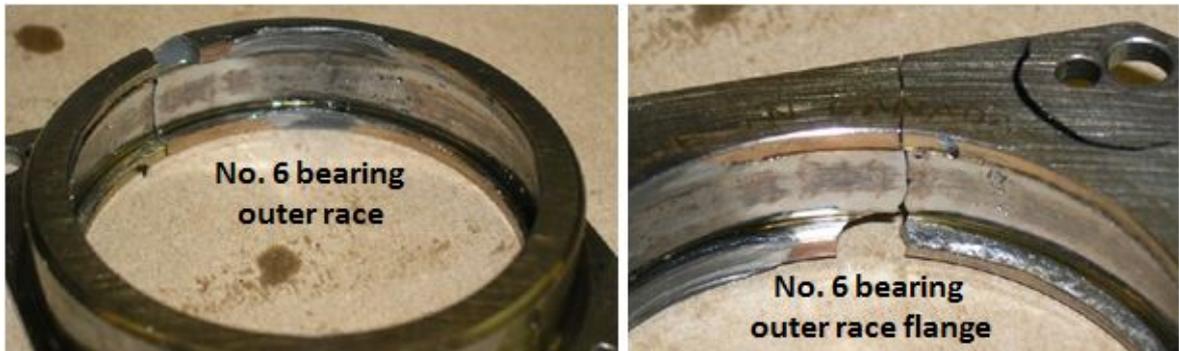
The manufacturer concluded that the engine No. 1 power section lost useful power due to the disintegration of the combining gearbox left hand 1<sup>st</sup> stage gear input shaft roller bearing (No. 6 Bearing), which allowed radial movement and vibration of the left hand 1<sup>st</sup> stage gear and disengagement with its mating idler gear. This unloaded the No. 1 Power section power turbine drive train, allowing the power turbine to accelerate to an overspeed condition and release the power turbine blades, with resultant damage to the adjacent and drive train components. One No. 6 bearing outer race retaining bolt locking key washer was not in place, which resulted in loosening of the bolt with subsequent vibration and eccentric loading leading to fracture of the inner race and liberation of the rolling elements. The No. 6 bearing is accessed only at overhaul or major repair. The facility conducting the last overhaul of the combining gearbox could not be determined from records forwarded with the engine.

**Figure 3: No 6 bearing outer race** Photograph courtesy of Pratt and Whitney Canada

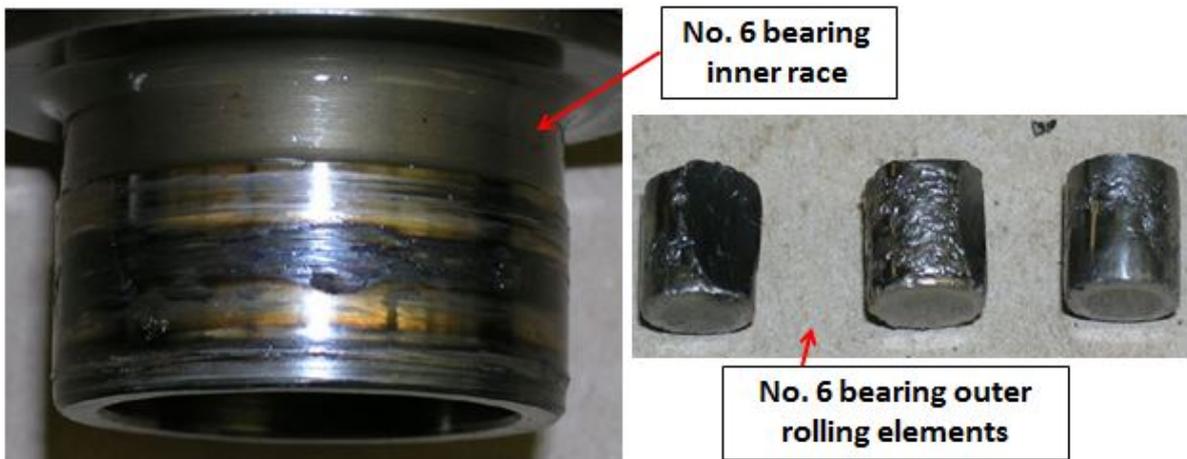
**Figure 4: No 6 Bearing race and rolling bearings** Photograph courtesy of Pratt and Whitney Canada

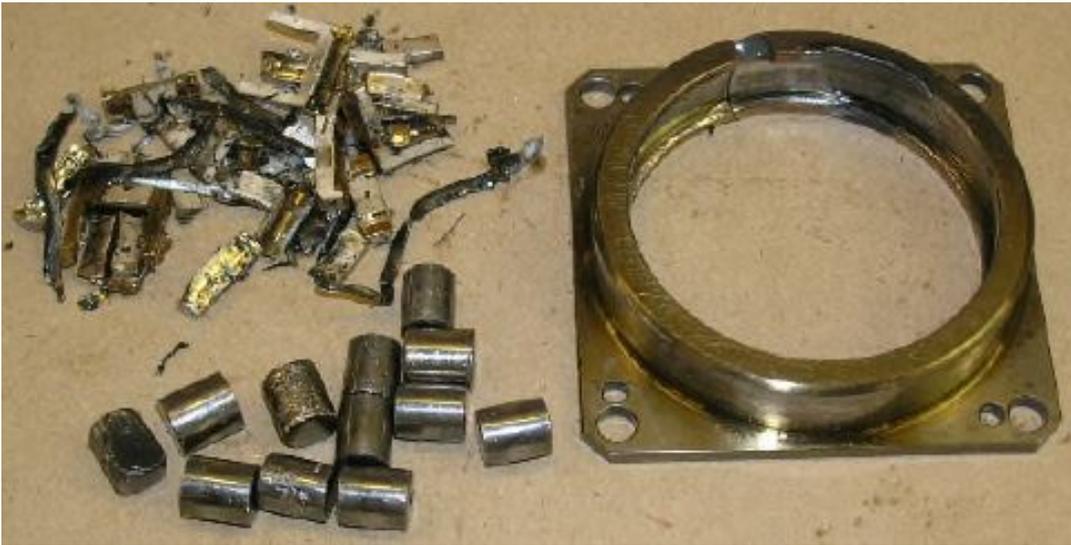
**Figure 4: No. 6 bearing showing failed components** Photograph courtesy of Pratt and Whitney Canada

The AIC accepts the Pratt and Whitney Canada finding that the engine No. 1 power section lost useful power due to the disintegration of the combining gearbox left hand first stage gear input shaft roller bearing (No. 6 Bearing), which allowed radial movement and vibration of the left hand first stage gear and disengagement with its mating idler gear.
