AIC 14-1001

**PAPUA NEW GUINEA
ACCIDENT INVESTIGATION COMMISSION
SHORT SUMMARY REPORT**

**Sunbird Aviation Limited
P2-SBC
Pilatus Britten Norman
BN2T Islander
Kikori Aerodrome, Gulf Province
PAPUA NEW GUINEA
23 April 2014**

Runway excursion – landing, involving Britten Norman Islander (Turbine) BN2T, P2-SBC

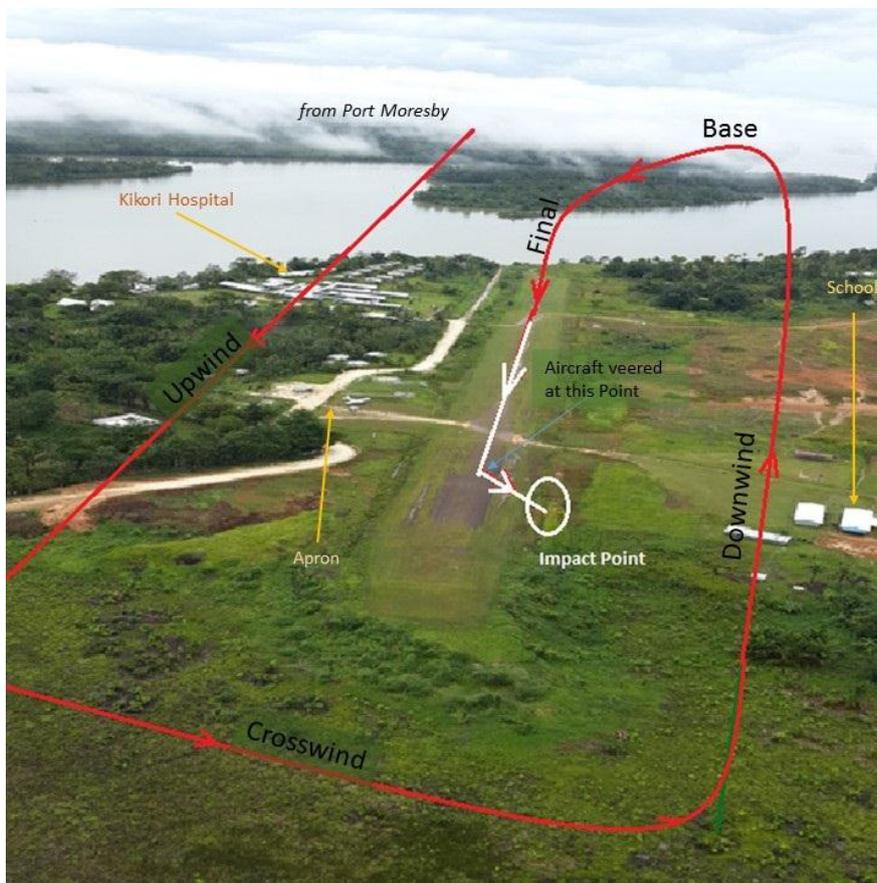
Figure 3: The pattern flown on arrival at Kikori from Port Moresby

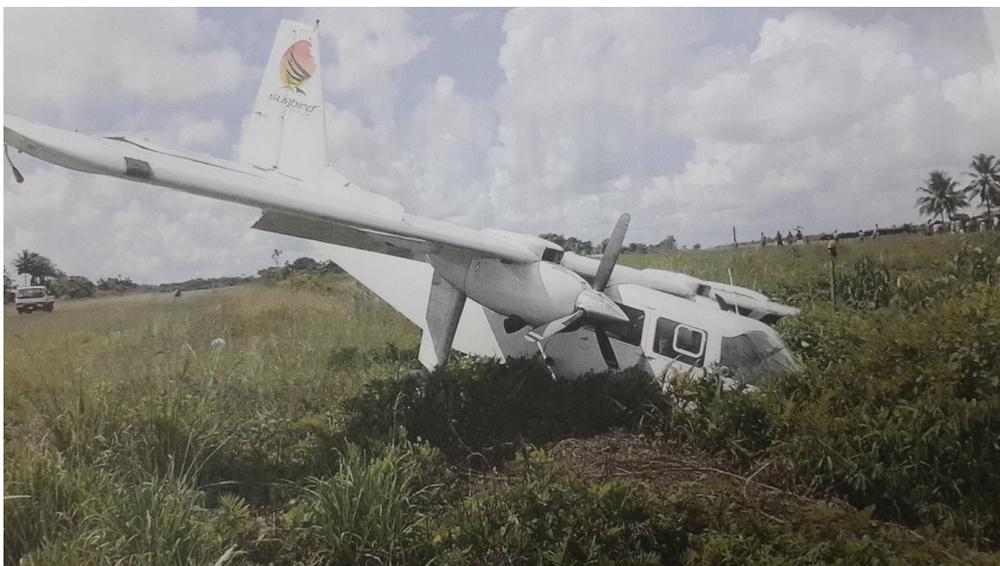
As the aircraft approached the mid-point of the runway, he applied braking pressure after lowering the nose wheel to the ground. At approximately abeam the taxiway to the parking bay, the aircraft veered left and ran off the runway (See Figs 3 and 5). The pilot stated that, although he applied even brake pedal pressure (on the left and right brakes), he experienced differential braking which caused the aircraft to veer to the left. He also said that he steered to the left to avoid running off the end of the runway. The aircraft subsequently impacted an embankment beyond the left side of the runway, approximately 70 metres from the runway end (Fig. 5).

Figure 5: Impact with a side embankment to the left of runway 30

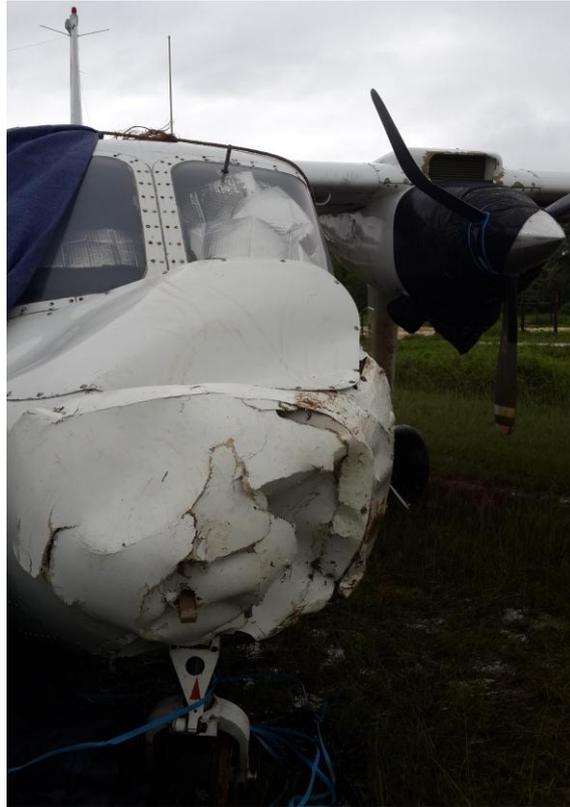
Figure 6: Damage to front of aircraft and the nose landing gear assembly

The nose of the aircraft was crushed and the nose landing gear partially collapsed rearwards during the impact with the embankment (Fig. 6). Two of the left propeller blades were bent.
