INTERIM STATEMENT

AIC 18-1002

YJ-AV71

Loss of directional control during landing roll

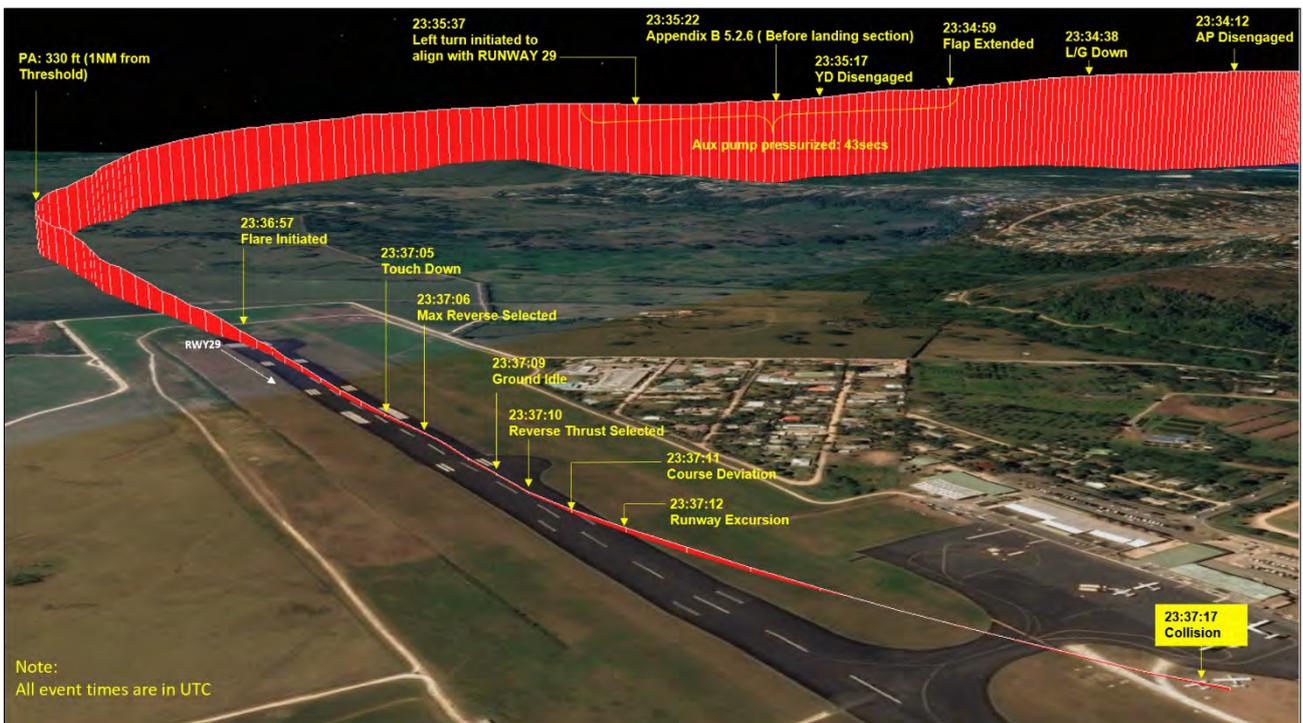
During the landing flare, the aircraft entered an un-commanded pitch up, forcing the PIC to release control of the power levers, and using both hands he pushed the control column forward in order to regain control of the pitch and therefore lowered the nose of the aircraft. The copilot subsequently placed his hands on the power lever controls as the aircraft landed. Flight data analysis showed that one second after touchdown, both power levers were recorded to have been set to max reverse.

The aircraft did not have hydraulically powered nosewheel steering and main-wheel brakes. Rudder authority, for ground aerodynamic steering was substantially limited because the switch for manual operation was not set to the appropriate setting. Reverse thrust was applied during the landing roll, which induced a significant left yaw resulting in the subsequent runway excursion.

Figure 1: YJ-AV71 approach and landing

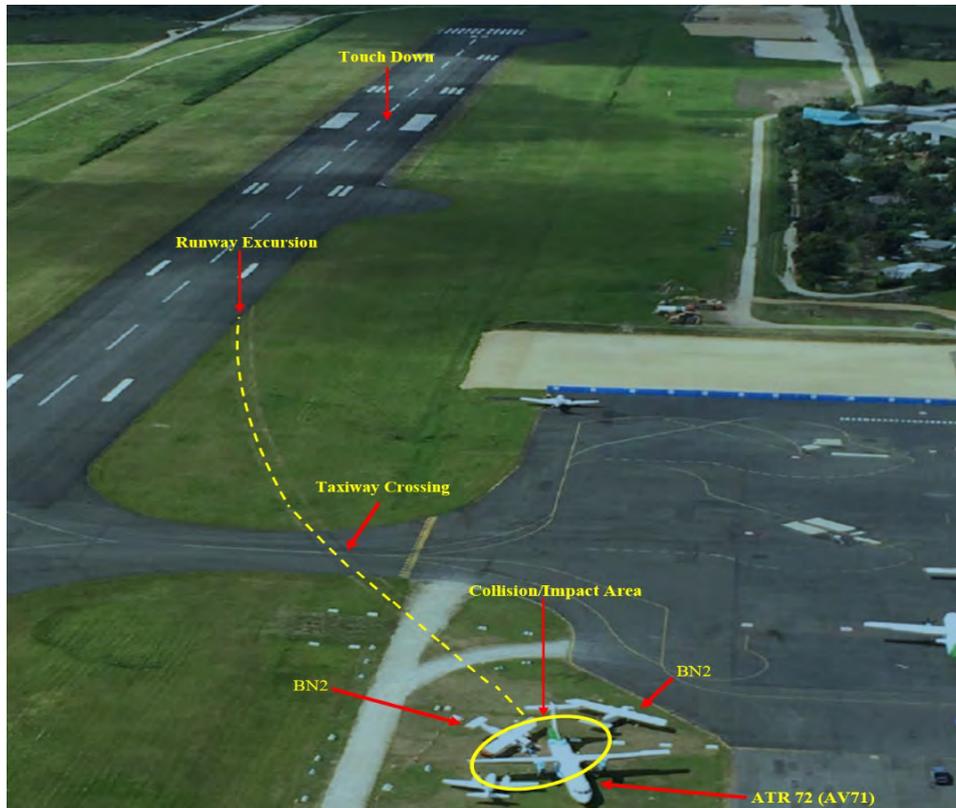
The crew reported that they could neither control, nor stop the aircraft during the landing roll. The aircraft diverged off the left side of the runway and crossed a taxiway before colliding with two stationary, unoccupied Britten-Norman Islander aircraft, about 320 metres from where it left the runway.

Figure 2: YJ-AV71 Runway Excursion

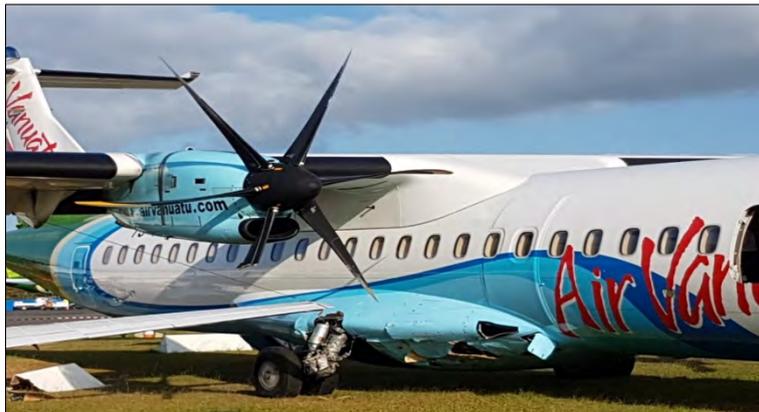
Figure 3: AV71 Right-side fuselage post impact damage

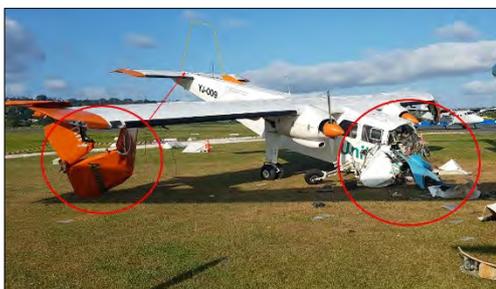
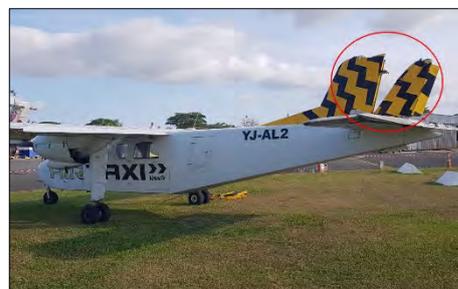
Figures 4 and 5: Damaged Britten-Norman Islander
