## PRELIMINARY REPORT

AIC 19 -1002

P2-SET

Air Tractor AT-502B

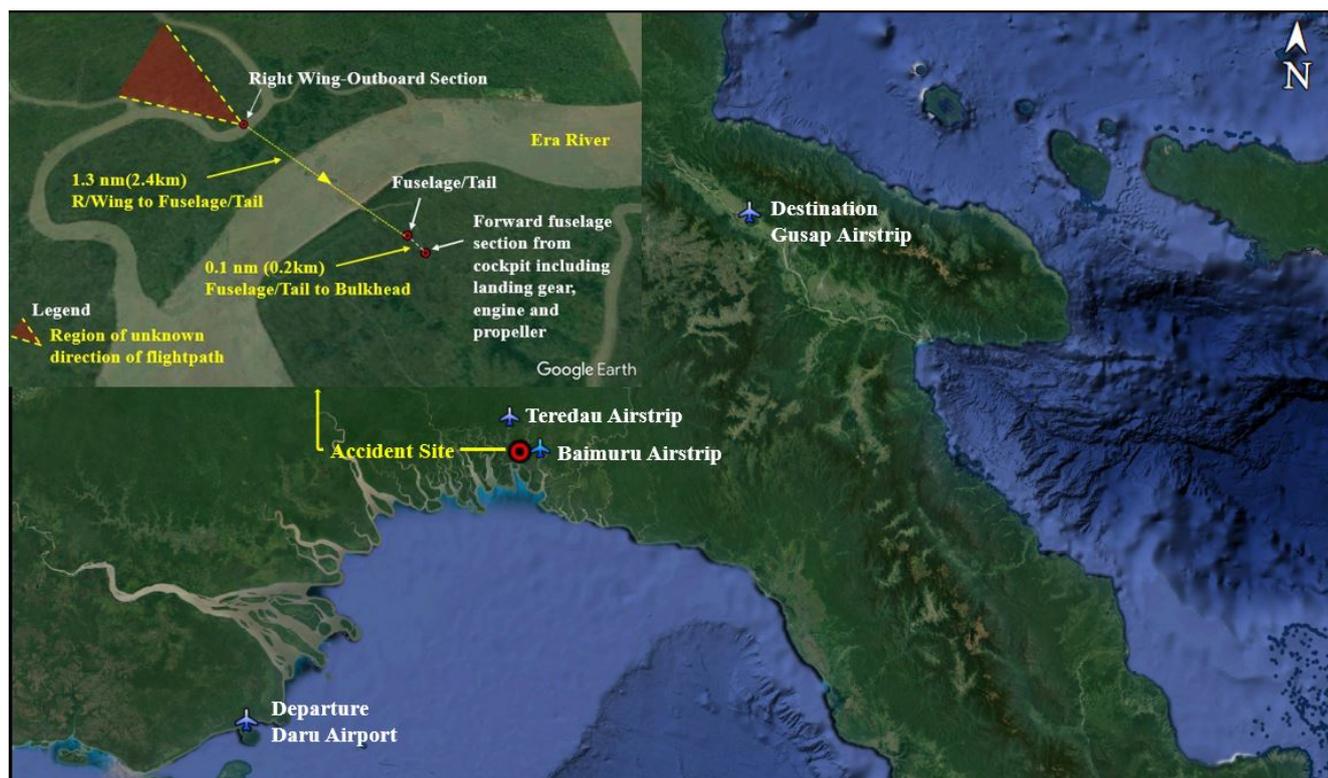
Figure 1: Depiction of accident location in relation to Baimuru Airstrip

The investigation team found that the outboard section of the aircraft's right wing was torn off as the wing clipped palm trees. The aircraft continued for another 1.3 nm before it impacted a thick tree trunk about 13 metres above ground level. The forward fuselage and engine section separated from the airframe at the bulkhead between the cockpit and the hopper. The forward fuselage including the hopper, main landing gear, engine and propeller continued another 290 metres along the direction of the flight path before becoming deeply embedded in mud. (See figure 1).
