PRELIMINARY REPORT

AIC 20 -1004

P2-MAF

Runway Overrun at Yenkisa Airstrip

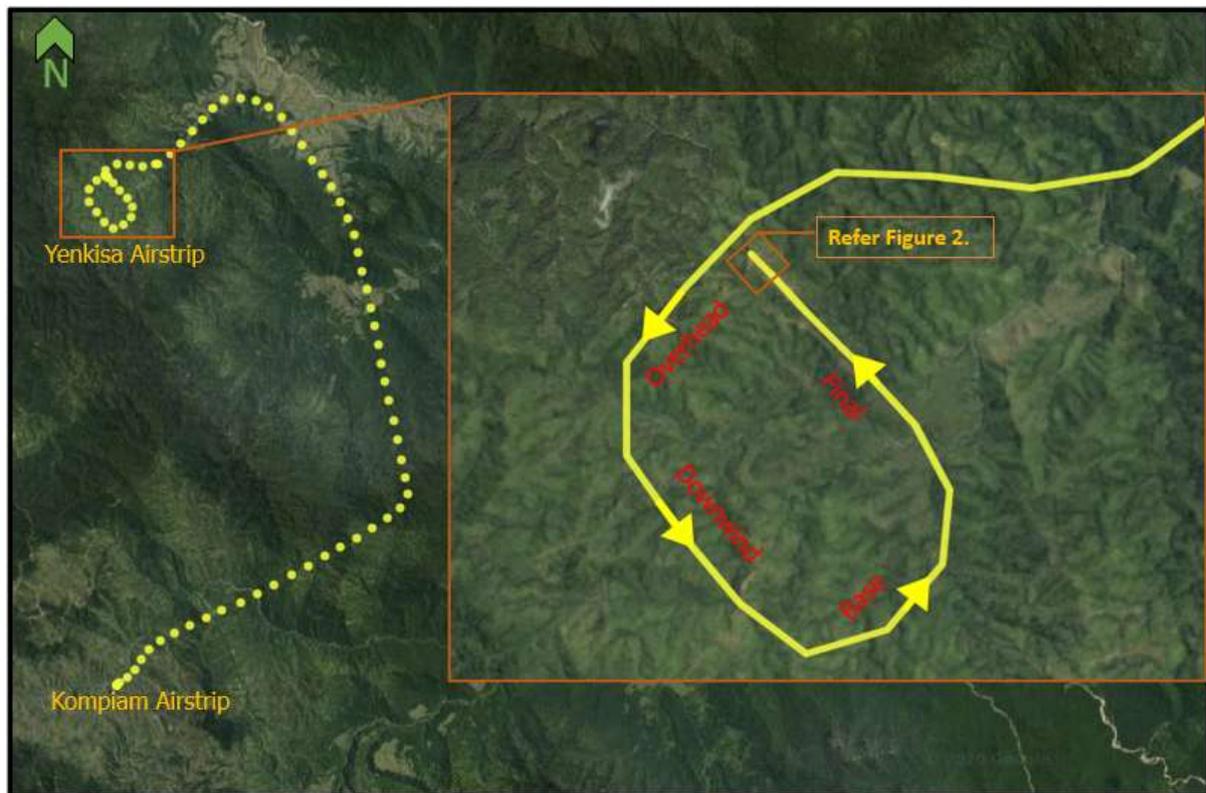
Figure 1: P2-MAF flight path and approach into Yenkisa airstrip.

According to the V2 Tracker³ recorded data, the aircraft entered the Yenkisa area through the North Eastern valley (see Figure 1). At 03:06 UTC, the aircraft arrived overhead the airstrip at an altitude just above 1,200 ft AGL⁴.

The recorded data showed that the aircraft turned onto the downwind leg just under 1 nm from the airstrip and tracked 1.1 nm towards the South East, parallel to the airstrip (see Figure 1). The pilot then commenced a descending base leg from about 800 ft AGL at an airspeed of 79 kt and subsequently made the final turn, lining the aircraft up on the final approach path at about 400 ft AGL, about 0.5 nm from the threshold, selecting 30° flaps and maintaining an airspeed of approximately 71 kt.

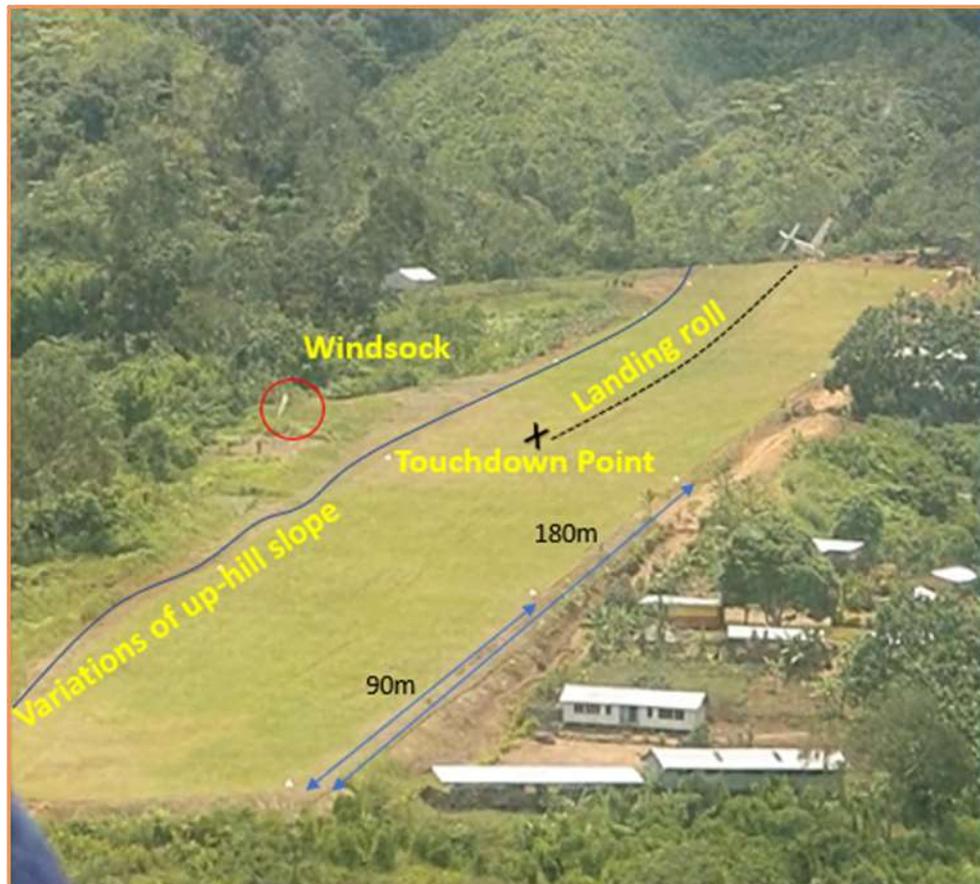
During interview, the pilot stated that while overhead the airstrip, he checked the area for wind direction and intensity and strip surface conditions. The windsock located just after the 180m cone marker on the left of the airstrip (see Figure 2) indicated very light north-easterly wind. The trees just before threshold 32 indicated no movement which signified little to no wind at the landing area. There was also no visual sign of standing water on the airstrip.

Figure 2: Overrun illustration of P2-MAF at Yenkisa airstrip.

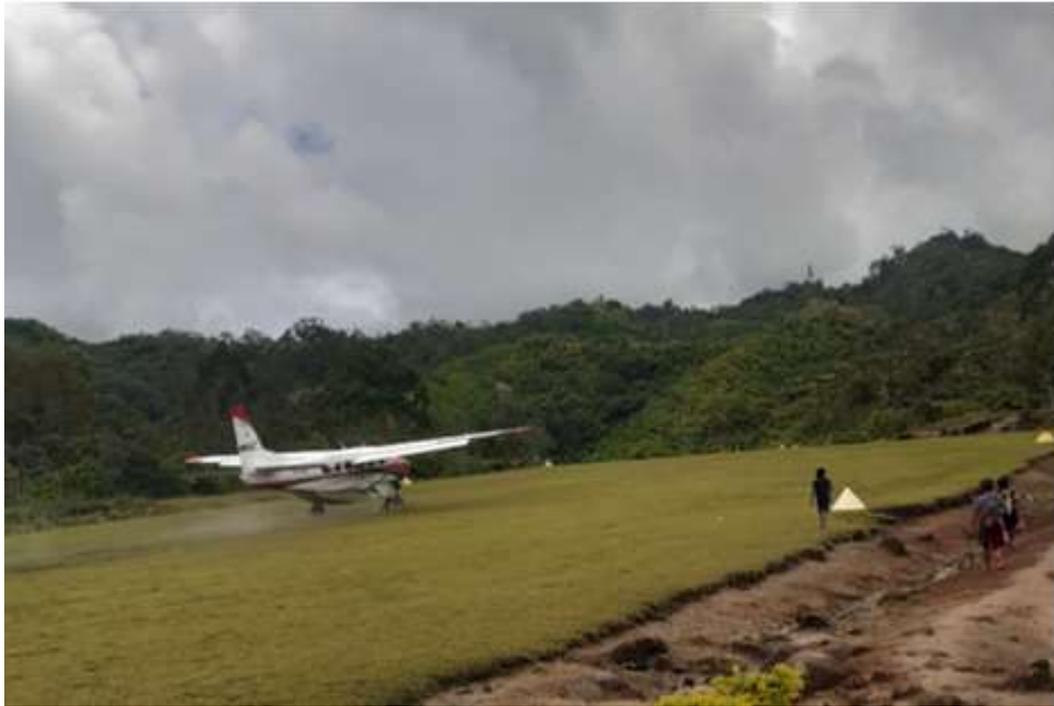
The pilot stated that he immediately selected idle⁵, then moved the power lever into the beta⁶ range just past the idle gate and applied full braking upon touchdown. However, the aircraft skidded forward on the airstrip as it aquaplaned⁷. Evidence of water on the airstrip surface was captured in an image by a witness (Figure 3).

Figure 3: Standing water on airstrip coming out from under the tyres of P2-MAF during landing roll. (Source: Witness)

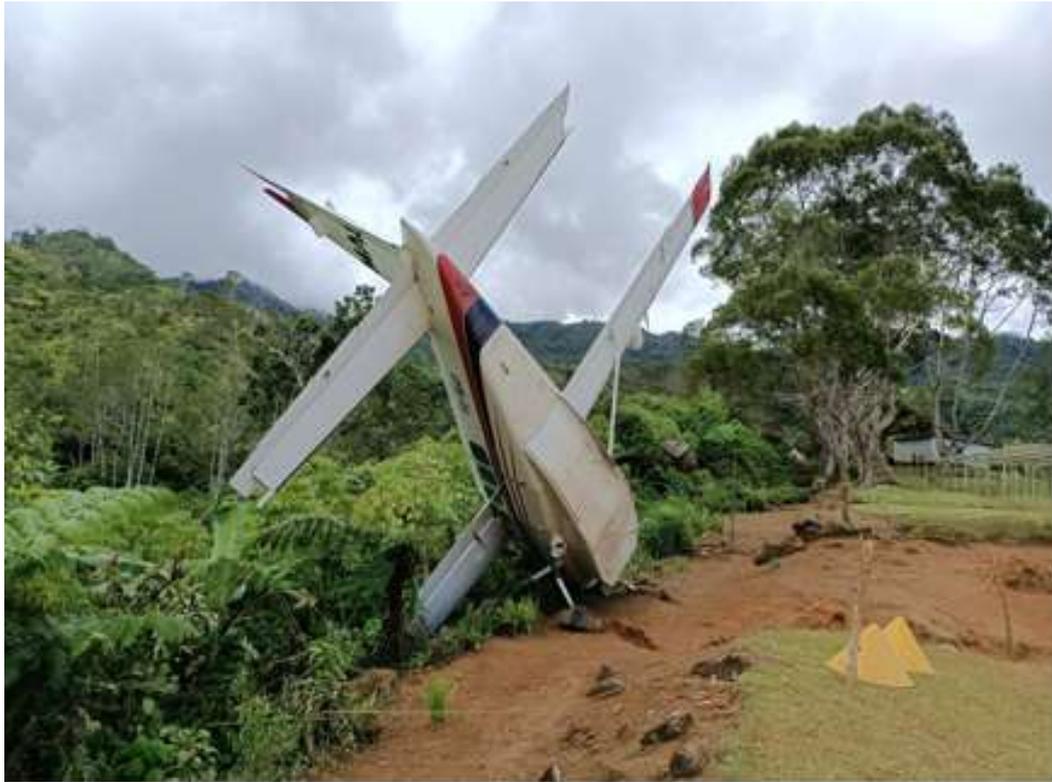
Figure 4: Back view of aircraft tilting on left side into gully at the end of runway.

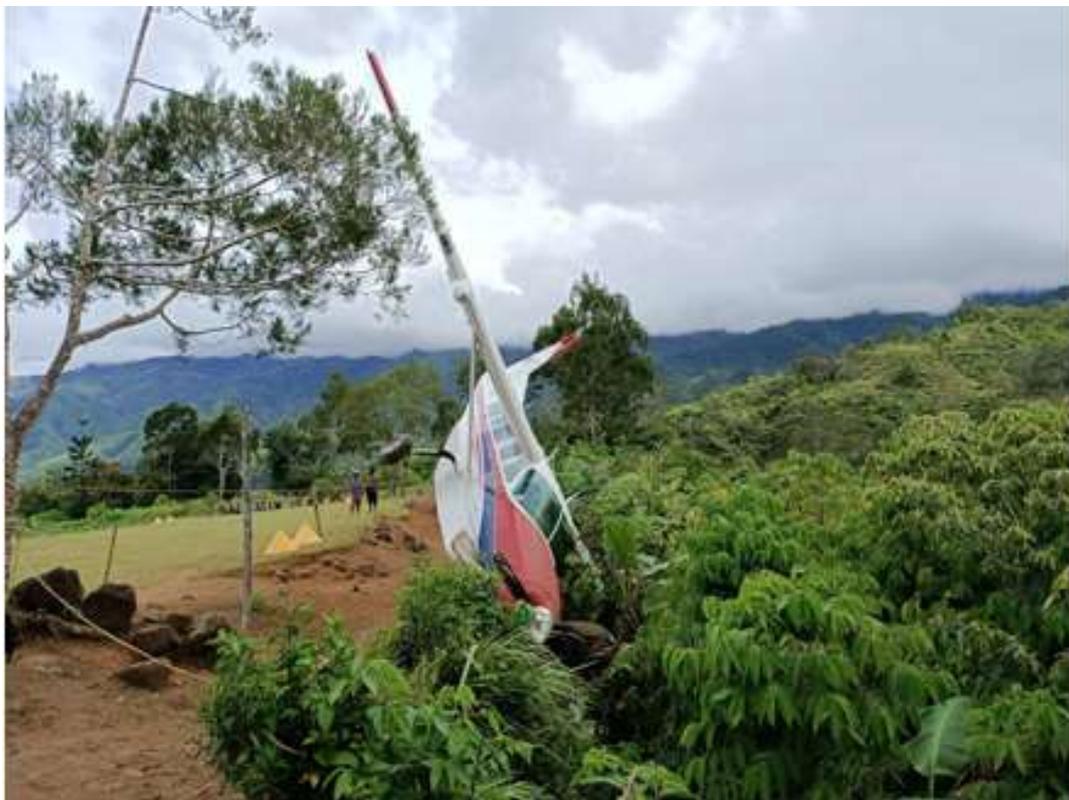
Figure 5: Front view of aircraft tilting on left side into gully at the end of runway.

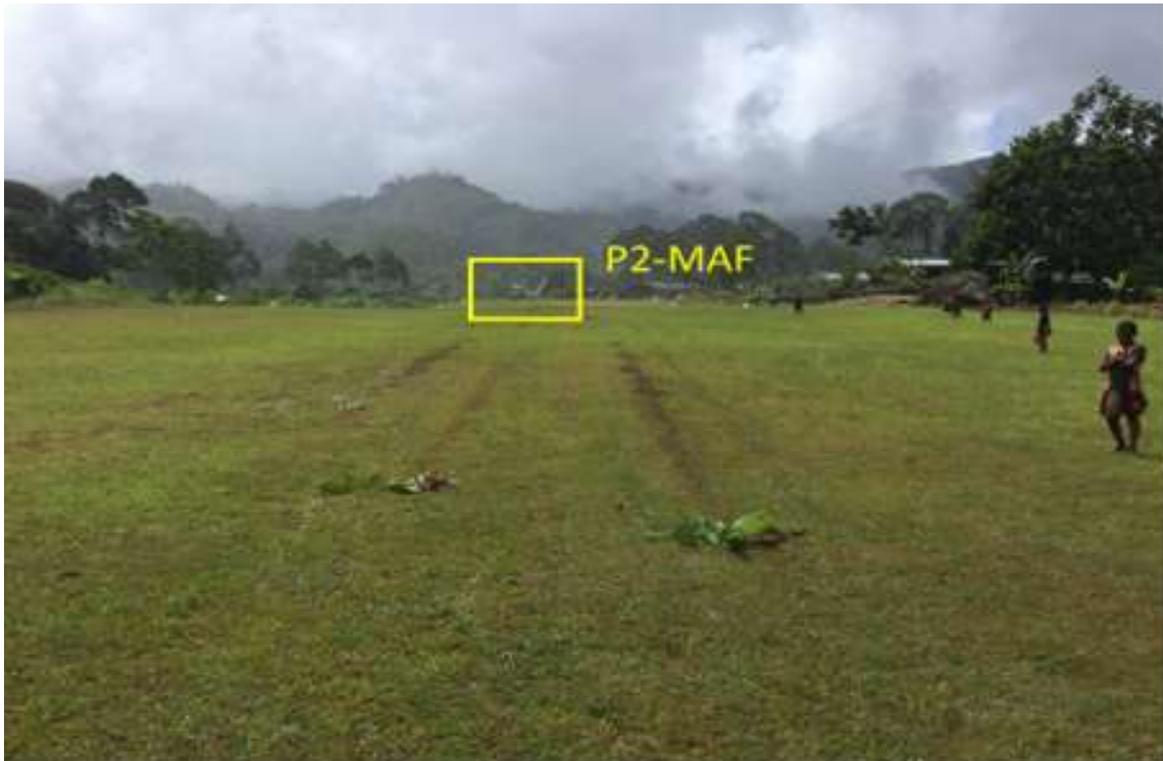
After clearing the tree, the pilot attempted to recover a normal descent. However, at that time the aircraft had already passed the strip 32 threshold, touching down more than 180 m beyond the threshold.

Figure 6: Touch down points of aircraft's wheels on airstrip marked with leaves by locals.

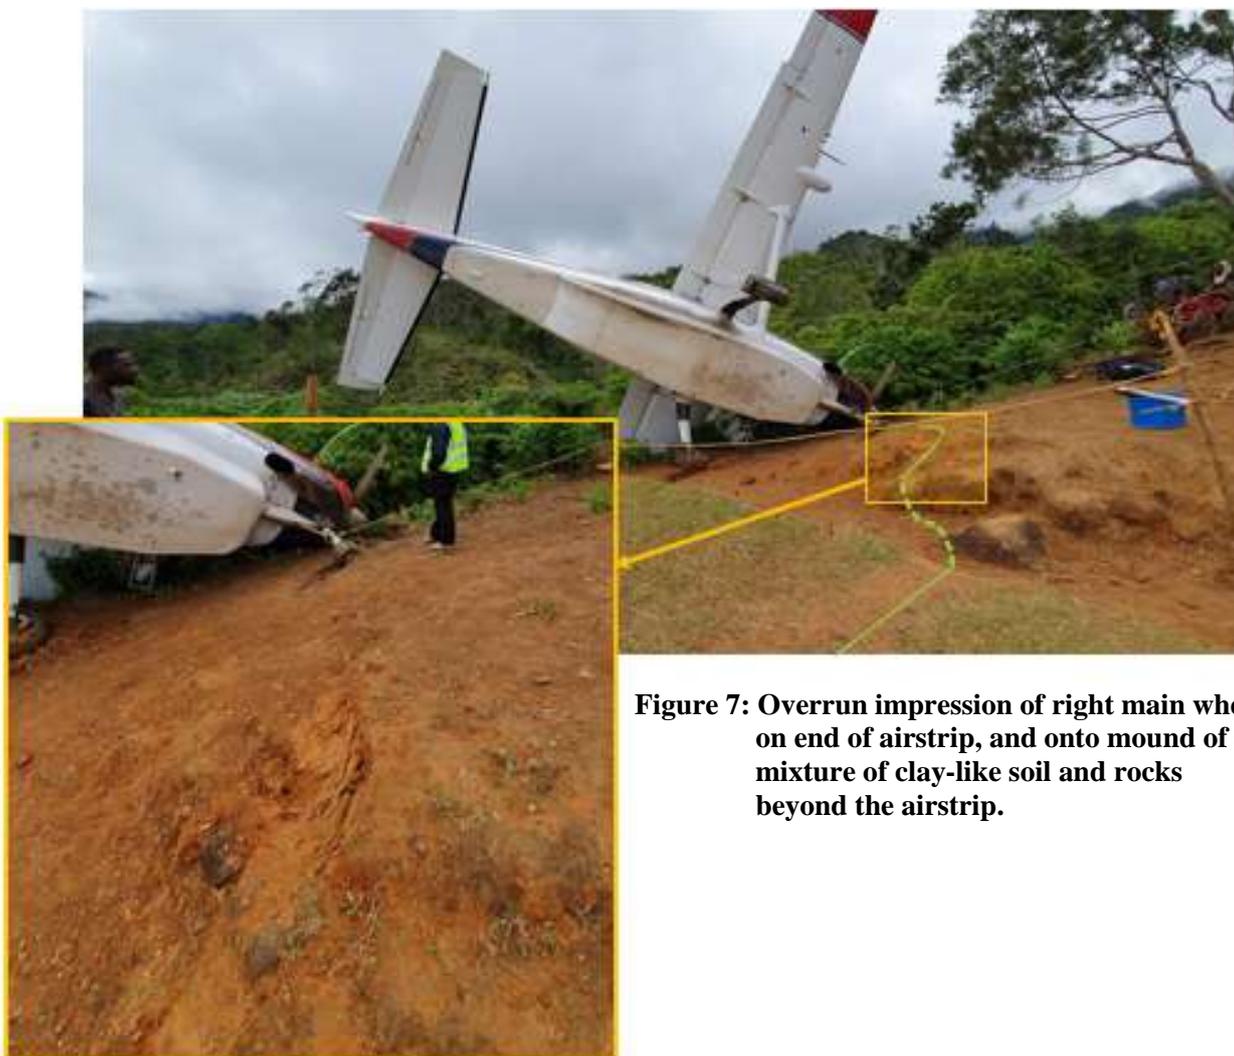
The tyre tracks at the end of the strip (see Figure 7) showed that the right main wheel hit a mound of clay-like soil and rocks as it left the defined strip boundary. This brought the aircraft onto its left side and the left wing subsequently tipped into the gully. The left main wheel fell onto its left side as the right main wheel was raised into the air, and the nose wheel dug into the ground. All propeller blades had evidence of contact with the ground.

Figure 7: Overrun impression of right main wheel on end of airstrip, and onto mound of a mixture of clay-like soil and rocks beyond the airstrip.

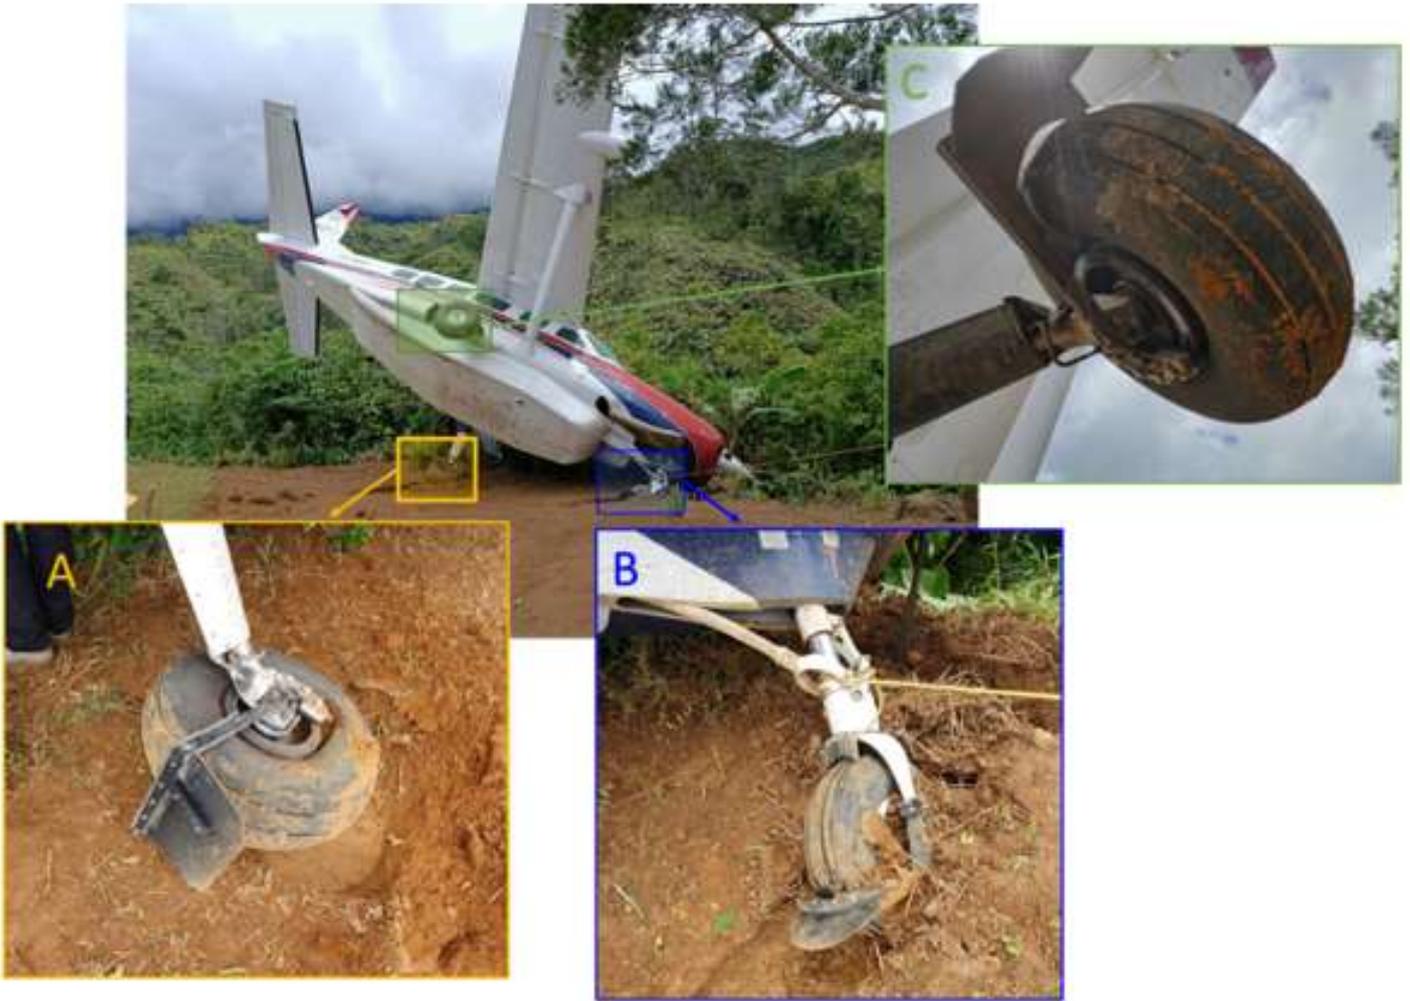
Figure 8: A – Left main wheel laying on its left side supporting the tilted aircraft, B – nose wheel dug into ground, C – Right main wheel in the air upon left side-turn.

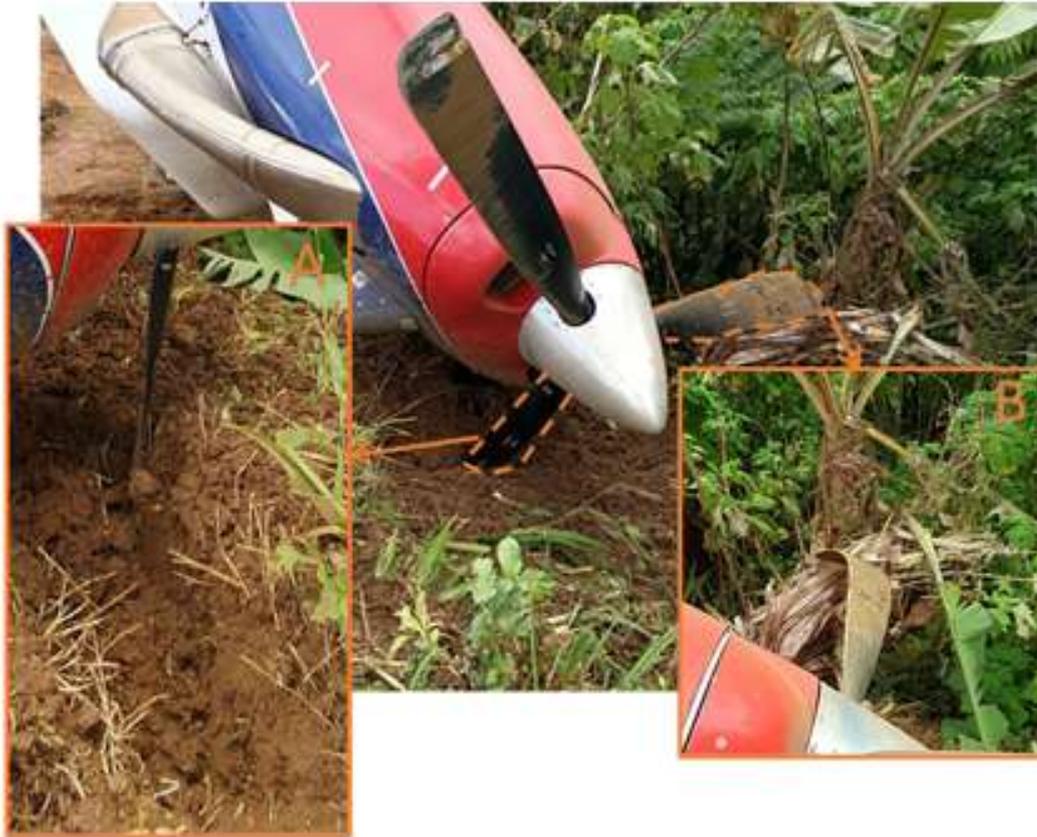
Figure 9: All propeller blades showing evidence of contact with ground. A – propeller dug into the ground, B – propeller significantly bent due post impact with ground.

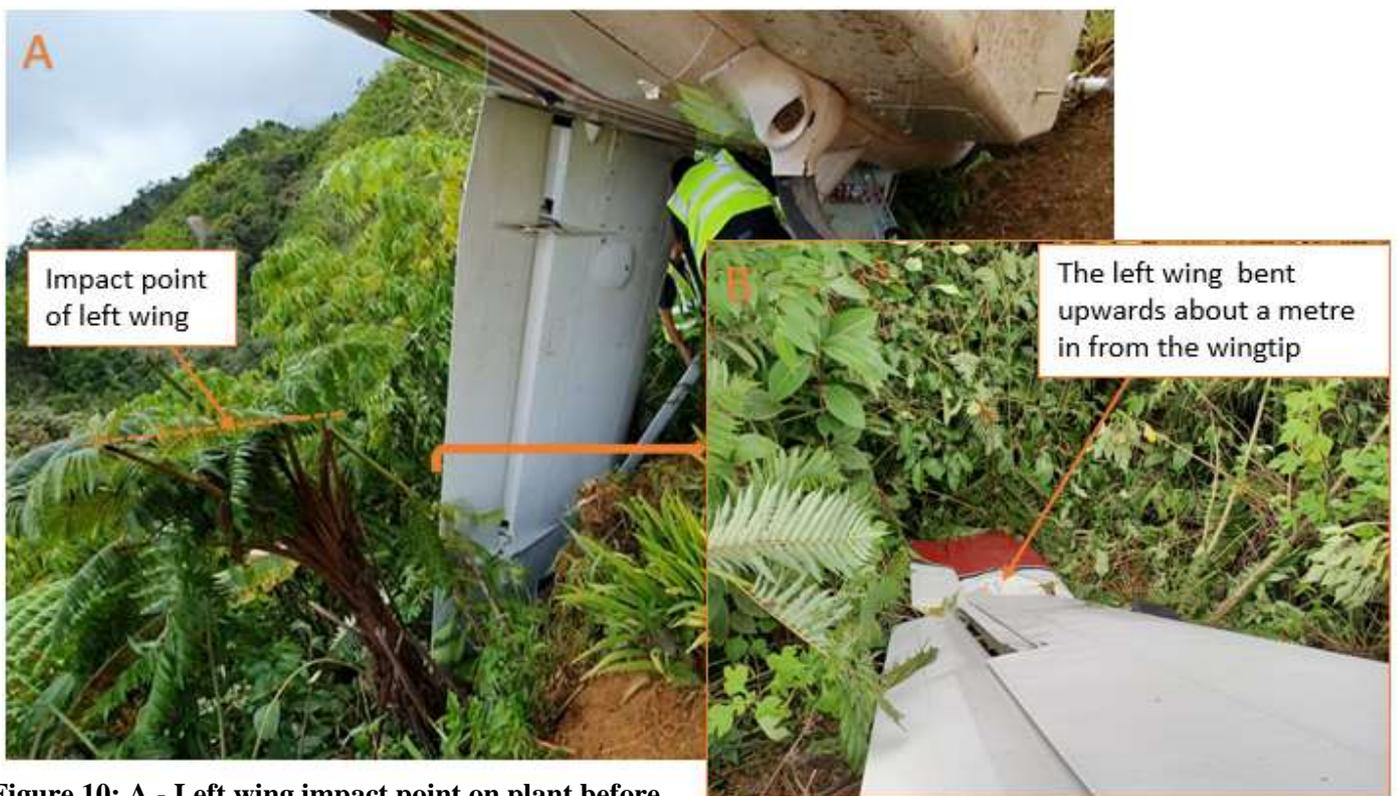
Figure 10: A - Left wing impact point on plant before tilting into gully at the end of runway, B – wing bent upwards about a metre in from the wing tip.
