PRELIMINARY REPORT

AIC 20-2001

VH-QOE

In-flight smoke in the cabin

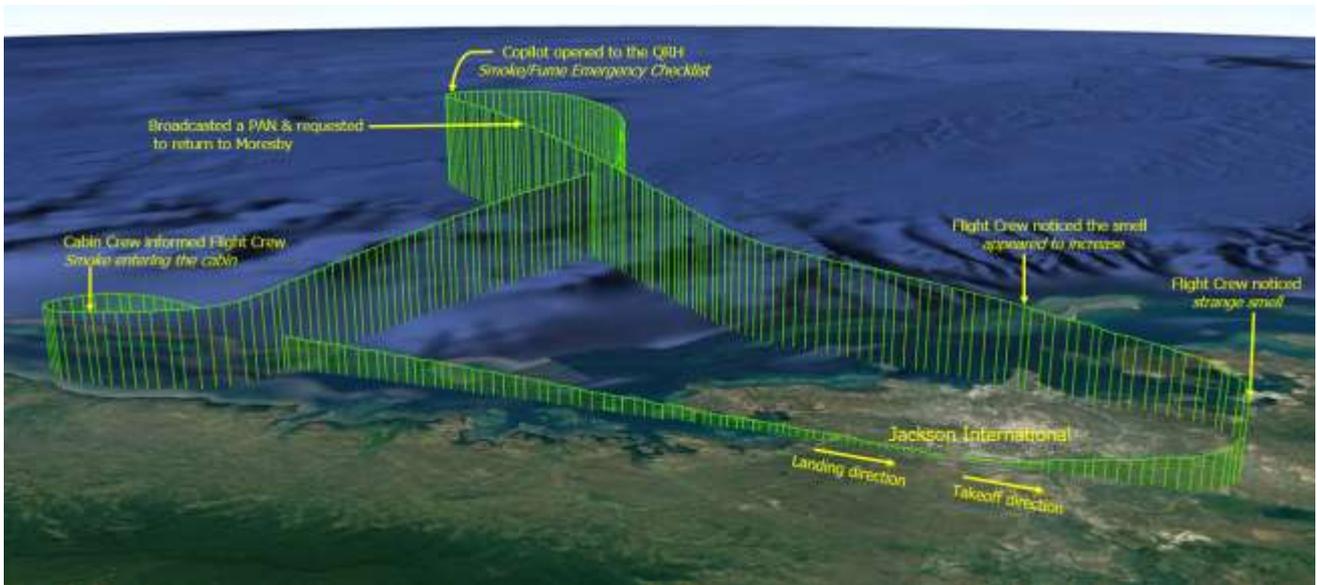
Figure 1: Depiction of VH-QOE flight path.

At about 01:30, approximately 30 nm from Port Moresby the aircraft was levelled at FL 180. After broadcasting a PAN and obtaining the clearance from the Air Traffic Control (ATC)⁵, the flight crew commenced to return to Port Moresby, making a right turn and descending to FL 100.

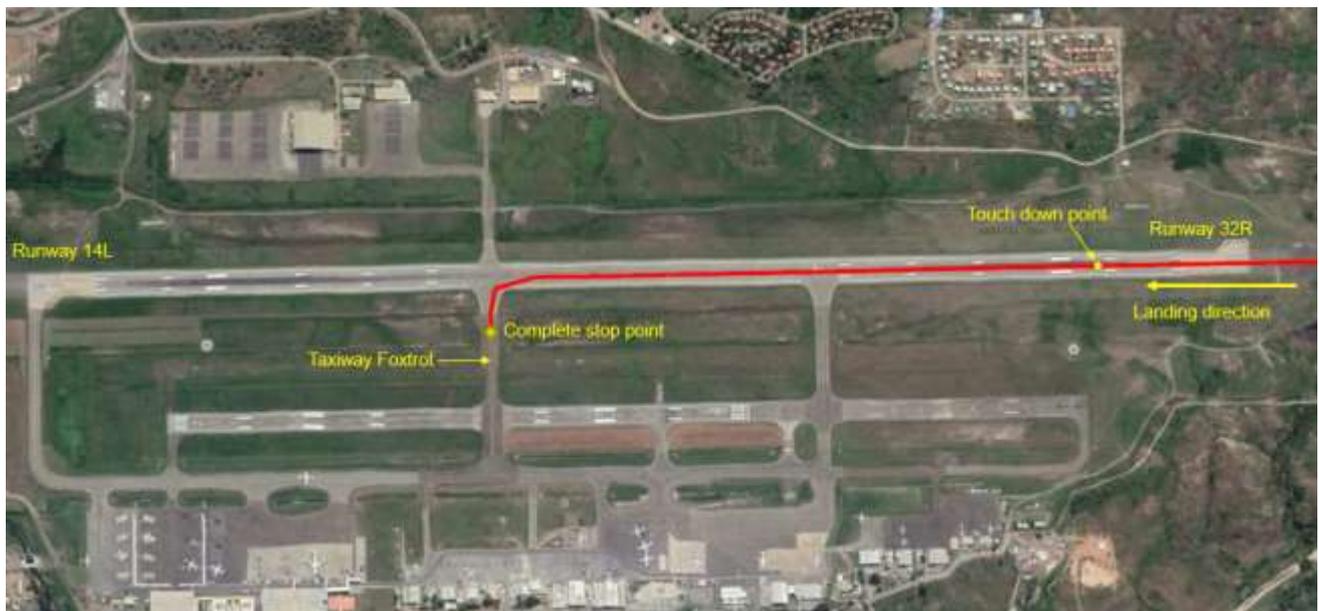
The aircraft continued its landing roll to exit the runway via taxiway Foxtrot (figure 2) where it came to a complete stop. In that position, the passengers and the crew exited the aircraft through the main door.

Figure 2: Touch down and final position of the aircraft.
