**FINAL REPORT  
AIC 19-1004**

**Air Sanga Limited  
P2-ASZ**

**PAC 750**

**Abnormal airstrip contact during landing**

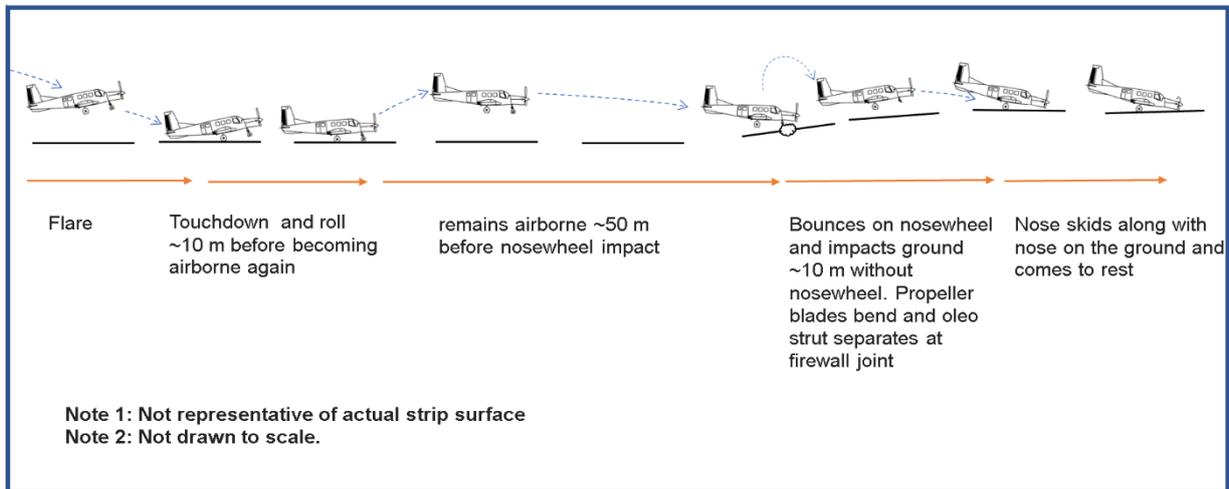
The aircraft travelled about 10 m before the nose dropped towards the ground bringing the propeller and oleo strut to eventually impact the ground. The propeller blades were bent significantly, the oleo strut separated at its firewall joint as the nose plunged into the ground.

**Figure 2: General sequence of events during landing.**

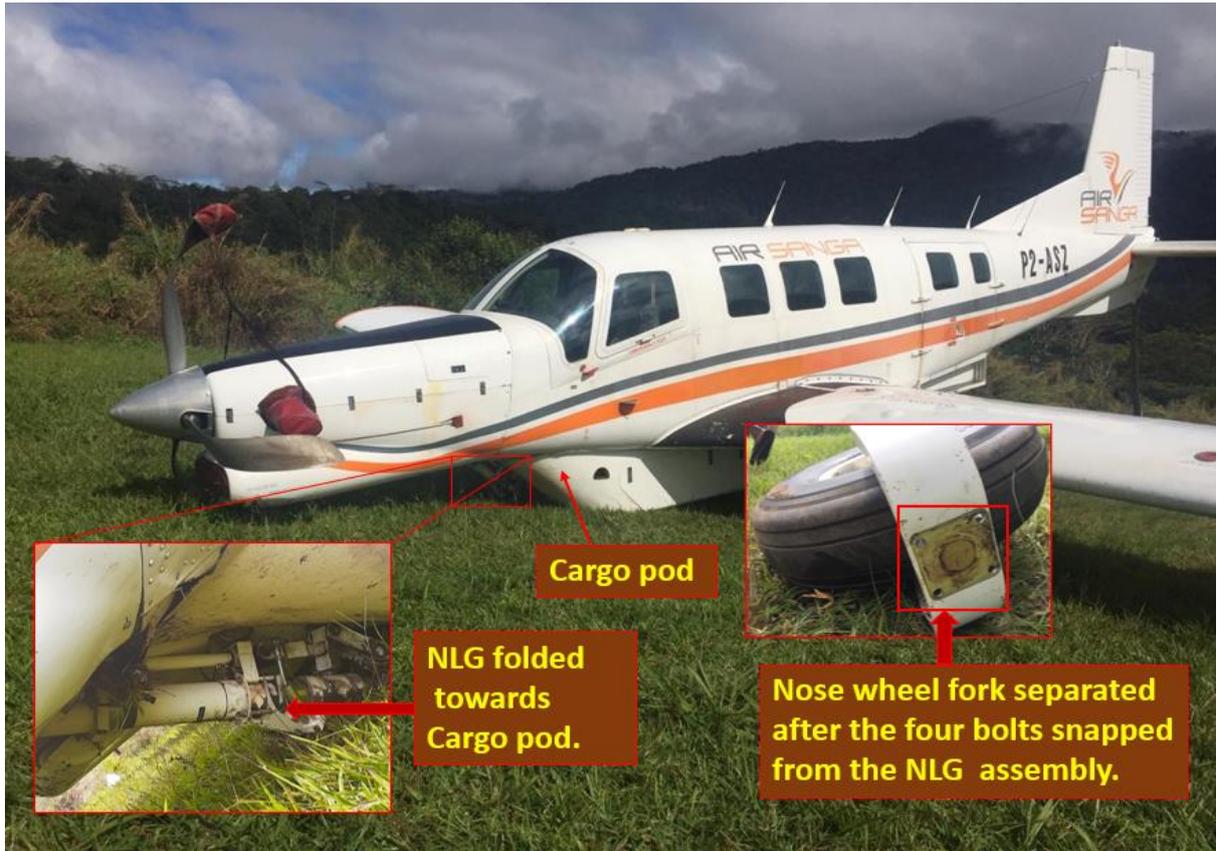
**Figure 3: The nose wheel separation and nose landing gear strut damage.**

The bolts holding the nosewheel fork to the strut socket snapped and caused the fork and wheel to separate from the strut. (see Figure 7)

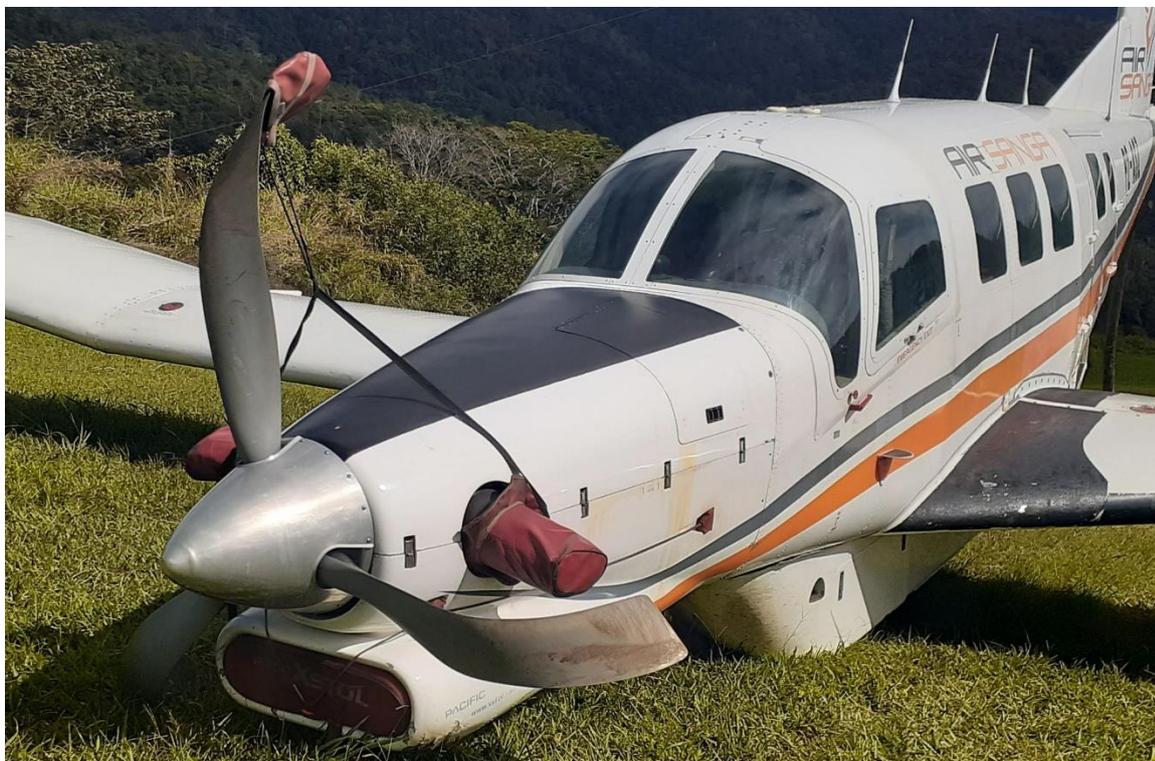
**Figure 4: Propeller damage.**

Propeller damage was caused and resulted when the nose collapsed towards the ground with reverse power present.

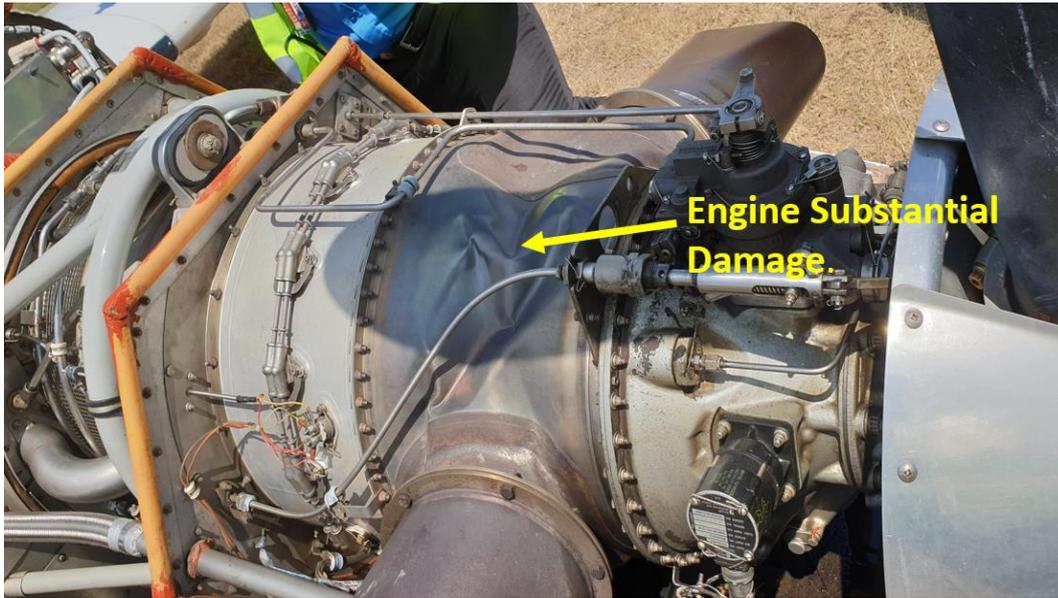
**Figure 5: Substantial damage of the engine reduction and exhaust section.**

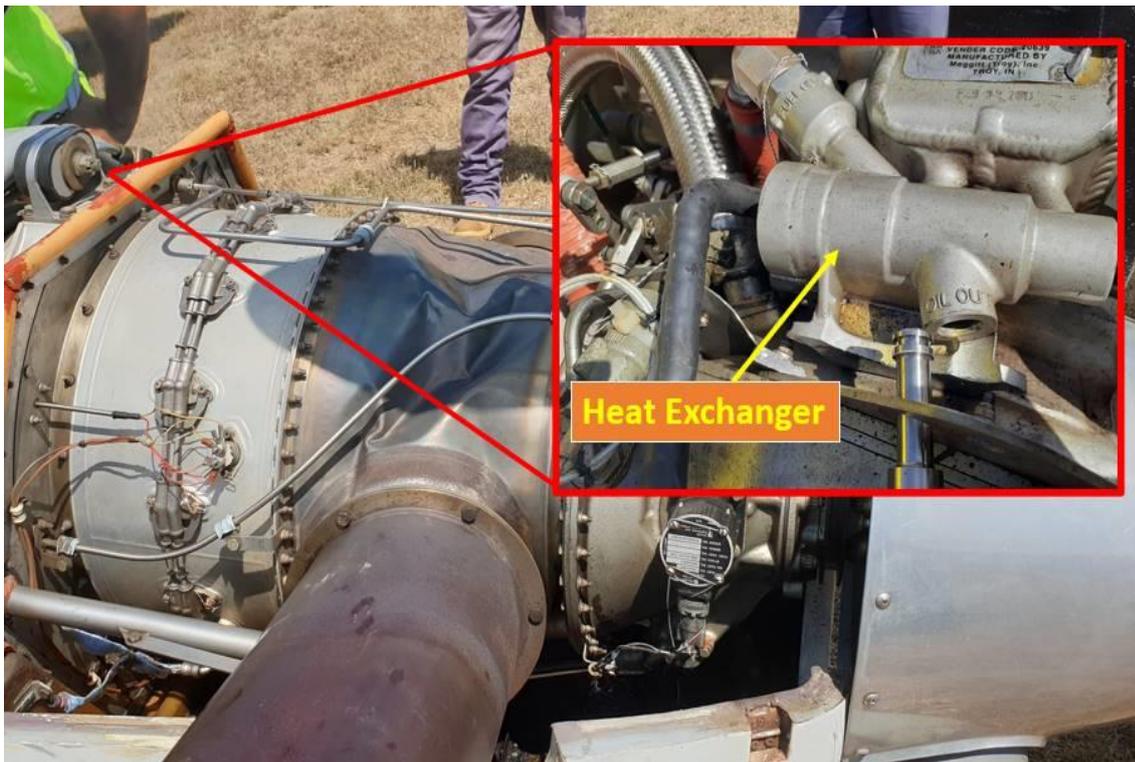
**Figure 6: Damage to the fuel and oil heat exchanger.**

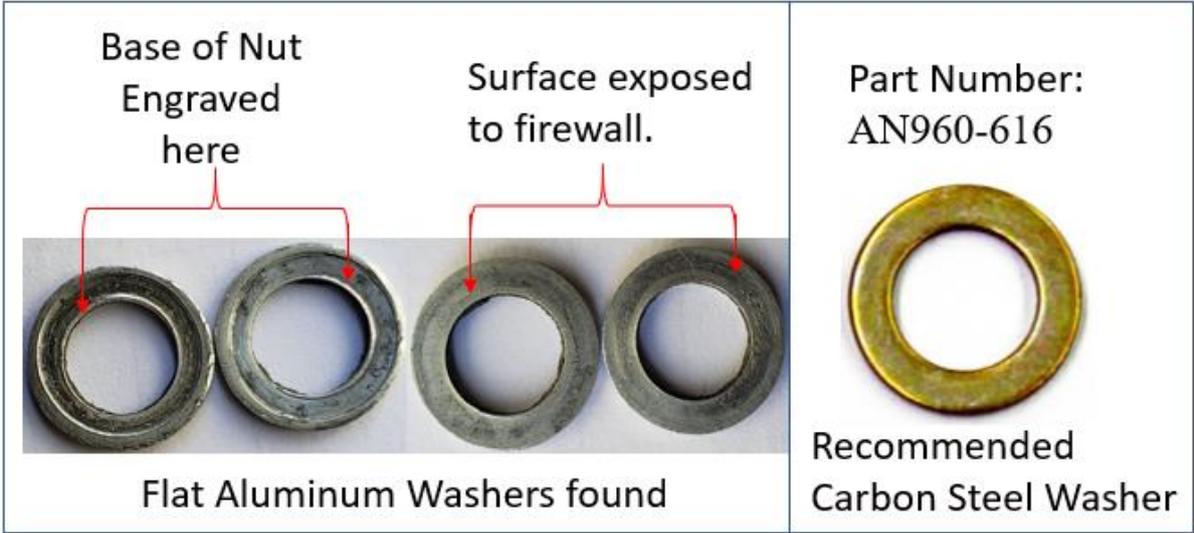
NAS stated that during the MSB maintenance action carried out on 14 August 2019, the existing washers were removed and reinstalled with the castellated nuts. The investigation found that during that maintenance, the engineers did not recognize that incorrect washers were installed.

The AIC was unable to find records of the fitment of the aluminum washers.

**Figure 8: Aluminium washers found and Manufacturer’s recommended washers.**

The investigation found that the two aluminum washers recovered from the attachment of the firewall inside the cockpit did not conform to specifications of the PAC750XL MSB, which required to use carbon steel washers.

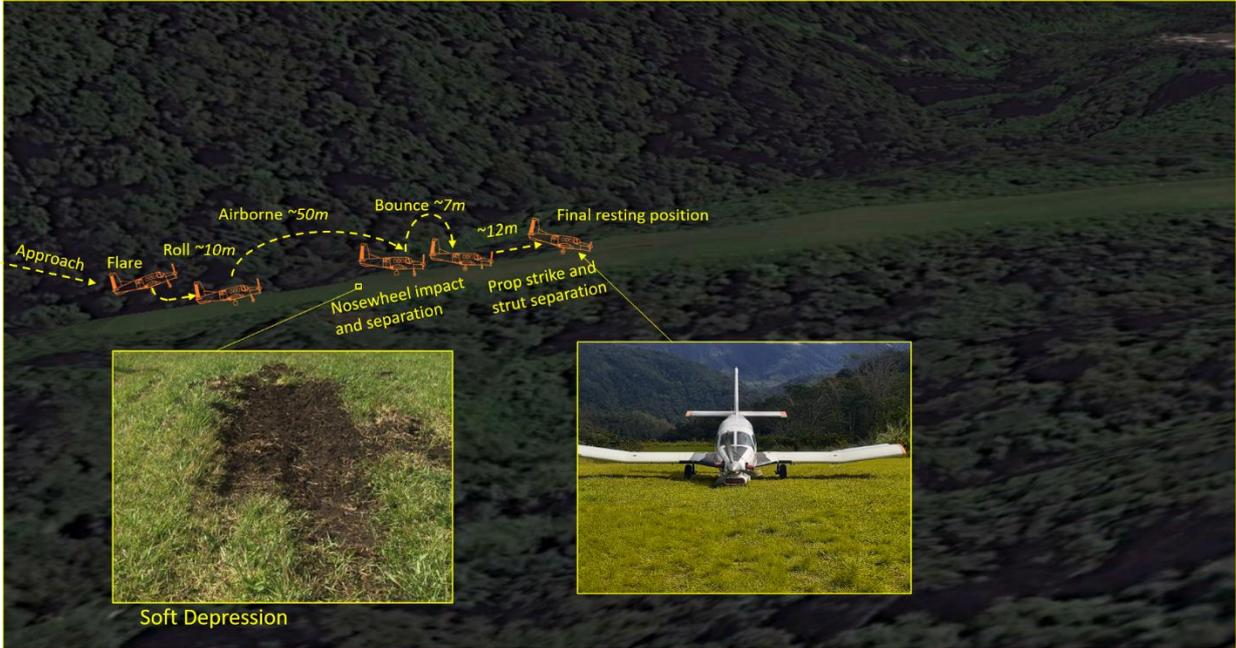
The nosewheel was found near a soft depression on the strip. This was determined to be where the nose wheel separated from the nose landing gear oleo at the fork.

There were no grounds marks observed between the depression and the aircrafts oleo impression and propeller strike marks. Propeller strike marks and oleo impression marks were observed about 7 m from the depression. This suggests that the aircraft bounced off the ground and as it contacted the ground again, the oleo collapsed allowing the propeller blades to strike the ground. All three propeller blades were significantly bent along the mid sections, indicating that they impacted the ground with engine power. The engine sustained substantial damage at the exhaust segment while oil and fuel heat exchanger mounting snapped off exposing of oil line. Moreover, the nose landing gear assembly was separated from the firewall and collapsed towards the forward face of the cargo pod causing it to dent.

Figure 9: Aircraft touch down to the final resting position (not drawn to scale)
