**FINAL REPORT**

**AIC 20 - 1002**

**Cessna 208 Caravan**

**Loss of control during landing at Miyanmin Airstrip**

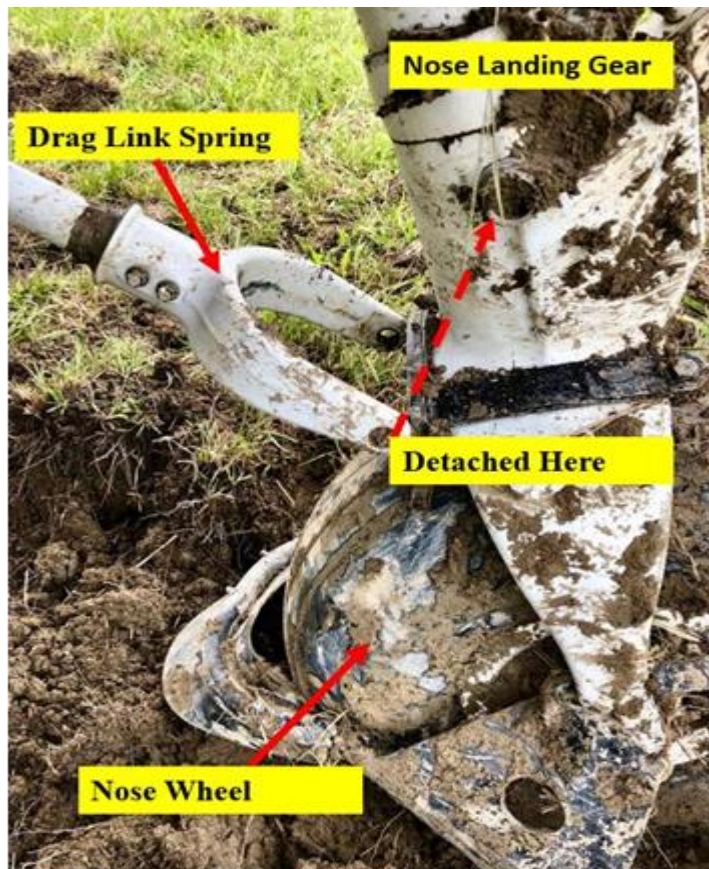
The aircraft sustained substantial damage to the nose landing gear (NLG), propeller blades and the outboard section of the right wing.

Figure 2: Damage to nose landing gear

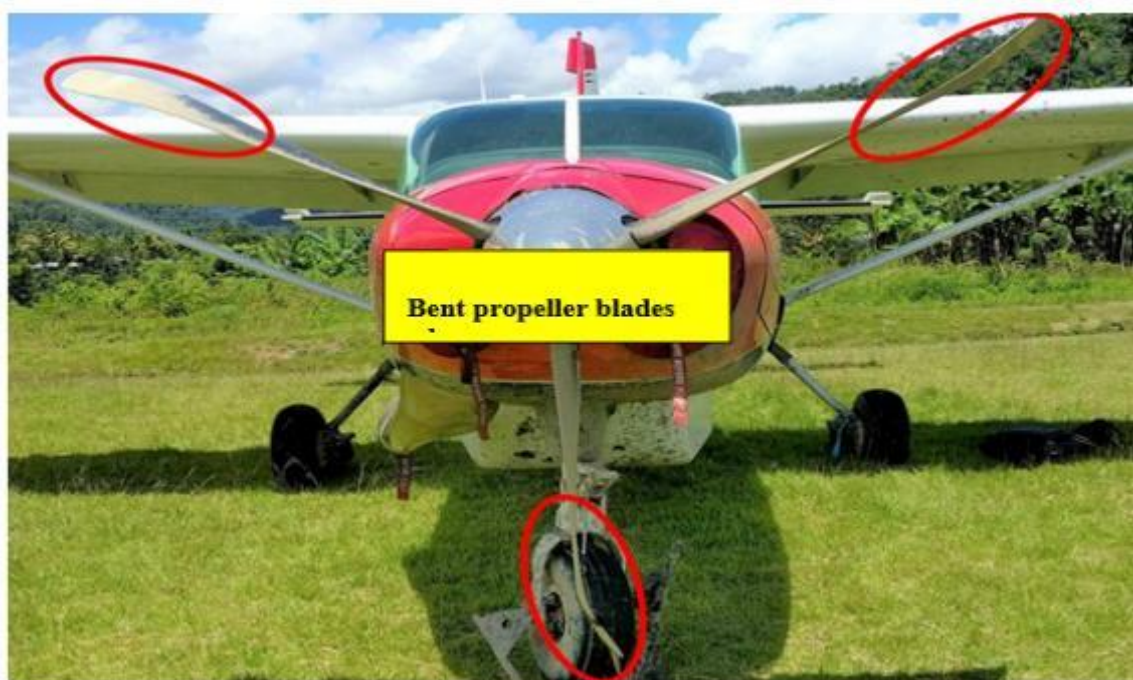
Figure 3: Damage to propeller blades

It was evident from the damage to the propeller blades that the propeller was being powered and that the blades were in the idle to beta range when they struck the surface, followed by the right wing impacting the ground.

The damage on the propeller blades indicated that there was power at the time of impact.

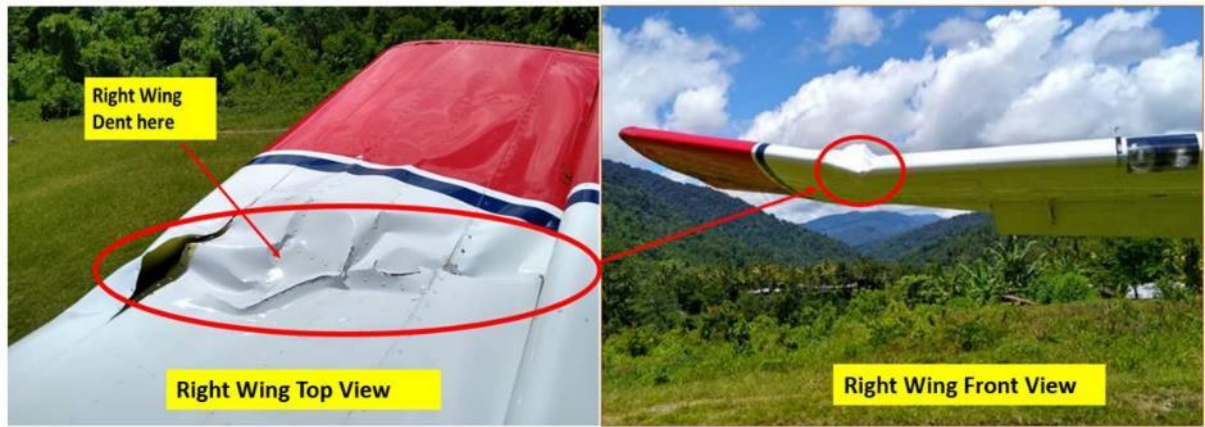
**Figure 4: Damage to right wing**

The outboard section of the right wing impacted the ground and was bent upwards when the aircraft tipped to its starboard side (See Figure 4).

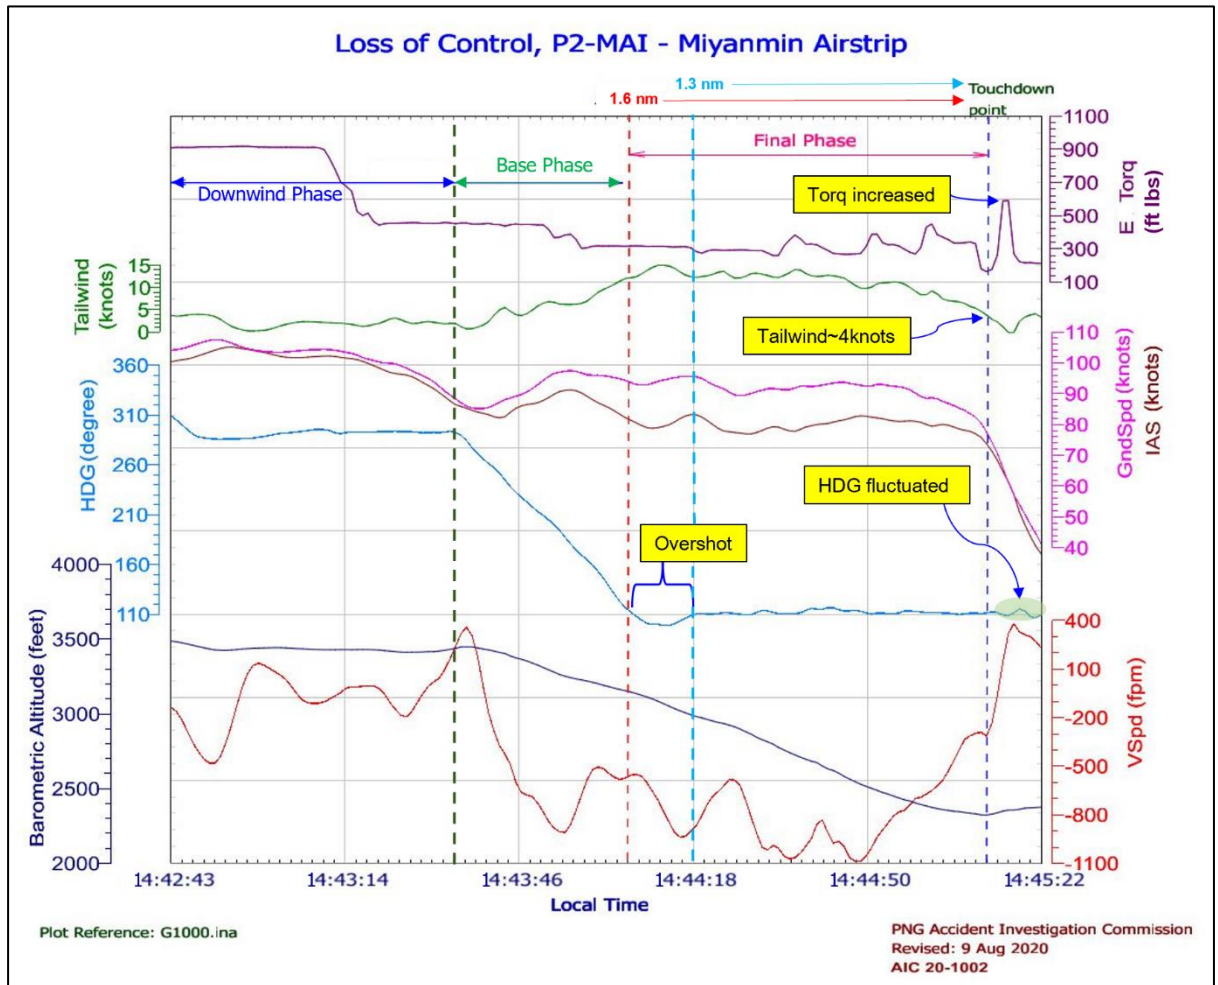
About 2 seconds after touch down, the torque parameter began to increase and subsequently developed a peak value of 591 lb-ft.

An increase in torque was an indication of the application of the reverse thrust. About the same time the torque was increasing, the heading began to fluctuate which was an indication of the aircraft commencing to lose directional control.

Figure 5: G1000 recorded parameters data plot of the accident flight.

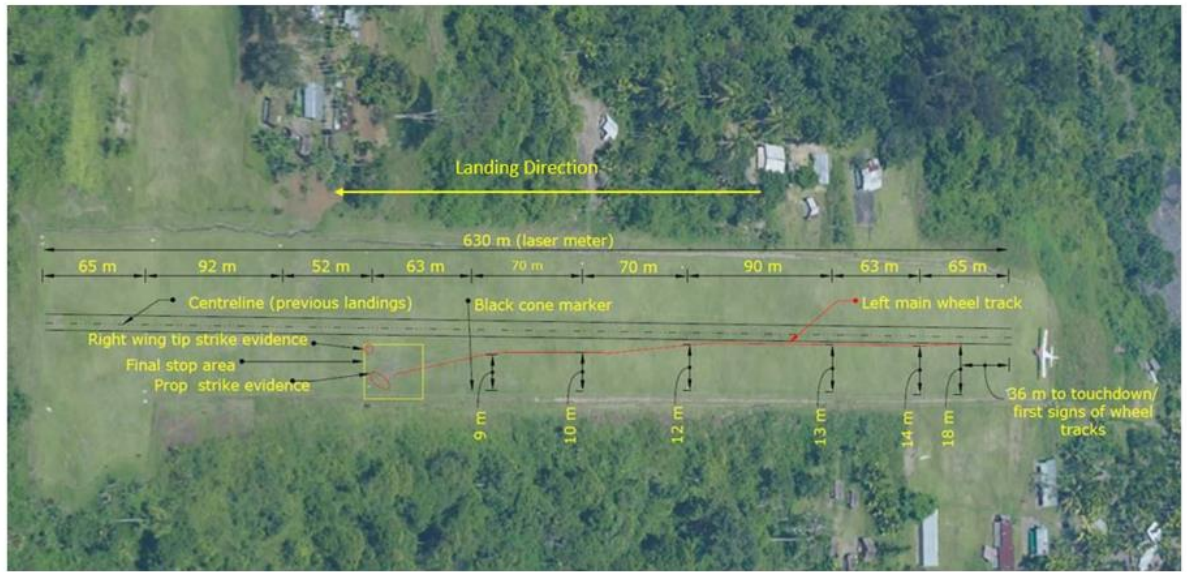
**Figure 6: Overview of landing roll track-Full length (Source MAF PNG)**

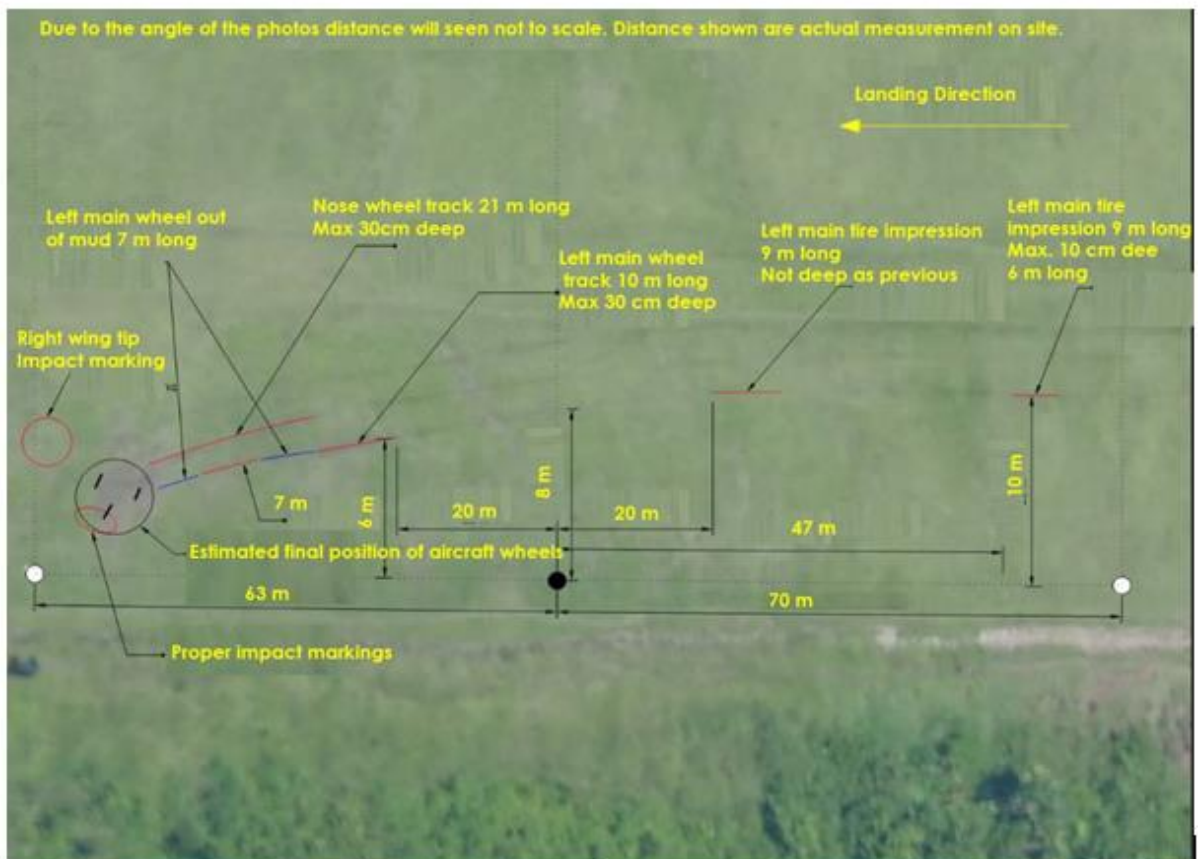
**Figure 7: Overview of landing roll track-Mid length (Source MAF PNG)**

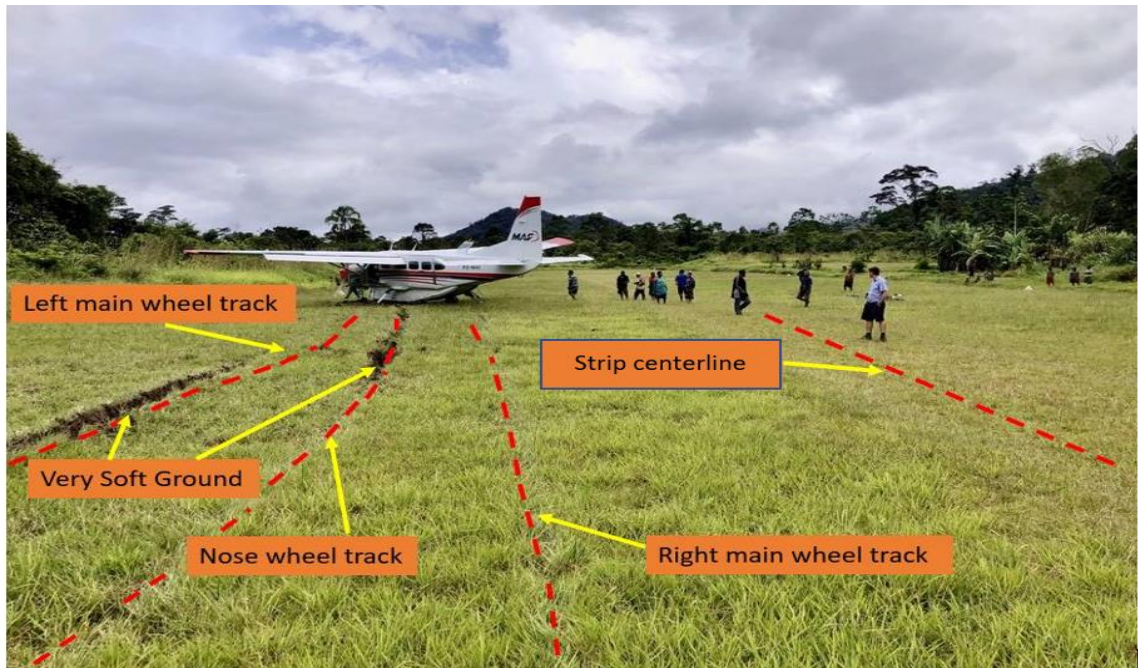
Figure 8: Tyre and impact markings on the runway
