PRELIMINARY REPORT

AIC 22 - 1003

BELL 206 L3

Tailrotor Strike during take off

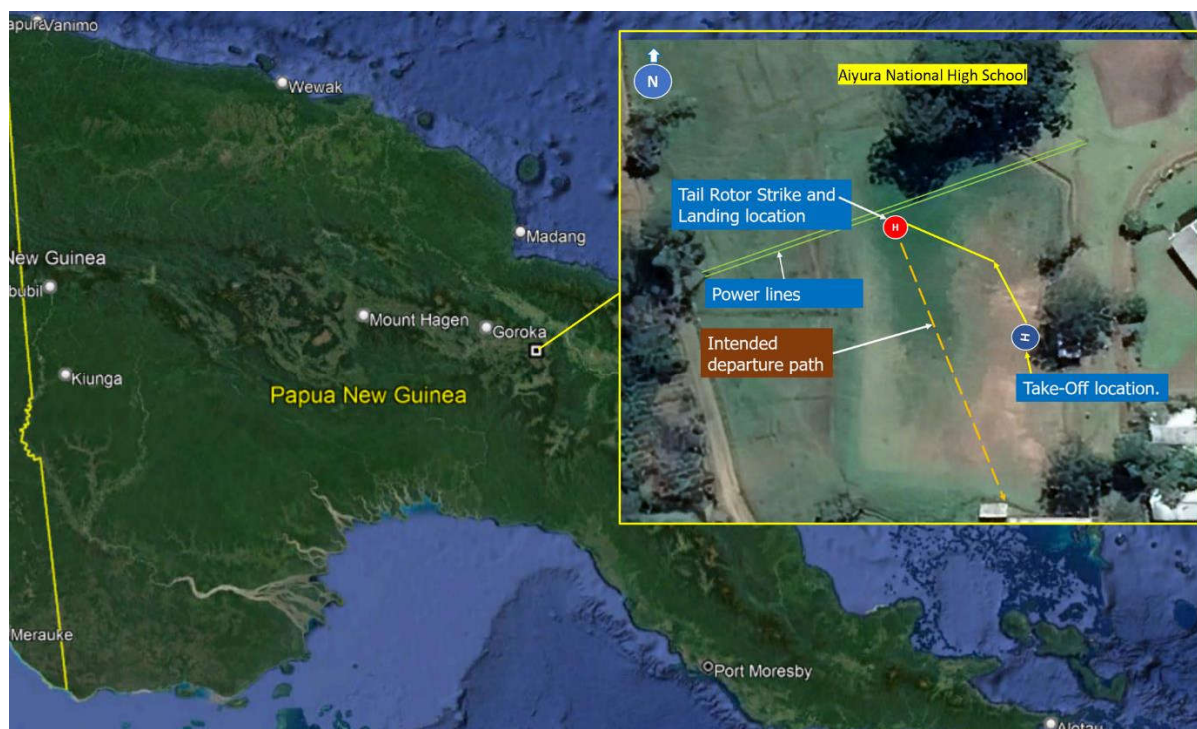
Figure 1. Figure 1: P2-SIL take off area.

The V2-Track³ recorded data shows that the helicopter lifted off to a height of 6m, turned left and began tracking towards the northwest side of the field. As the helicopter reached the edge of the open field, the pilot commenced a turn toward the Southwest, the pilot's intended departure track. The pilot stated that during this turn, he felt a sudden strong vibration through the antitorque pedals and cyclic pitch control. He stated that he suspected that the tail rotor had struck an obstacle. He subsequently reduced power and landed the helicopter.

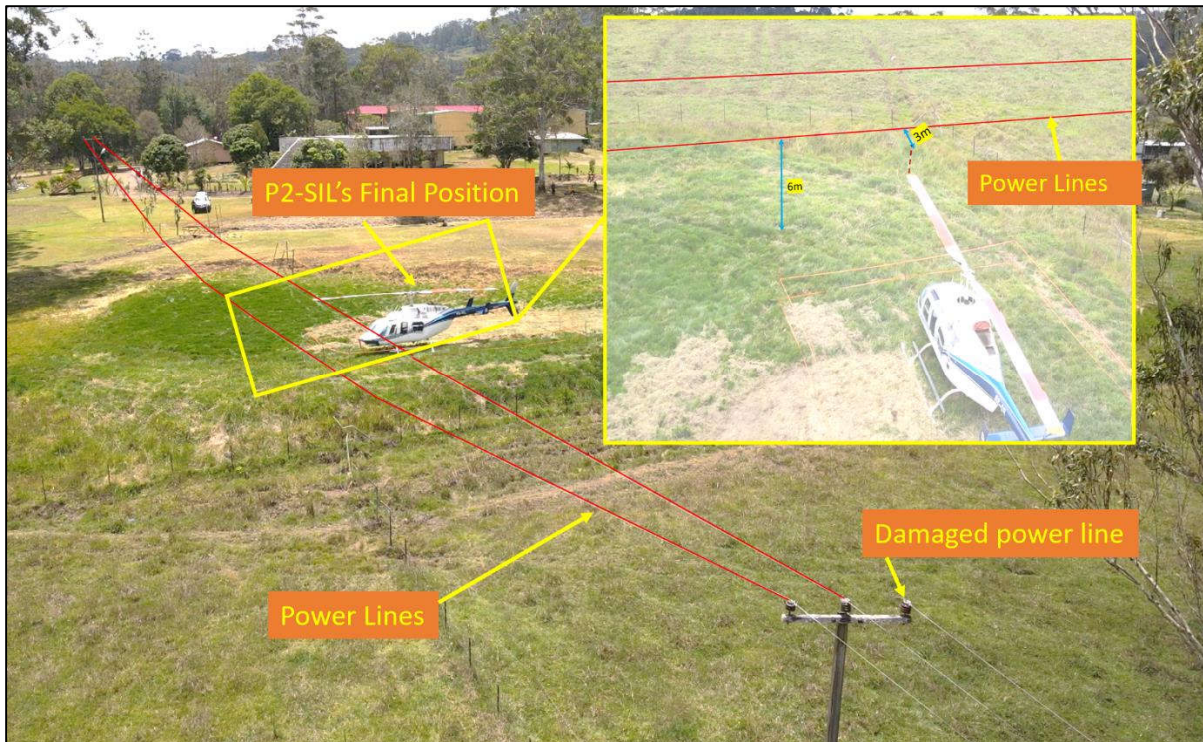
Figure 2. Obstacles and Final position of P2-SIL.

He recalled checking the passengers after shutting down the engines, to ensure they were safe and further assisted them to exit the helicopter safely. He subsequently inspected the helicopter and found damage to the tail rotor blades. A power line was also observed about 3m from the helicopter's resting position, running generally across the edge of the field at a height of about 6m.

It was therefore concluded that the helicopter tail rotor blade had struck a power line.

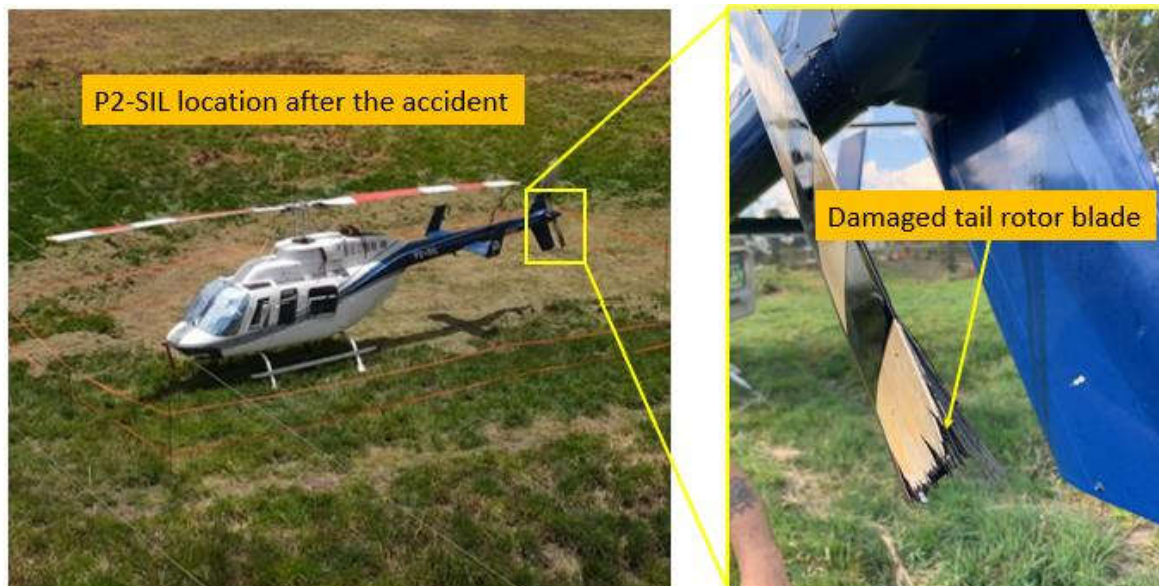
Figure 3. Damage sustained to the tail rotor blade.

Aircraft manufacturer and model:	Bell Helicopters, Bell 206 L3	
Registration:	P2- SIL	
Serial number:	51511	
Engine manufacturer and model	Rolls Royce Corporation, 250-C30P	
Engine serial number	CAE-895211	
Main Rotor Blades Manufacturer	Bell Helicopters	
Main Rotor Blade 1 and 2 Serial Numbers	BH 215656 and A 8853 respectively	
Type of operation:	Charter flight	
Persons on board:	Crew: 1 Pilot	Passengers: 5
Injuries:	Crew: Nil	Passengers: Nil
Damage	Substantial damage to tail rotor blade edge and tail rotor gearbox mounting structure.
