**FINAL REPORT
AIC 22-1001**

On 18 January 2022 at 11:20 local time (01:20 UTC), the AIC was notified by NiuSky Pacific Limited via email of an accident involving a PAC 750XL aircraft, registered P2-BWE, owned and operated by Niugini Aviation Services Limited at Tekin Airstrip, Sandaun Province. The AIC immediately commenced an investigation.

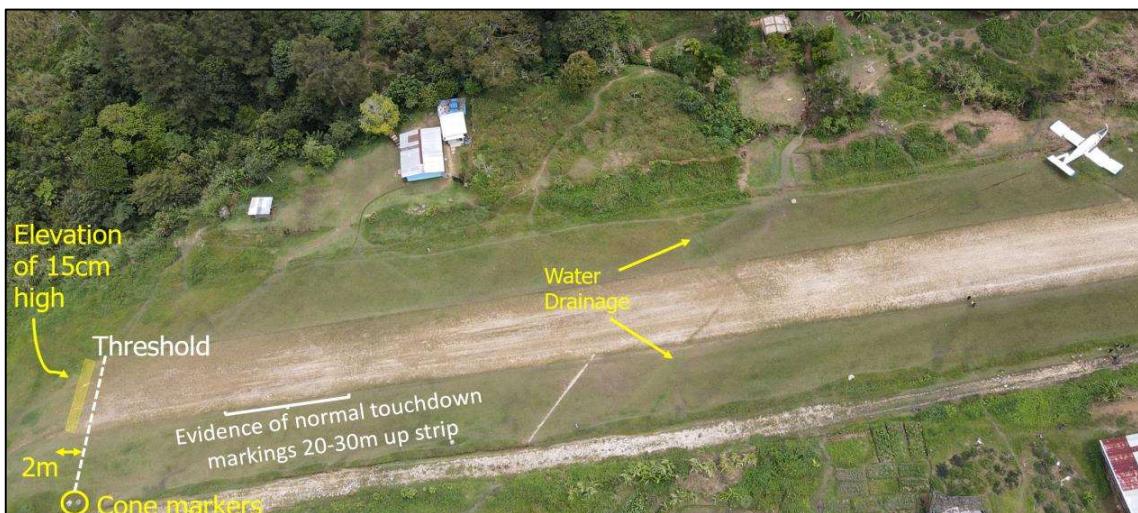
Figure 7:Tekin Airstrip with indications of onsite observation

During the onsite investigation, it was observed that the runway surface was hard and comprised of unsealed gravel with light overgrowth of grass. There were several water drainage run-offs from the centre of the runway towards the grass runway.

There is an inclination that begins from the grass surface just before the start of runway 18 that reaches an elevation of about 15cm.

There were two cone markers to the right of runway 18 about 5m up the runway from the edge of the runway. Their purpose was to indicate the designated landing threshold of the runway where the surface is levelled, however it was observed that the cone markers were not in good condition to be clearly visible. The runway surface shows evidence of a normal touchdown point 20-30m up the runway of the designated landing threshold.

The AIC identified that although the runway surface conditions at Tekin Airstrip was suitable for the aircraft to land at the time of the accident, there were some existing hazards such as the two cone markers that did not clearly indicate the designated landing threshold for the normal touch down point, 20-30m up runway from the edge of runway 18. The AIC determines that this hazard most likely contributed to the pilot landing the aircraft short of the designated landing threshold.

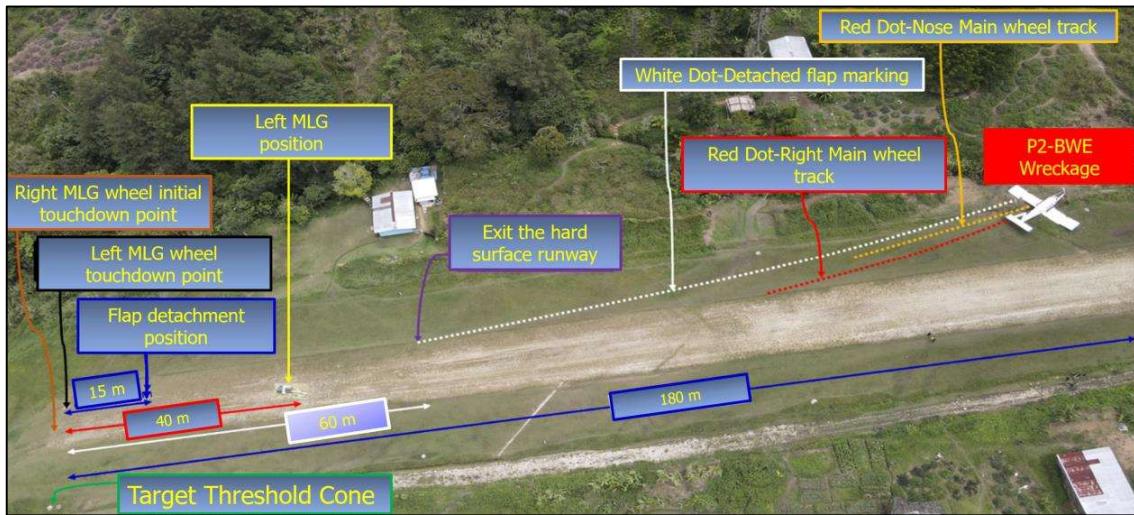
Figure 9: Aircraft's wreckage distribution

During the on-site investigation, it was established that the aircraft's initial touchdown was about 2m short of the designated landing threshold indicated by cone markers and the MLG collapsed subsequently. The investigation also established that 15m from the initial touchdown point, the aircraft's left-wing assembly dropped, hit the ground and the flap detached and began to drag on the surface creating markings. About 40m after the initial touchdown, the left MLG assembly⁹ was found on the runway surface.

The tire tracking markings on the surface showed that about 61m from the initial touchdown, the aircraft began to exit the runway or veer left of the runway, onto the grass runway and continued until it impacted the drain which was adjacent to the edge of the grass runway.

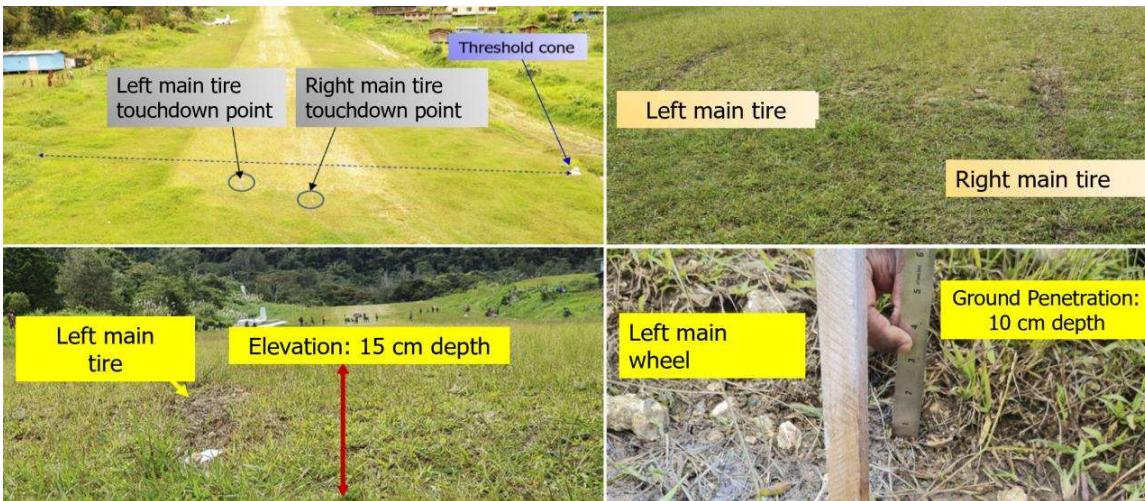
Figure 10: Aircraft's initial touchdown points

The on-site investigation team also established from the tire track markings that during the initial touchdown, the aircraft's left main landing tire hit the elevation of about 15cm high at the edge of runway18 and penetrated through the ground at a depth of 10cm.

The evidence also showed that the aircraft's right main tyre initially touched down a few centimetres prior to the left main tyre touchdown point, however, there was no sign of heavy ground penetration as a result.

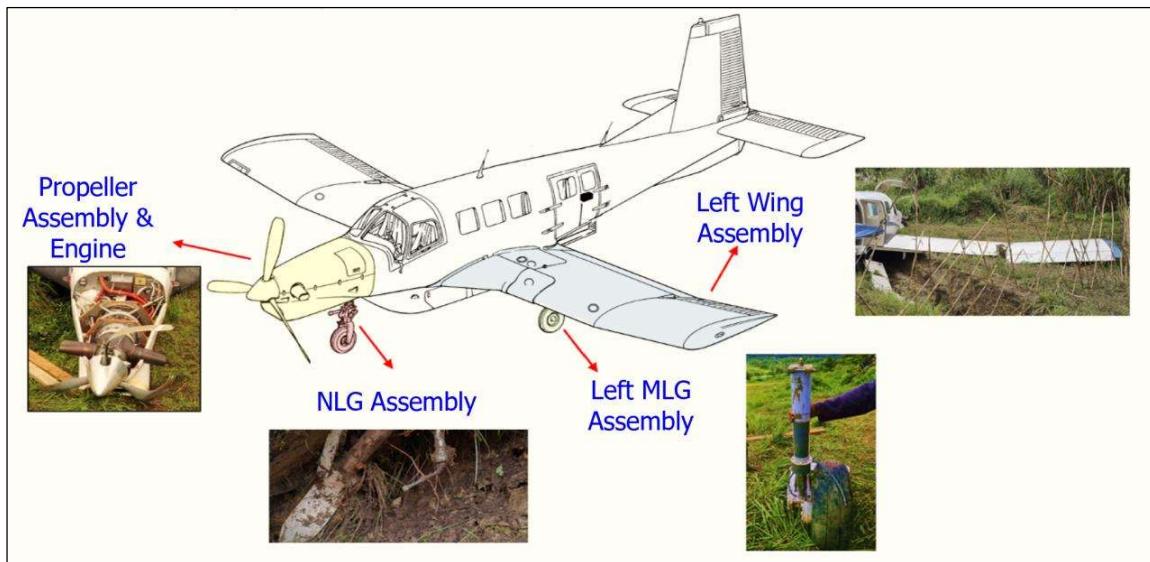
Figure 11: Damages sustained by P2-BWE

The aircraft sustained significant structural damages to the left MLG assembly, left wing assembly, nose landing gear assembly, the propeller blades, and the engine exhaust section.

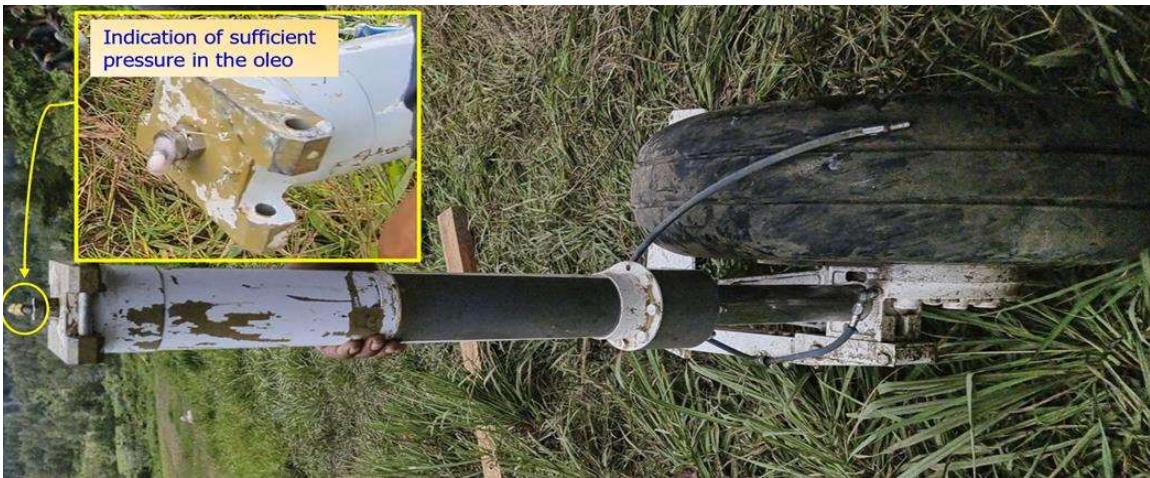
Figure 12: Evidence of sufficient pressure in the oleo strut

The on-site investigation team also identified that the left MLG oleo strut that had detached from the aircraft was extended and there was also evidence of fluid coming out of the valve cap. This indicated that there was sufficient pressure in the oleo strut allowing it to extend.

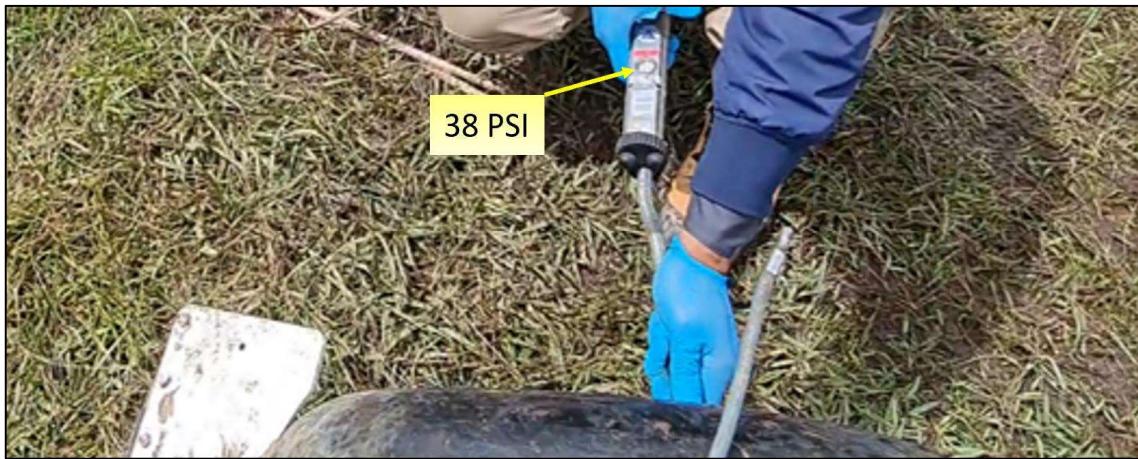
Figure 13: Evidence of sufficient pressure in the left main landing tire

The on-site investigation team also measured the pressure of the left main tire at Tekin Airstrip and identified that the pressure was 38 psi.

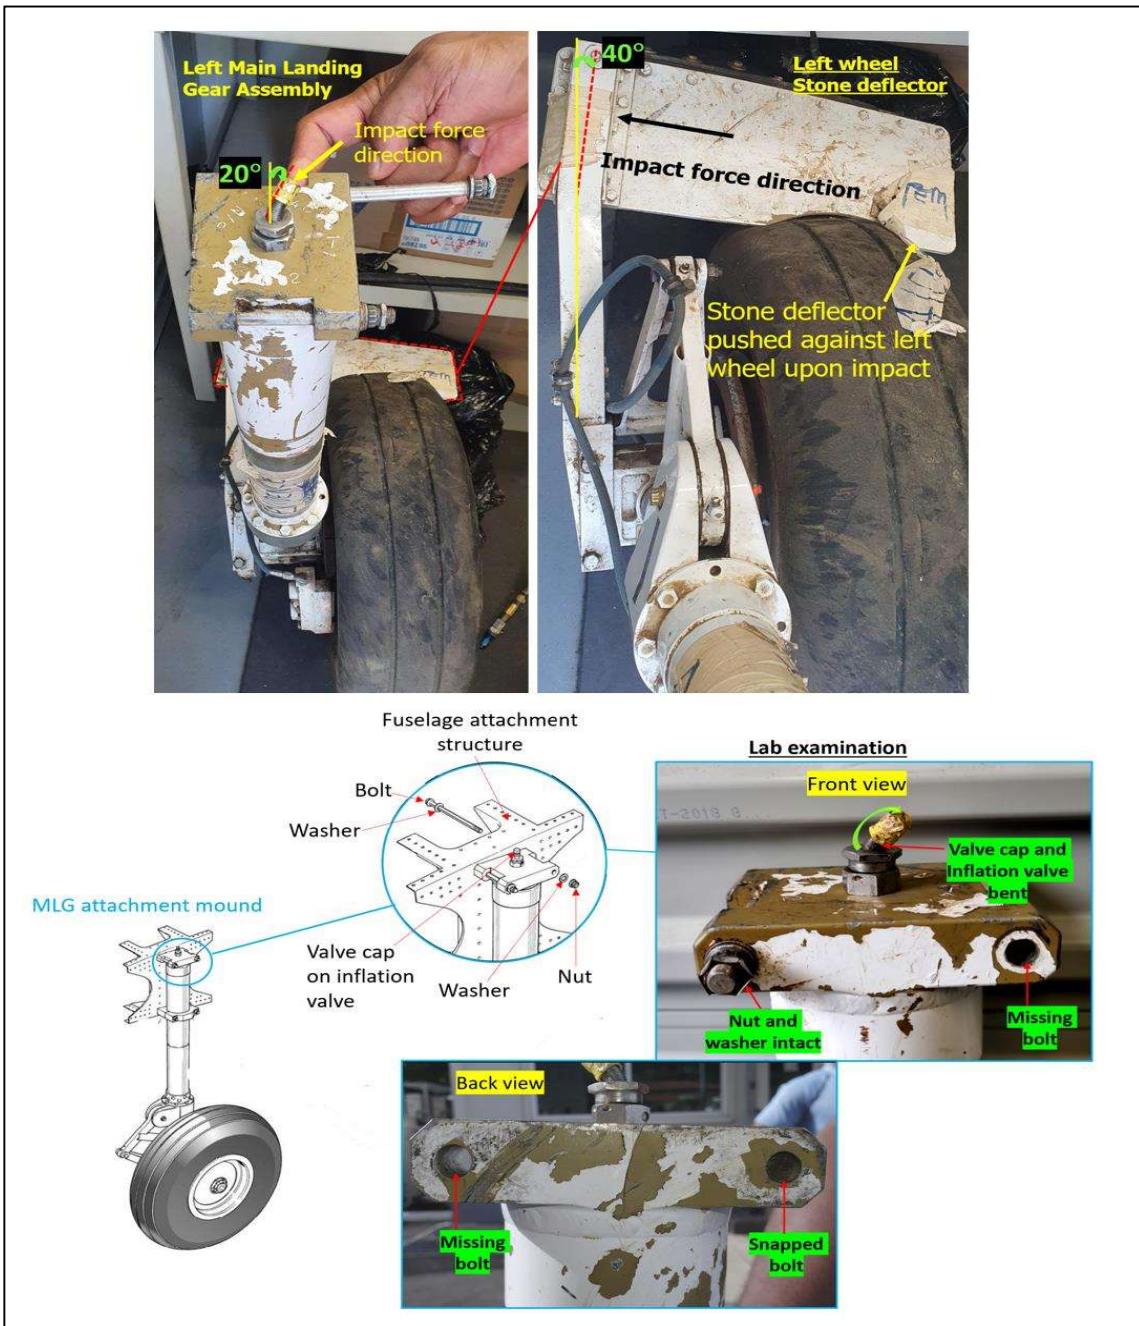
Figure 14: MLG Laboratory Examination

- tire assembly was intact with no damage
- Strut oleo with the allowable amount of fluid and pressure with valve core cap intact
- Torque link was intact and had castellated nut with safety split pin missing
- Brake assembly unit was intact with hose supplying fluid snapped off from the top; and
- Both strut upper attachment bolts sheared off at the head side

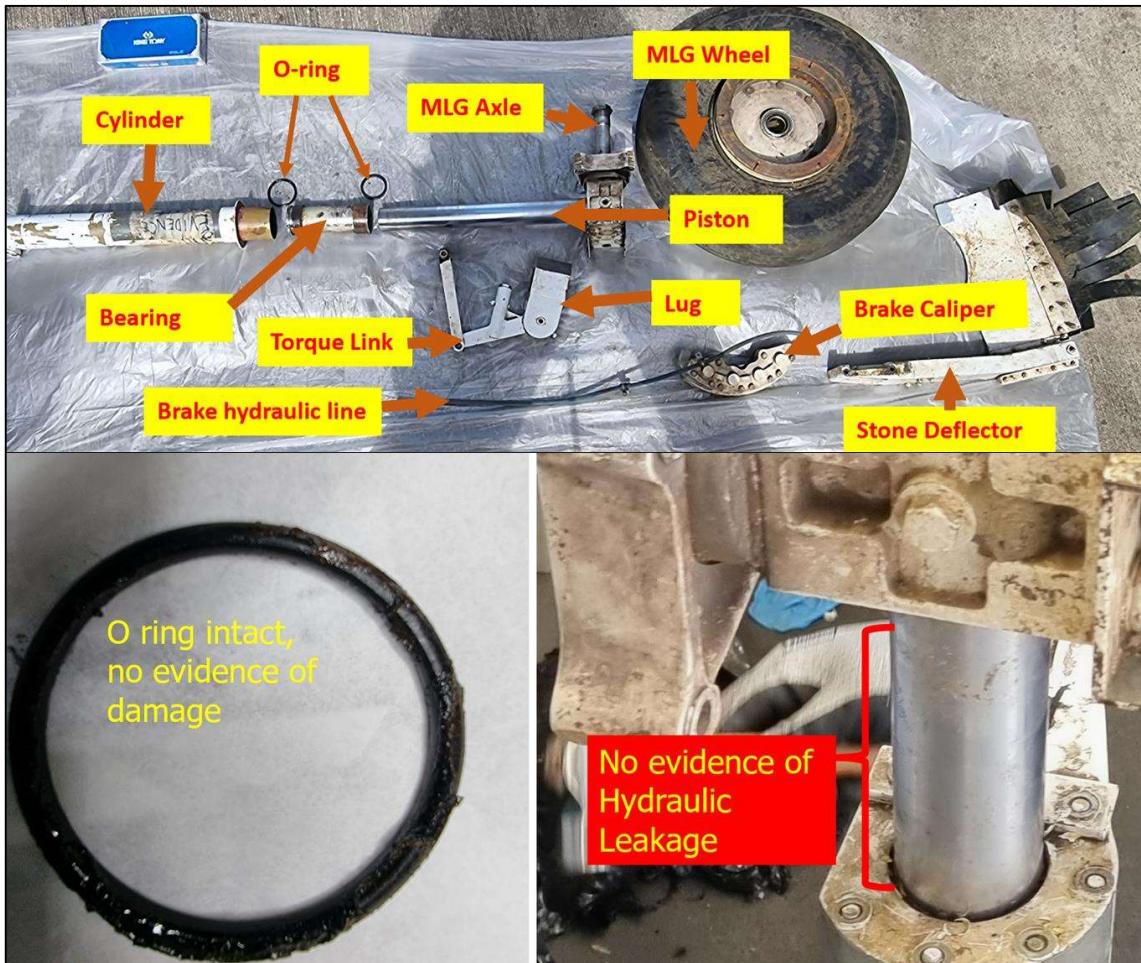
Figure 15: Left MLG Disassembly

The MLG was disassembled by AIC and observed that all internal and external parts of the MLG strut assembly were intact including O ring had no visible damage. There was also no evidence of fluid leakage.

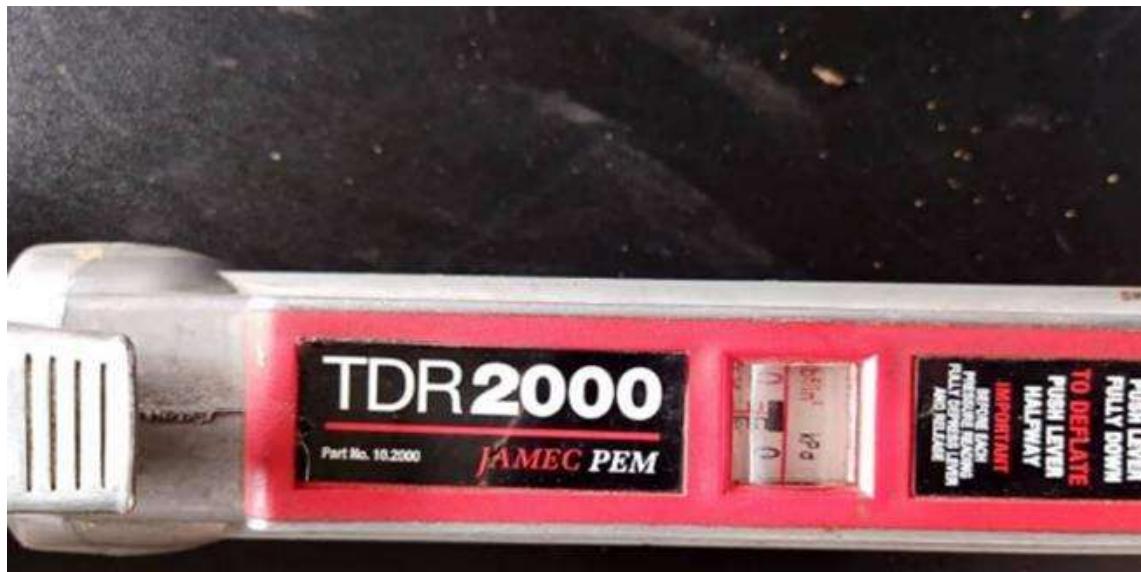
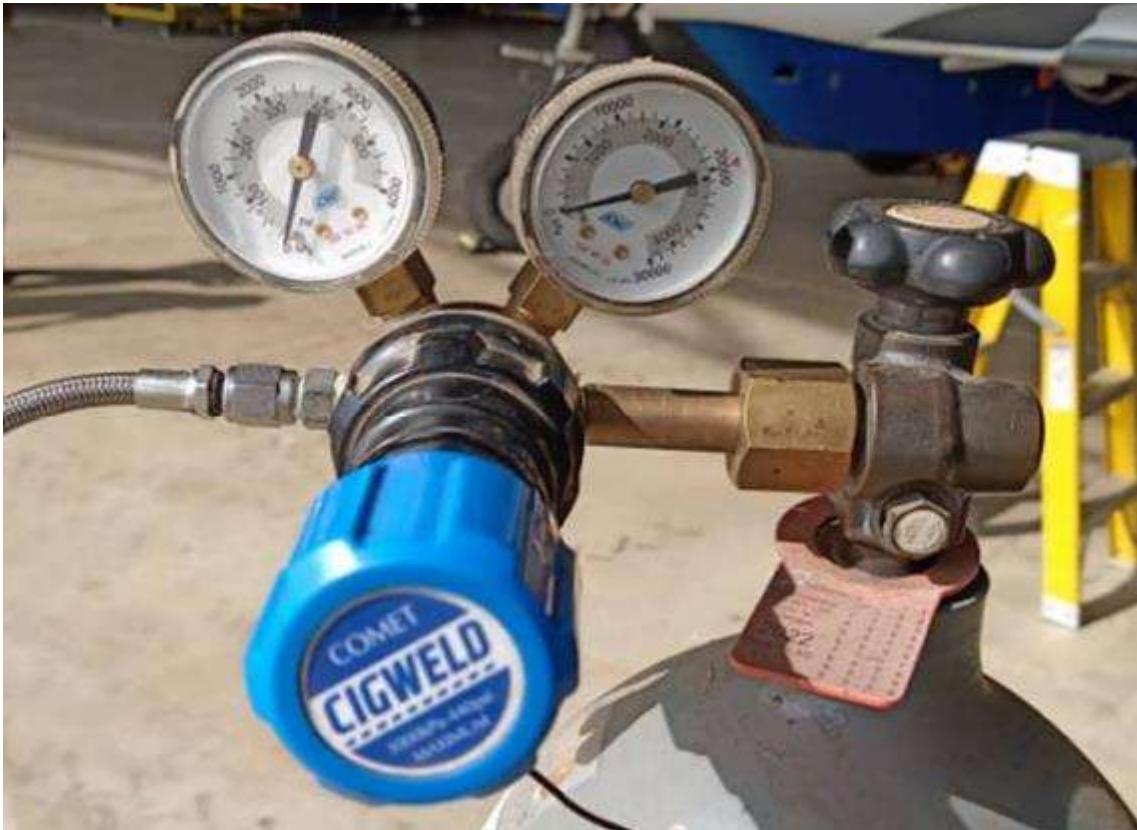
The Operator provided evidence of an existing Nitrogen regulator fitted with two gauges that connected to the Nitrogen bottle and Tyre Inflator-TDR, however, the evidence did not show the calibration date and expiration date.

Therefore, AIC requested the Operator to provide records of calibrated tools. The Operator provided a tool and equipment calibration register which did not include the records of the Nitrogen regulator gauges and tire pressure gauge. Upon further query regarding the calibration records of the two gauges, the Operator stated that they were sent to PNG National Institute of Standards and Industrial Technology (PNG NISIT) for calibration. After the calibration, the Operator provided the gauges, without their calibration records.
