PRELIMINARY REPORT

AIC 20 - 1001

DJI Matrice 210 RTK

RPA collision with pylon during aerial inspection

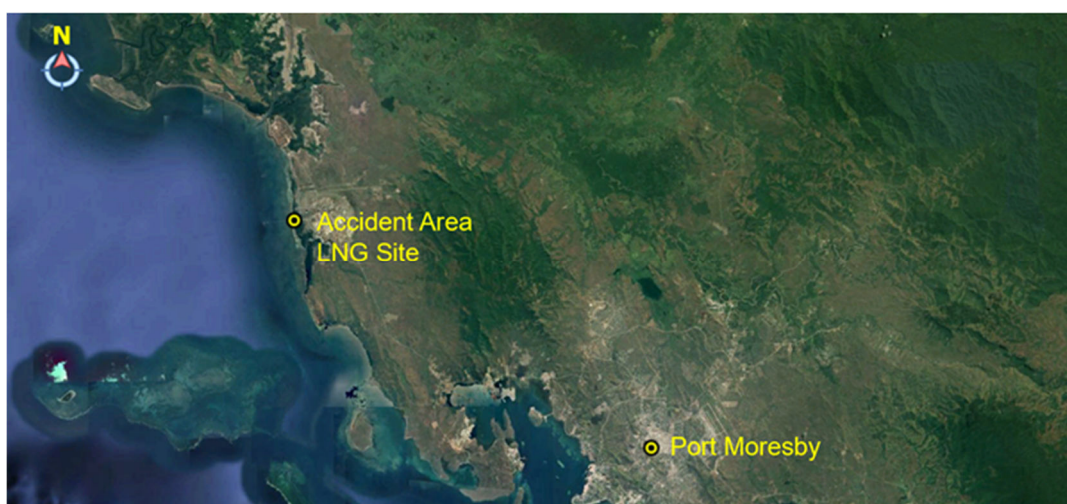
Figure 1: Area of the RPA operation

On 14 November 2019, at 09:42 local time (13 November 2019, 23:42 UTC¹), a DJI² Matrice 210 RTK remotely piloted aircraft (RPA), owned and operated by Applus Wokman (Applus), was being used to conduct an inspection of the underside of the jetty of the PNG LNG Exxon Mobil Marine Terminal, about 20 km (11 nautical miles) North West of Port Moresby, Papua New Guinea, when it collided with one of the jetty's pylons and dropped into the sea.
