PRELIMINARY REPORT

AIC 23-1006

Helicopter Controlled Flight into Terrain

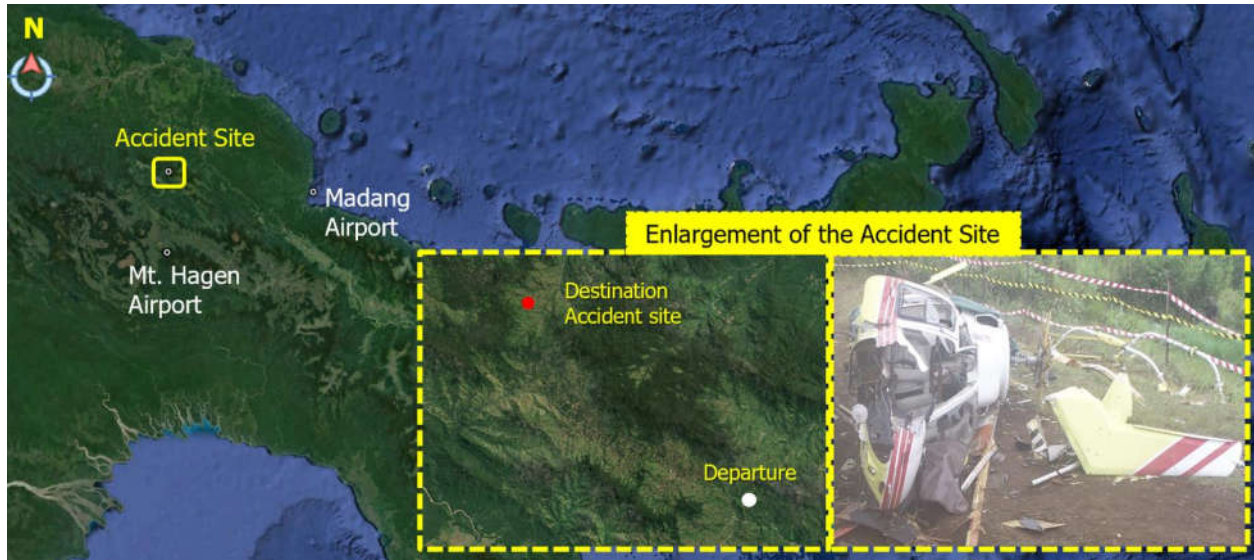
Figure 1: Overview of the P2-HSN accident site

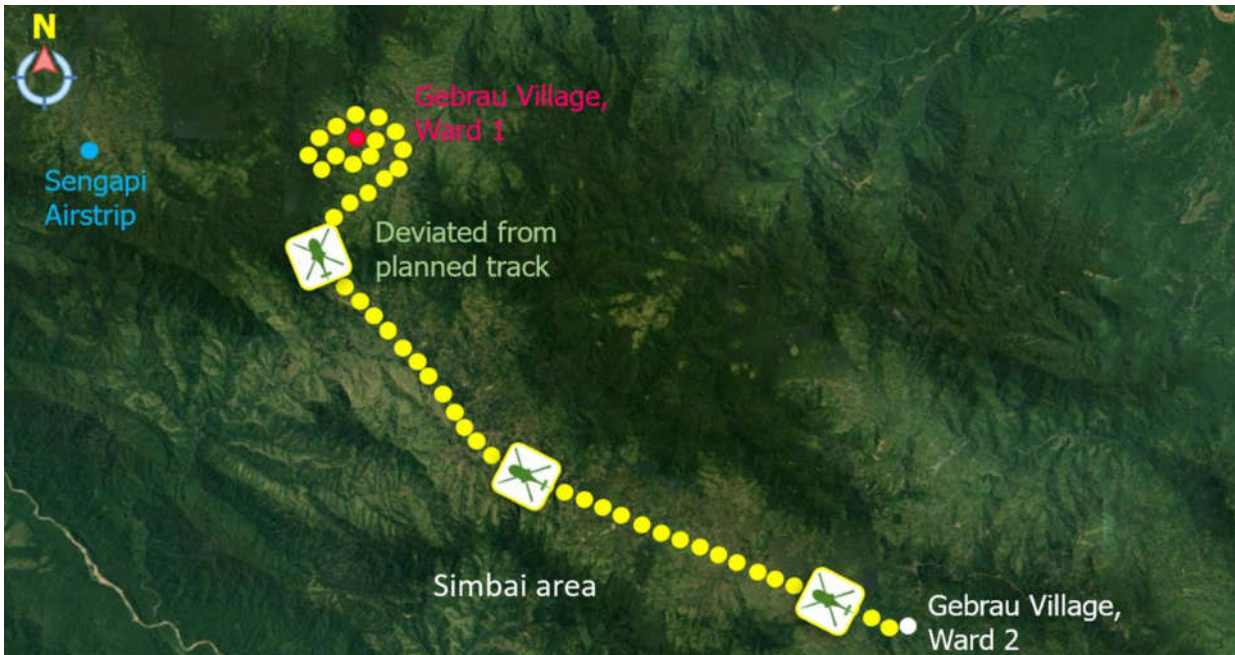
When the passengers returned, there was an additional person from Ward 2 to board the helicopter. The next destination was Gebrau Village, Ward 1, approximately 15 NM³ northwest of Ward 2 and about 6 NM east of Sengapi Airstrip (see Figure 2).

Figure 2: P2-HSN track to the destination, Ward 1 of Gebrau Village

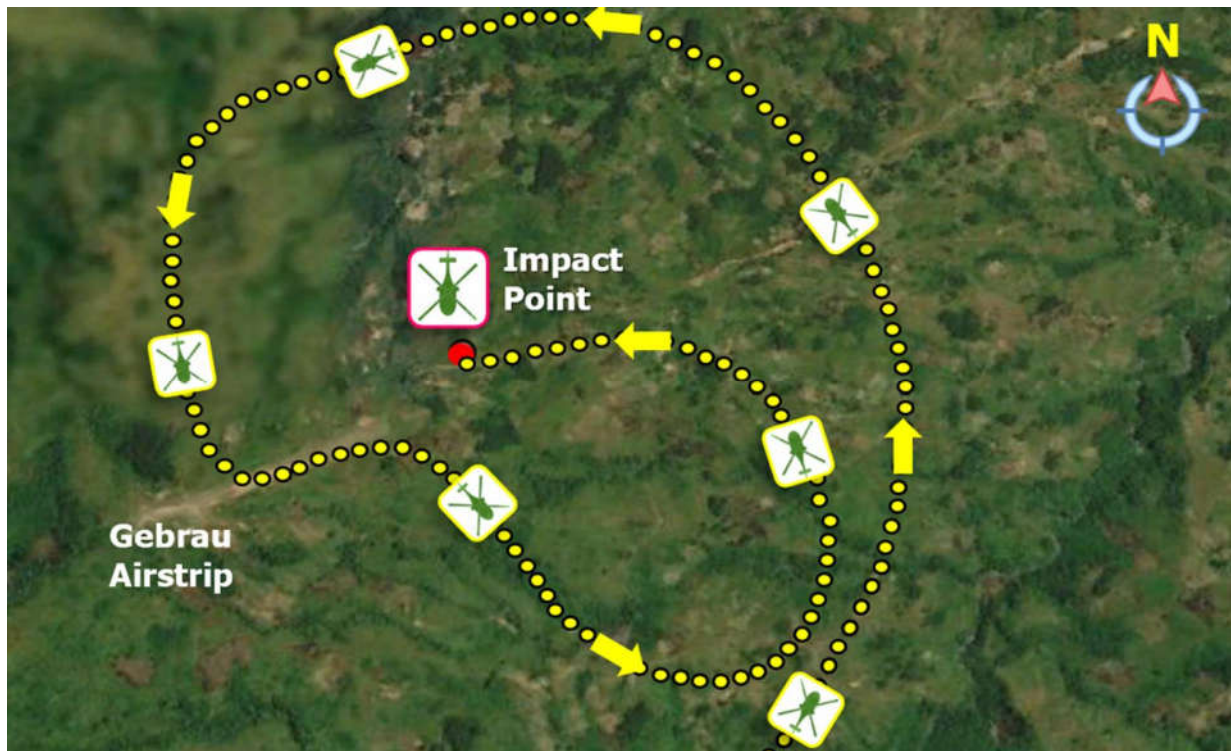
The recorded data showed that at about 15:10, the helicopter arrived in the Gebrau Ward 1 Airstrip circuit area. The pilot stated that as they flew over the airstrip, the passenger showed him a soccer field where villagers were waiting.

Figure 3: P2-HSN at Gebrau Ward 1 Airstrip circuit area.

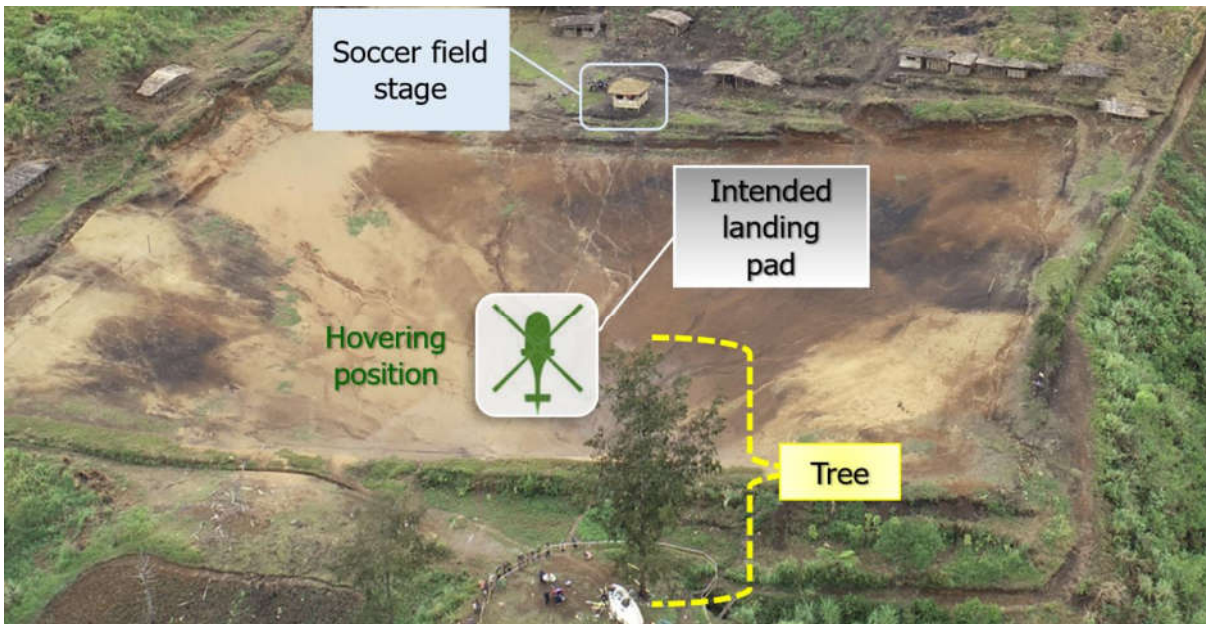
The pilot stated that as he entered the hover, there was dust from the ground blown into the air by the helicopter's rotor downwash. As he maintained a hover awaiting the dust to clear, the helicopter drifted towards the edge of the field where it collided with a tree.

The pilot recalled that the dust entering the cabin was dense and he was not able to maintain visual reference with the outside. He stated that he did not know that the helicopter had drifted backwards off the field and into the tree (see Figure 4).

Figure 4: Intended landing pad and main wreckage.

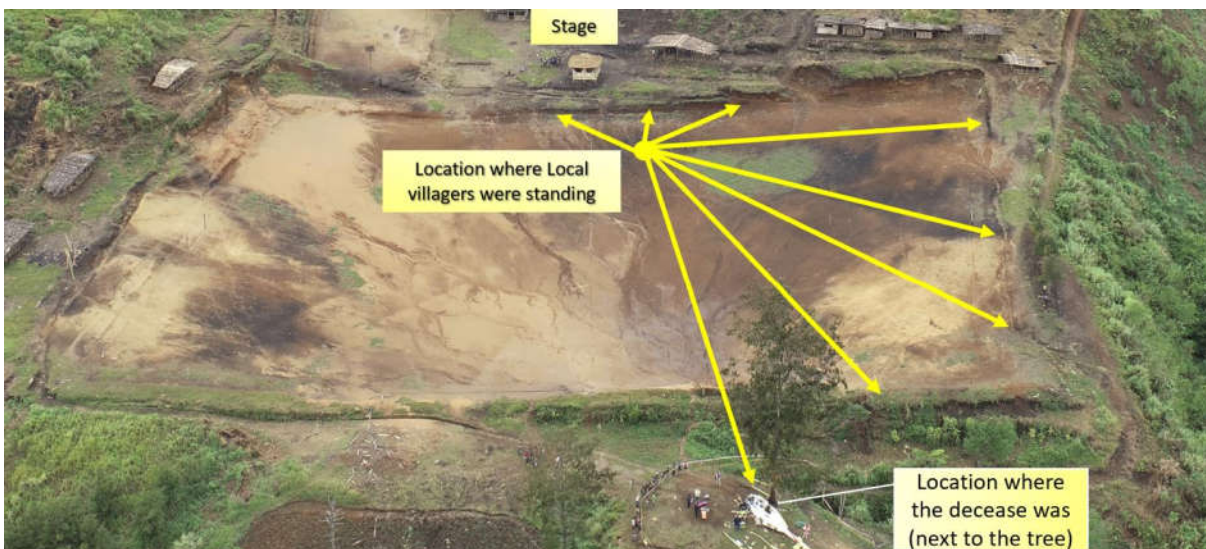
The pilot sustained minor injuries. The passengers and load master were reported to have sustained severe injuries. The AIC later learned that several villagers, watching the helicopter from the ground, also sustained injuries from detached helicopter parts and debris hurled into the air during the accident.

Figure 5: Locations where the local villages were standing

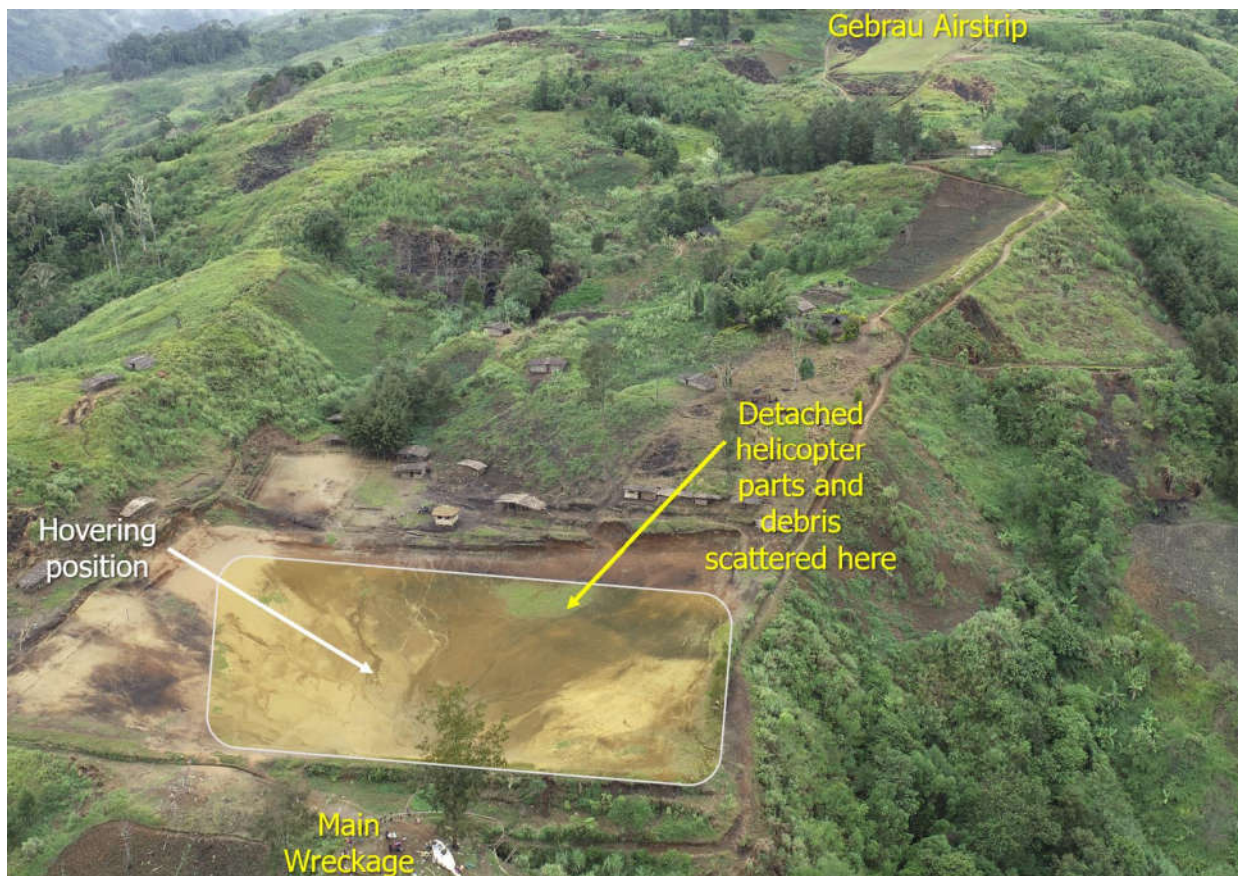
The wreckage distribution of P2-HSN.

Figure 6: P2-HSN wreckage distribution

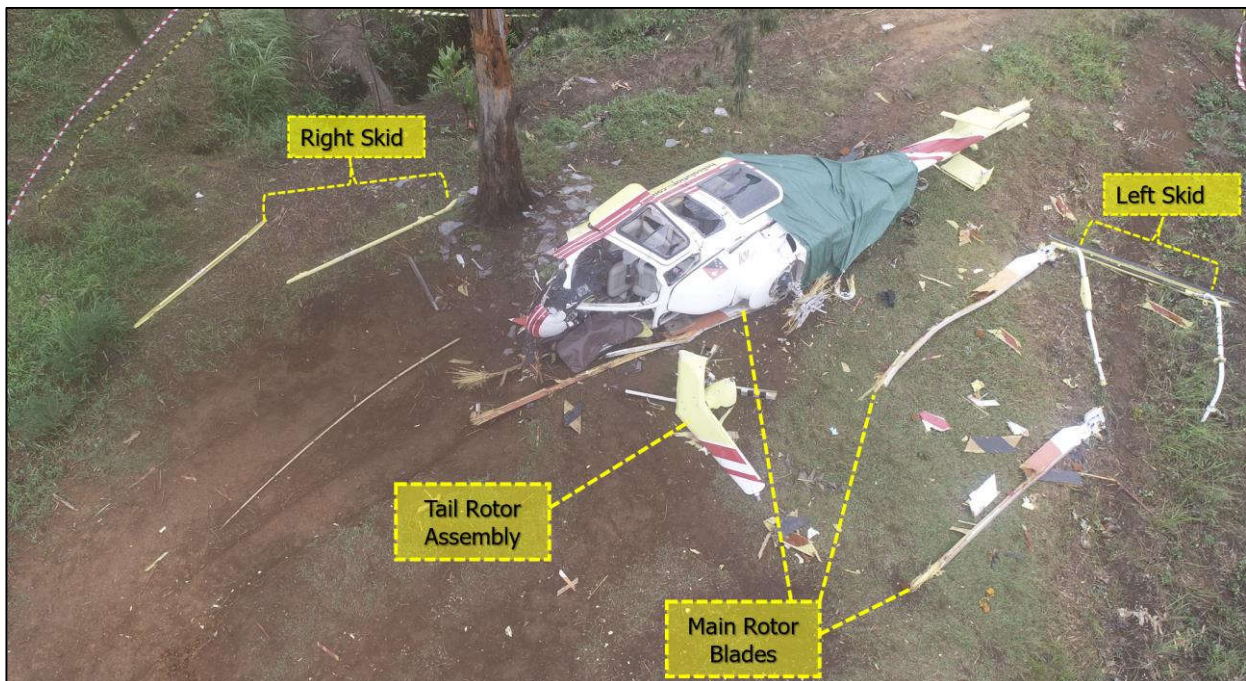
The main rotor blades, the skids and the tail rotor assembly were detached and separated from the main. The helicopter also sustained significant damages to its cockpit and the cabin.

Figure 7: Overview of the damages sustained by P2-HSN
