**FINAL REPORT**

**AIC 23 - 1001**

On 9 February 2023 at 13:30 local time (03:30 UTC), the AIC became aware through social media of an accident involving a PAC 750XL aircraft, registered P2-BJD, owned and operated by North Coast Aviation at Giramben Airstrip, Jiwaka Province. The AIC immediately commenced an investigation, and a team was deployed to the accident site on 10 February 2023.

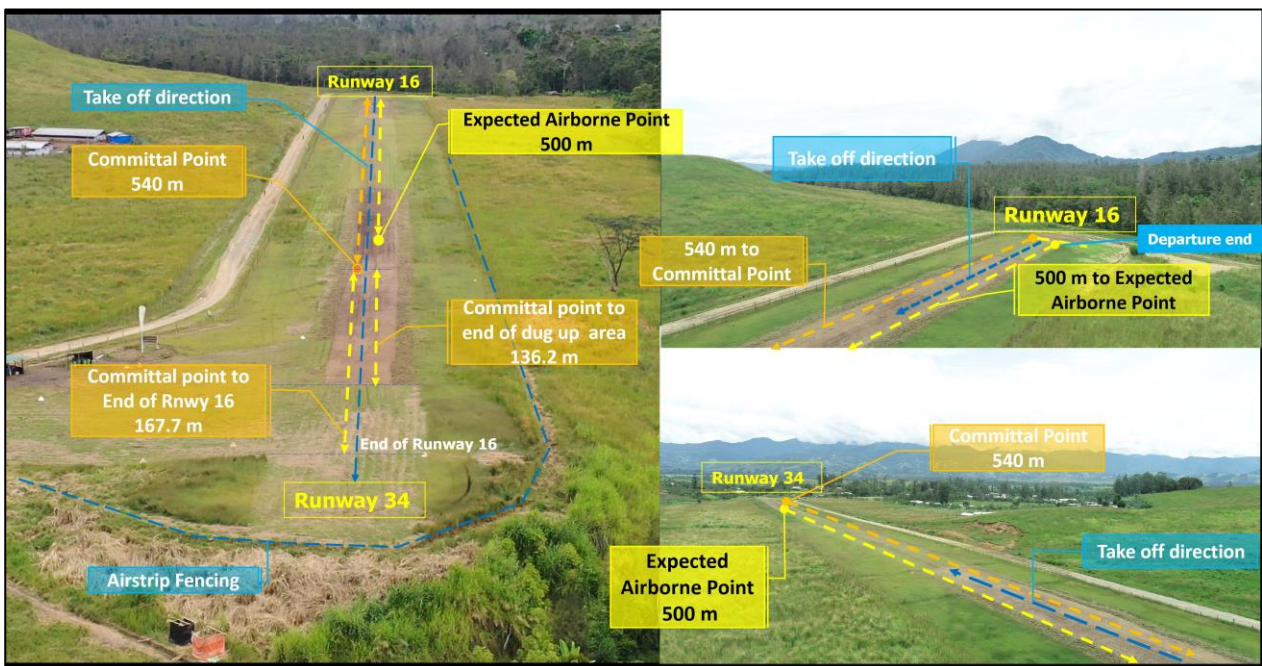
**Figure 2: BJD's expected airborne and committal points**

The pilot stated during interview that during the take-off roll, at the expected airborne point, with an airspeed approaching 60 knots (kts), he felt the right wheel hit what he thought was a soft spot<sup>6</sup> on the strip that dramatically reduced the momentum and speed of the aircraft. Eyewitnesses<sup>7</sup> reported that they saw the aircraft briefly get airborne then got back on ground again. The onsite team identified the expected airborne point to be about 500 m from the departure end.

The pilot recalled that by the time the aircraft got back on the ground, he realised that he had passed the nominated committal point, which was identified during onsite activities to be about 540 m from the departure end. The pilot stated that he decided to continue with the take-off roll, with full power hoping that the aircraft would regain speed on the dug-up<sup>8</sup> part of the strip, to get airborne again. Refer to *Figure 2*.

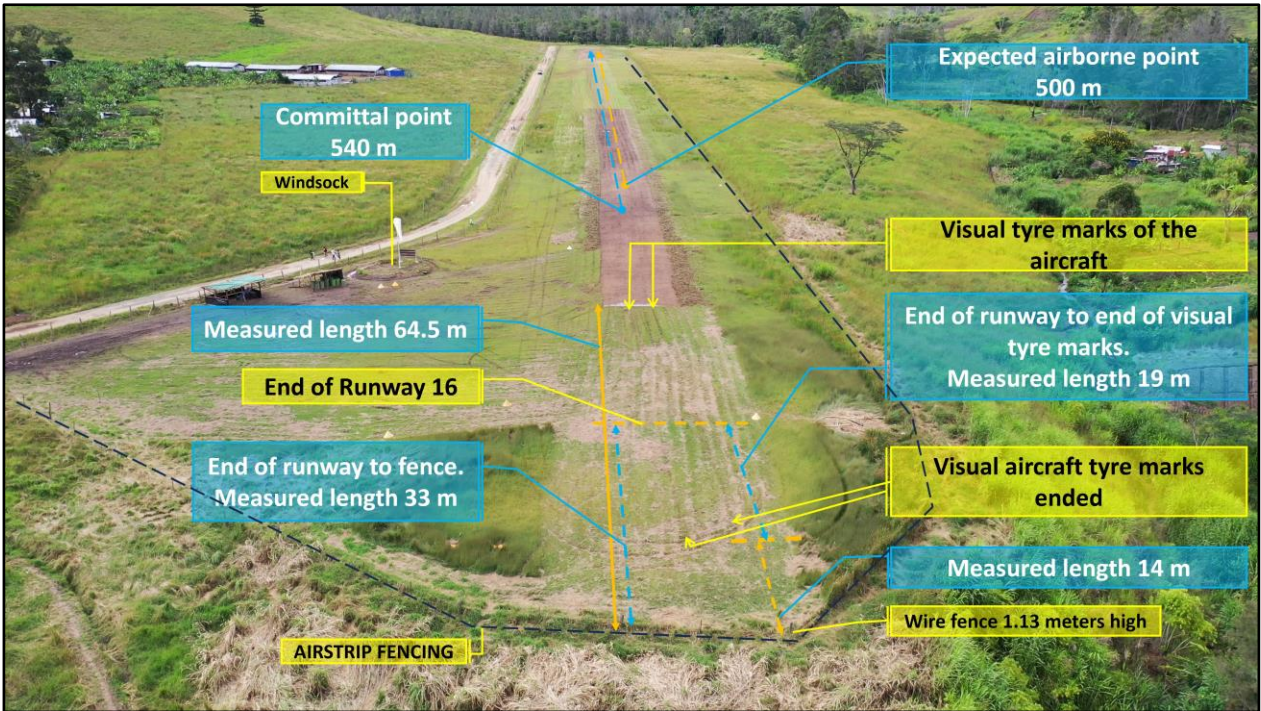
**Figure 3: Overview of BJD's take-off path from committal point to perimeter fencing**

According to the pilot, subsequent to the aircraft getting airborne, it struck the perimeter fence wire that run across at the end of the runway. The onsite team observed that the aircraft main landing gears got caught on a 1.13 m high perimeter wire fencing located about 33 m from the end of the runway. Refer to *Figure 3*.

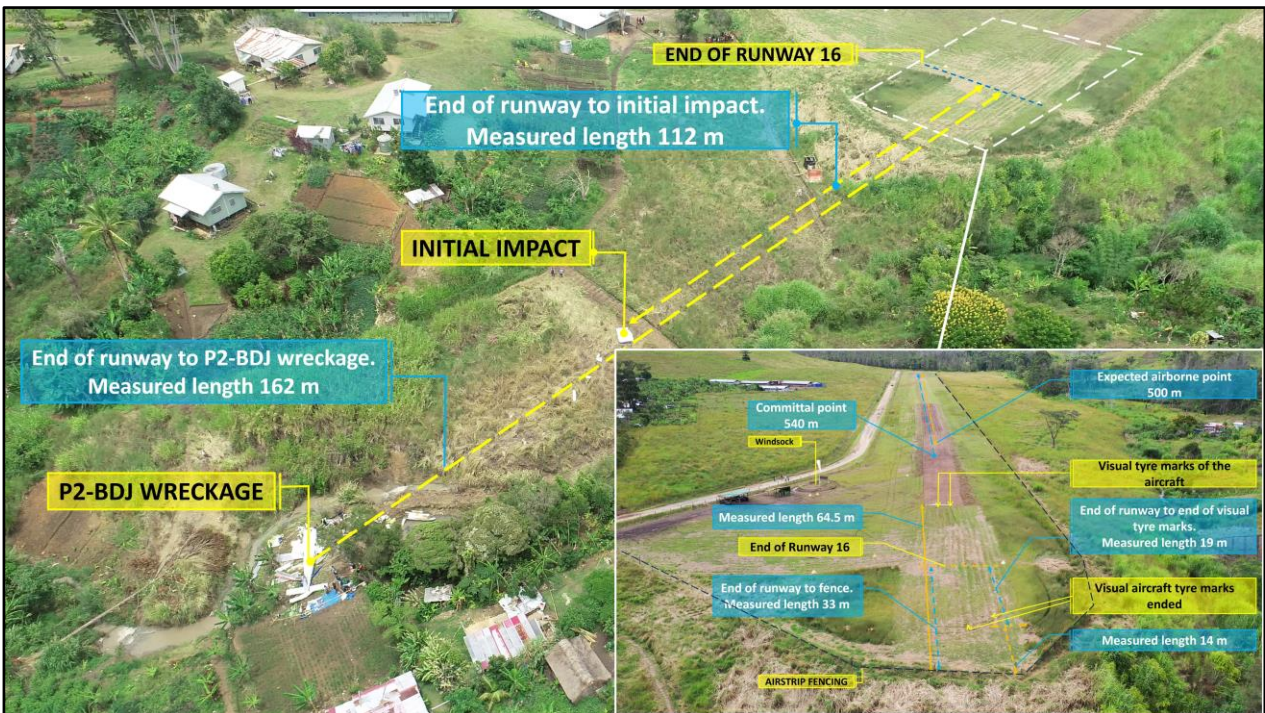
**Figure 4: Overview of BJD's flight path from the end of the runway 16 to the resting position**

The aircraft subsequently impacted terrain about 103 m from the end of runway. The pilot stated that he had no recollection from the time the aircraft initially impacted ground and there on, as he had lost consciousness. The aircraft continued with the momentum and came to rest, in a local village garden 162 m from the end of the runway. Refer to *Figure 4*.

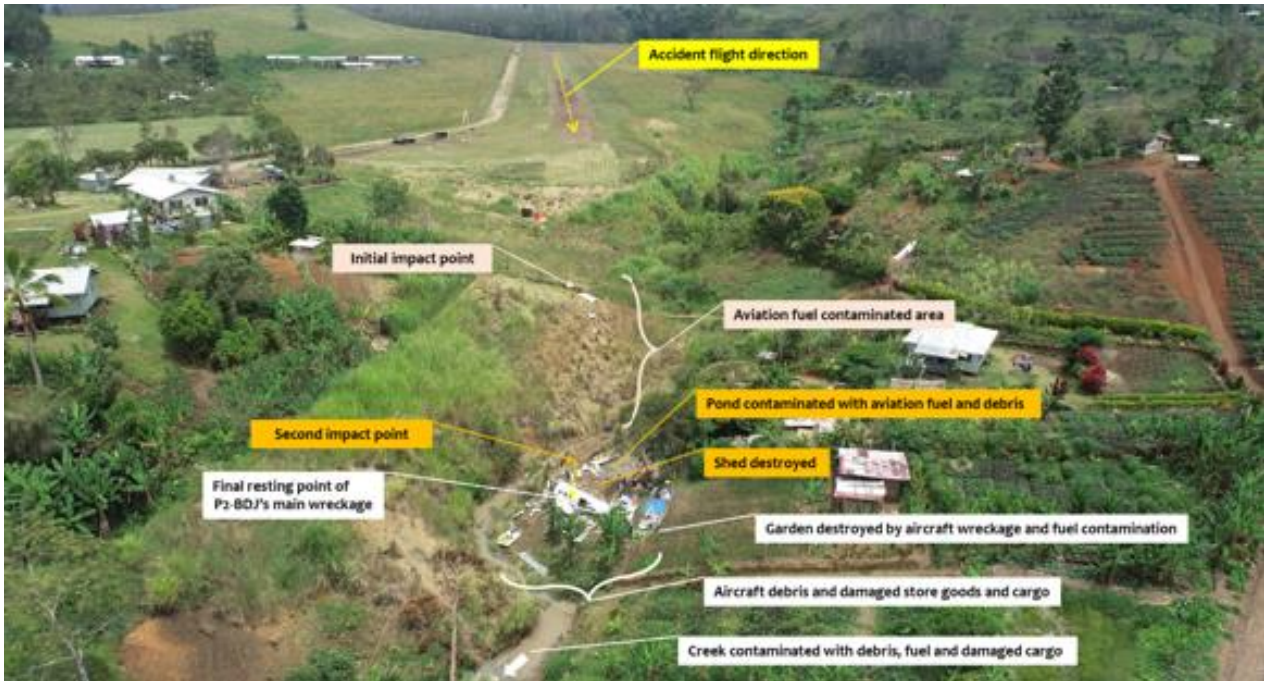
Figure 5: Damage to the environment and property along BJD's flight path

Eyewitnesses reported that upon the initial impact, they observed what they described as a ball of cloudy-like mist, around the area of impact, which lasted for a few seconds before fading away. The onsite team identified that the cloudy-like mist, may have been aviation fuel spray following the initial impact which was evident from the presence of strong fuel odor and the burnt/dried up vegetation around the initial impact area and leading to the second impact area.

The final resting position was in a garden which was destroyed by the aircraft wreckage and fuel contamination. The creek and pond adjacent to the aircraft main wreckage were contaminated with fuel from the aircraft, aircraft debris and damaged cargo. There was also a shed near the pond that was destroyed.

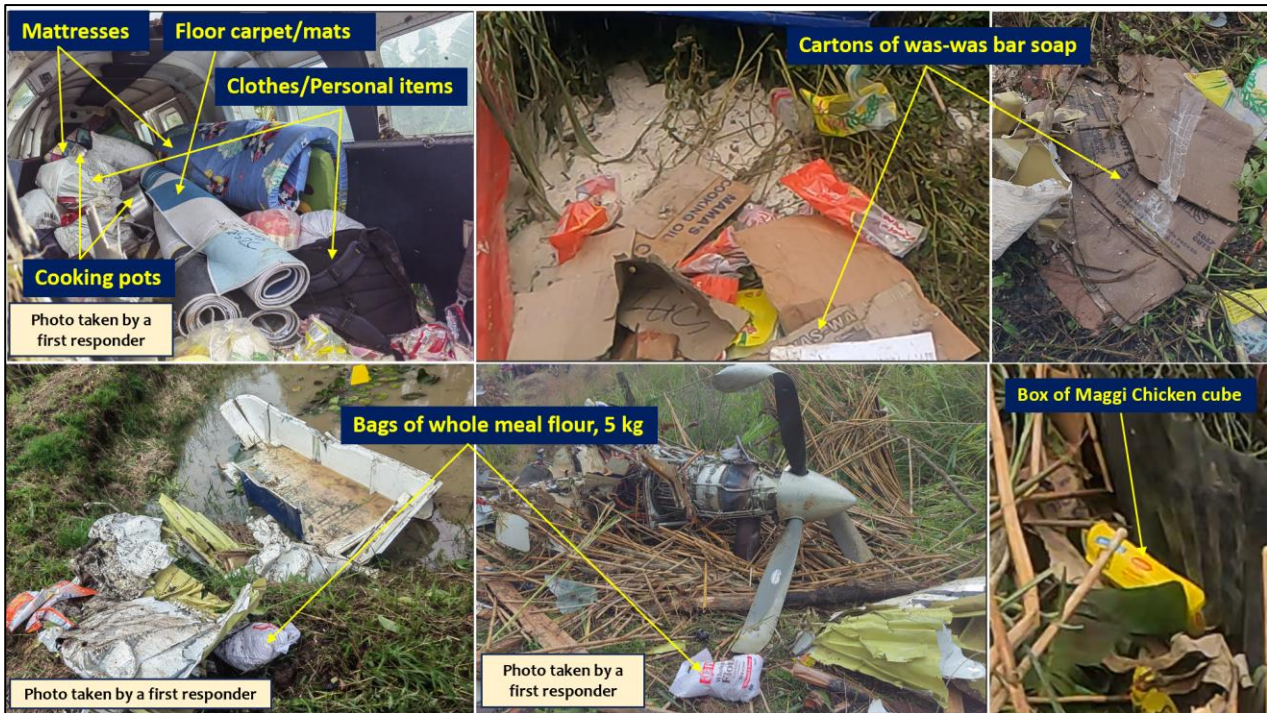
**Figure 6: Evidence of cargo in the aircraft cabin and the surrounding**

Furthermore, photos taken at the accident site by a first responder and the onsite team showed that certain cargo and baggage items were not accounted for, on the manifest of the accident flight.

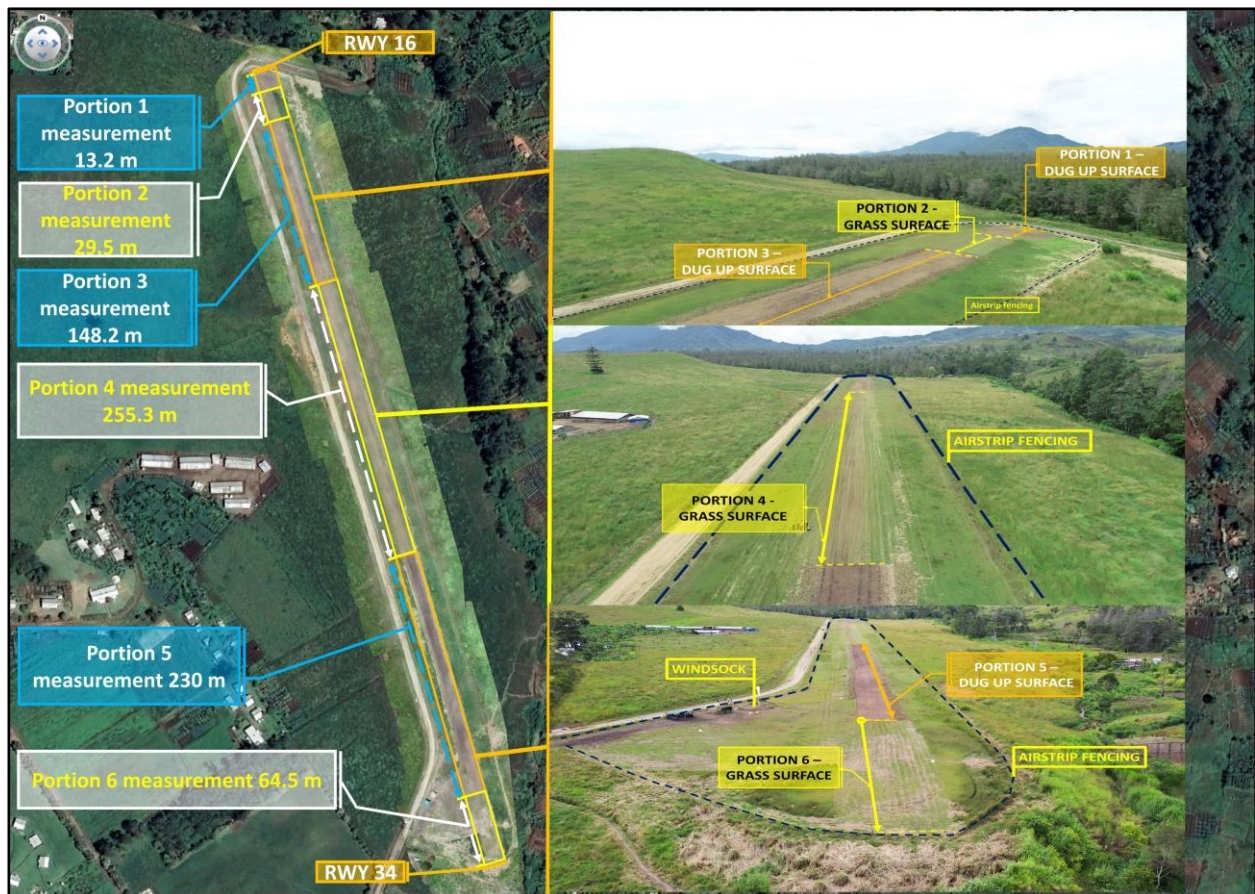
The strip surface was observed to be predominantly short grass, however, parts of it were dug up exposing ground that was composed of fine silt. According to the pilot, he engaged some locals at Giramben to dig up parts of the airstrip. The pilot described the grass that was dug up as thick, causing him to experience drag on the aircraft wheels during operations at Giramben Airstrip.

**Figure 9: Giramben Airstrip constructed in Pix4D using drone images showing portions of the strip**

Portions 1, 3 and 5 were dug up while portions 2, 4 and 6 were grass surfaces.

The onsite team also observed that the exposed silt surface had scarce standing water on parts of it throughout the length of the strip, while the rest was damp soil and wet short grass. It was identified from the drone images of the airstrip that portion 5, which was dug up, was visibly most damp in comparison to the other portions of the airstrip. From the interview with the pilot, the investigation identified that the 'soft spot' that he was referring to, was within portion 5 area. The onsite investigation was unable to identify a soft spot on the airstrip that had markings that indicated that the aircraft wheel had dug in.

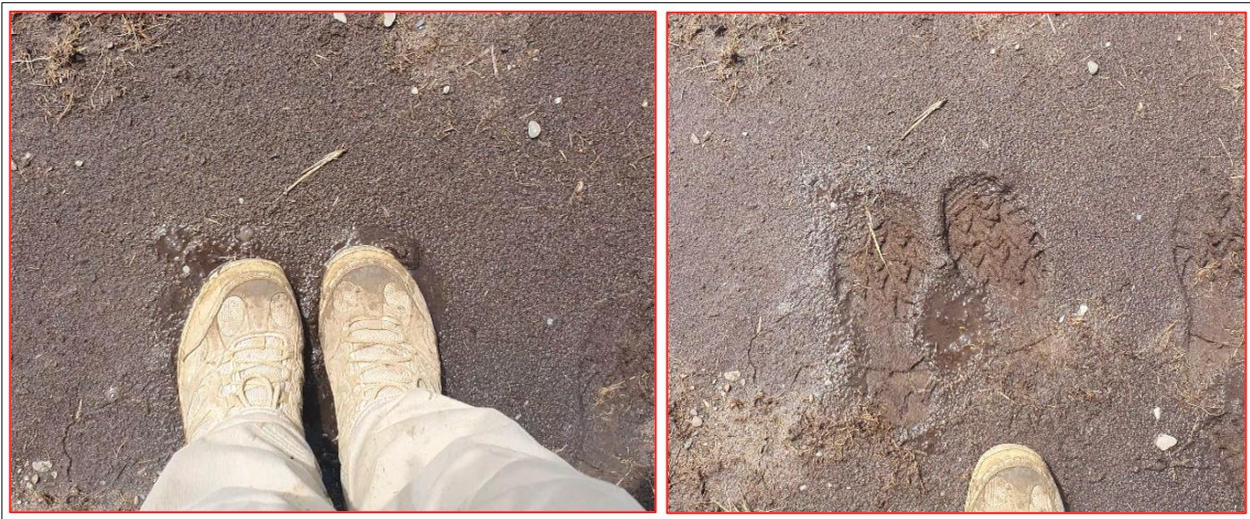
The onsite team selected a surface of exposed silt that had no standing water, along portion 5 of the airstrip, and assessed the surface condition by standing on that area. Water immediately emanated from the surface showing just how saturated, yet porous the soil was. The silt soil, although wet, did not stick on the boots. The exposed strip surface was found to be composed of compact soil, with loose sedimentary silt atop.

Figure 10: Selected portion 5 surface condition on assessment

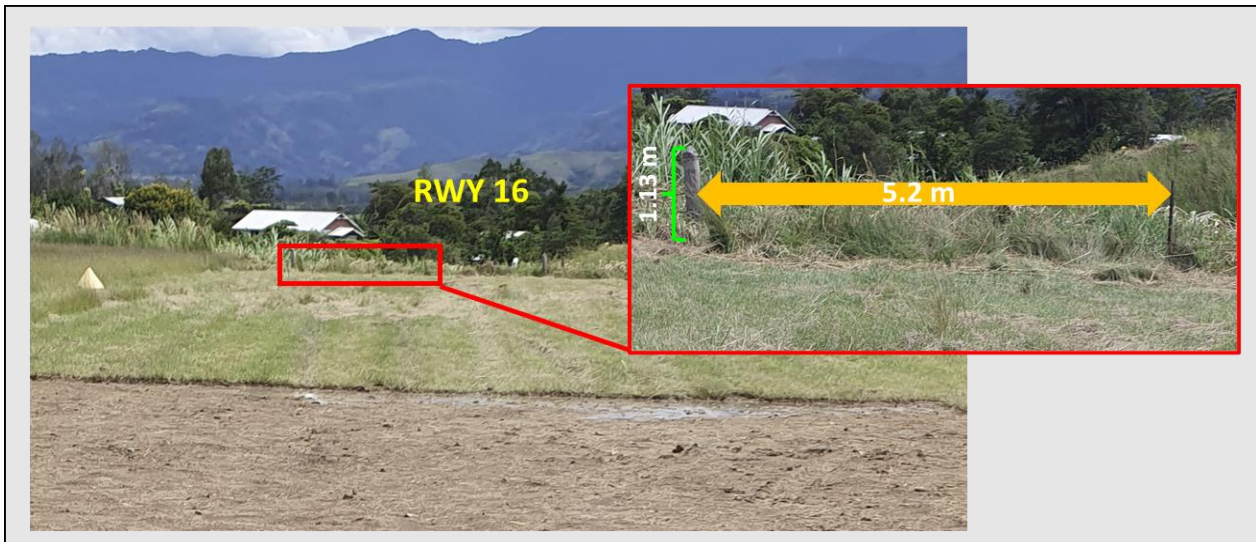
There was a windsock located at the Southeastern end of the airstrip, at the parking bay. Yellow cones were lined up at about 55 m in from the fencing at the end of the strip. This was on the sixth portion of the strip. The fencing post that showed evidence of being impacted by the aircraft measured to be 1.13 m in height, and 5.2 m to the next post, to the right. The fencing posts provided support to the barbwire that ran across the end of the strip.

Figure 11: Image looking towards runway 16 showing airstrip fencing and impacted fencing post

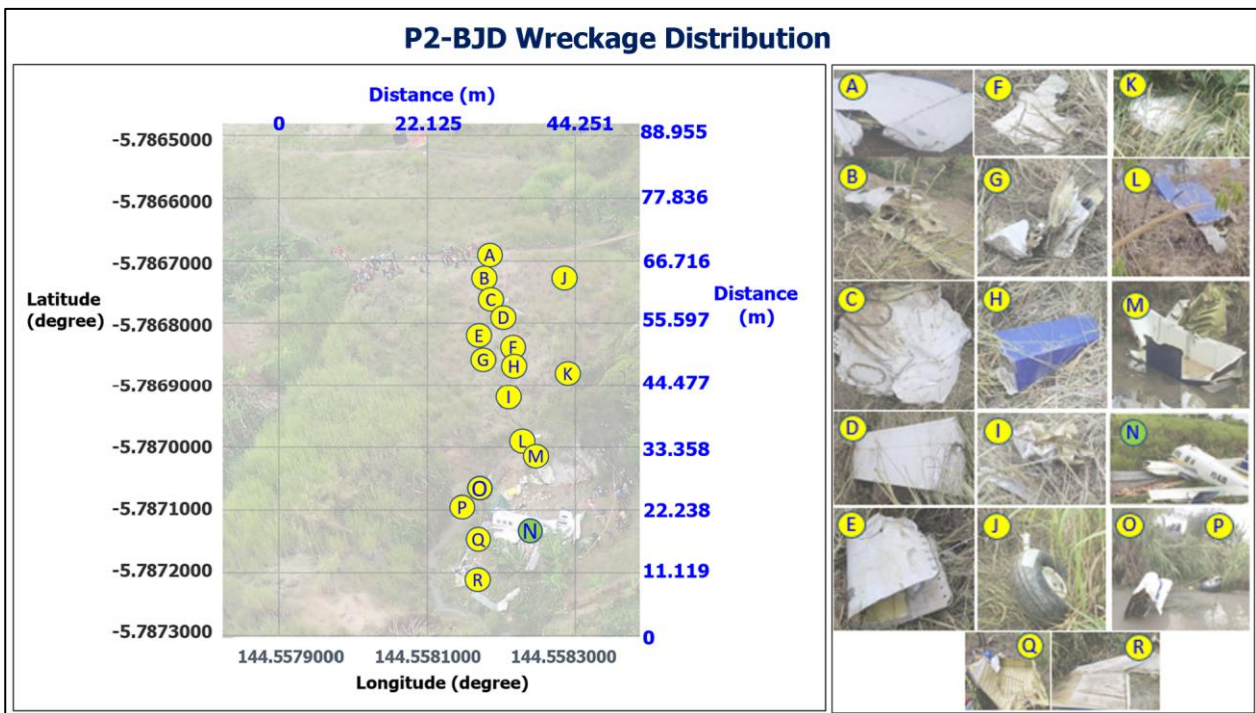
**Figure 12: Overall wreckage distribution.** A=RH outer wing, B=integral fuel debri, C=Bottom integral fuel debri, D=RH flap, E=RH wingroot leading edge fairing, F=RH wing debri, G=Integral Fuel tank cap, H=A cargo pod composite debri, I = integral fuel debri, J=Right MLG, K=RH wing inboard leading edge, L = A cargo pod composite debri, M=LH wing(integral outboard fuel tank), N=P2-BJD main wreckage, O & P= Lower engine cowl and nose wheel, Q=Cargo pod, R=LH wing tip wreckage

Evidence showed that the aircraft struck the 1.13 m high wire fencing, at the Southern edge of the airstrip then continued with a forward momentum for about 70 m from the wire fencing where it initially impacted ground. Subsequently, the right hand (RH) wing from the outer fuel tank, the right MLG and the right flap had all detached from the aircraft.

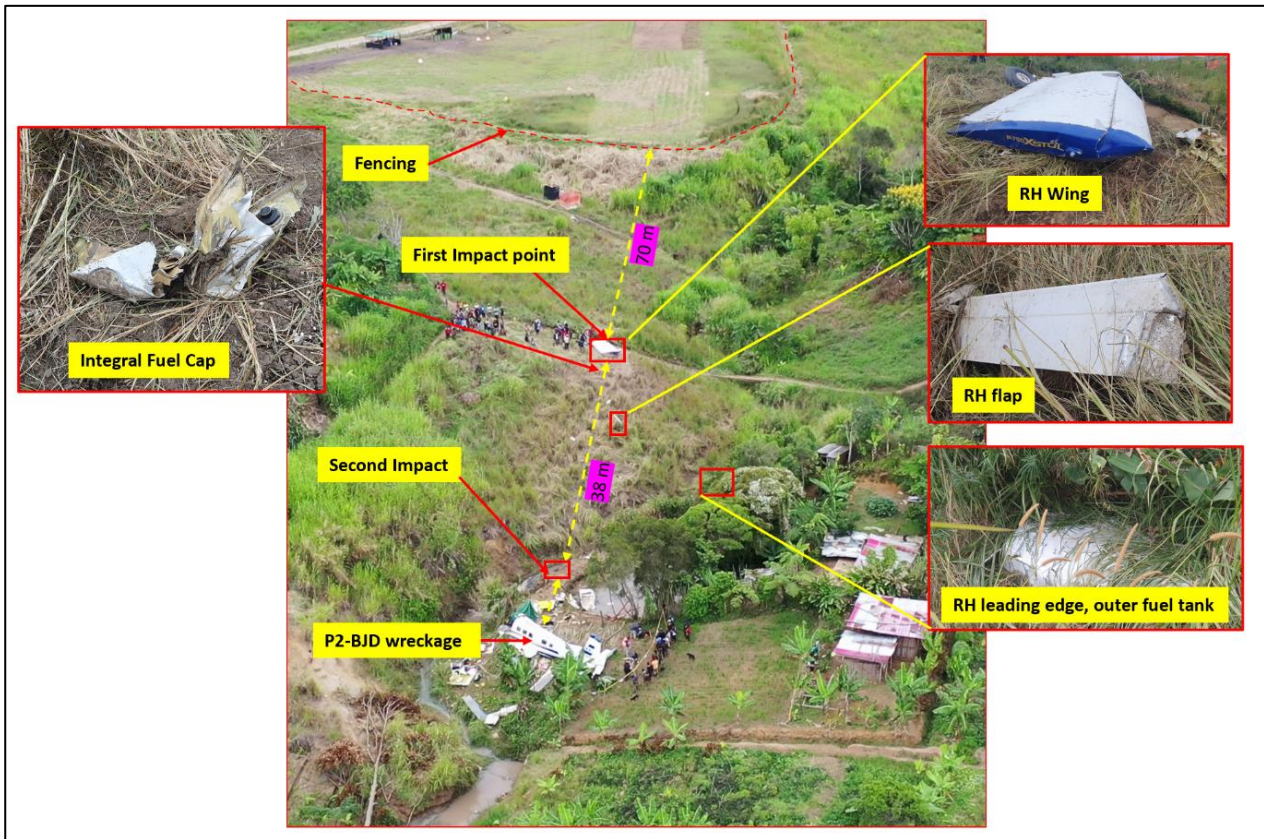
**Figure 13: Wreckage distribution after initial impact**

The RH outer wing and debris of the RH integral fuel tank, the outer RH flap and right MLG, the outer RH flap and right MLG were found within a 20 m radius of the initial impact area.

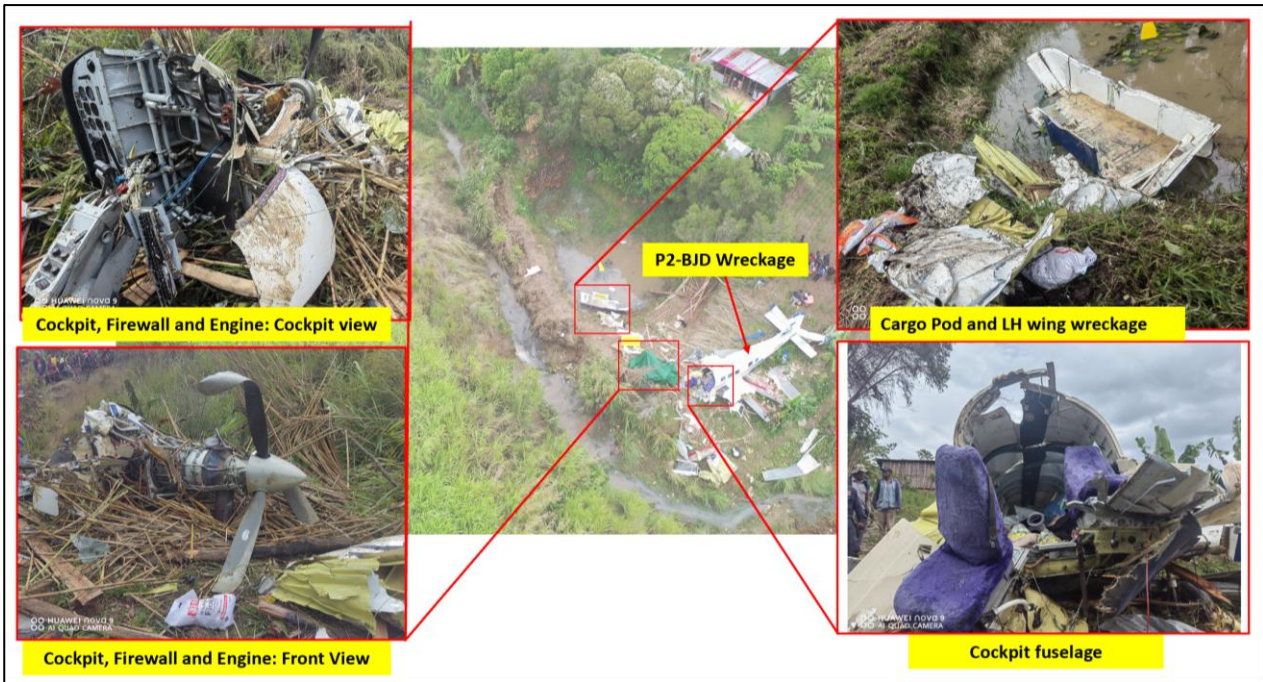
**Figure 14: Wreckage distribution after second impact**

Following the initial impact, the aircraft bounced off, continued with the forward momentum for another 38 m, where it made a second impact in a gully then destroyed an unoccupied shed along the way, before coming to rest perpendicular orientation to its take-off direction.

The wreckage of the left outer wing, the cargo pod and the nose landing gear (NGL) were found in the vicinity of the second impact point. The damage on the outer left wing indicated that it was completely detached/snapped during the impact.

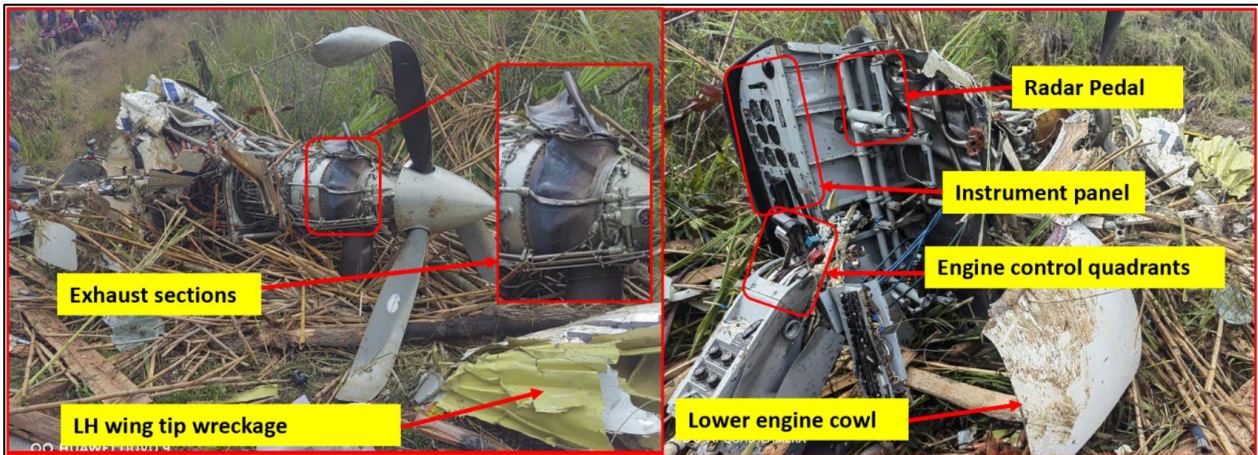
**Figure 15: Damage to the aircraft engine and propeller**

The engine sustained substantial damage to the exhaust section and the propeller blades also sustained substantial damage. The propeller damage indicated that the engine was operating at the time of the impact.

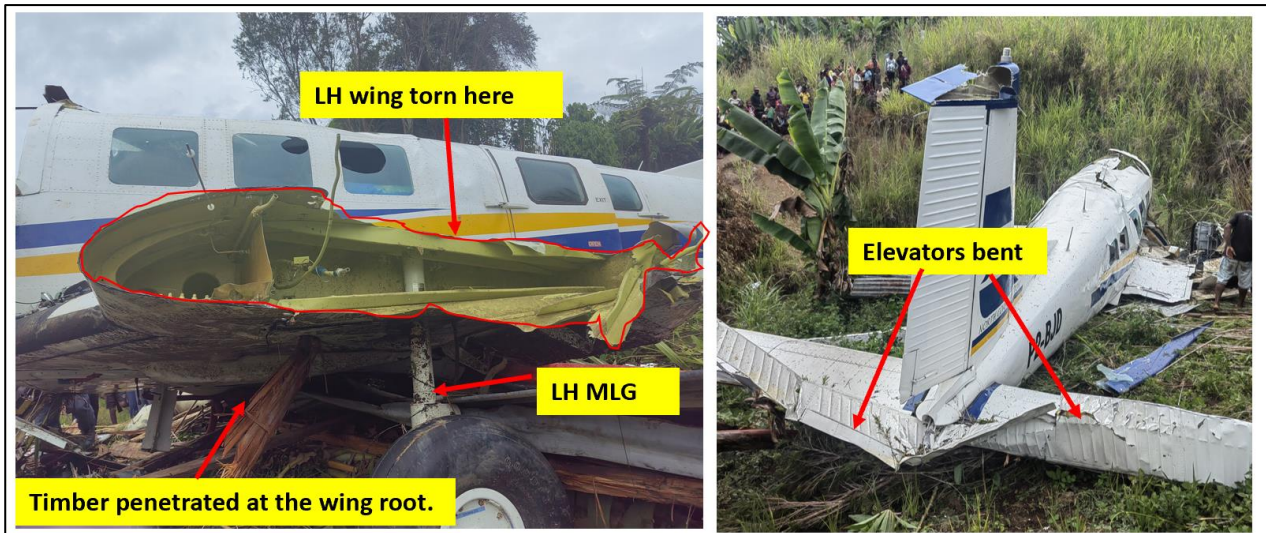
Figure 16: Damaged LH Wing and Elevator

The outer LH wing was torn off from the inner integral fuel tank through to the trailing edge of the wing. A piece of timber used to build the shed penetrated underneath the wing root of the LH wing. The LH outer wing wreckage was found 2 m from the wreckage.

The elevators were bent inward from the trailing edge. The onsite investigation team also inspected the elevator system and identified that there were no abnormalities with the system and found that the damage was caused by impact forces.

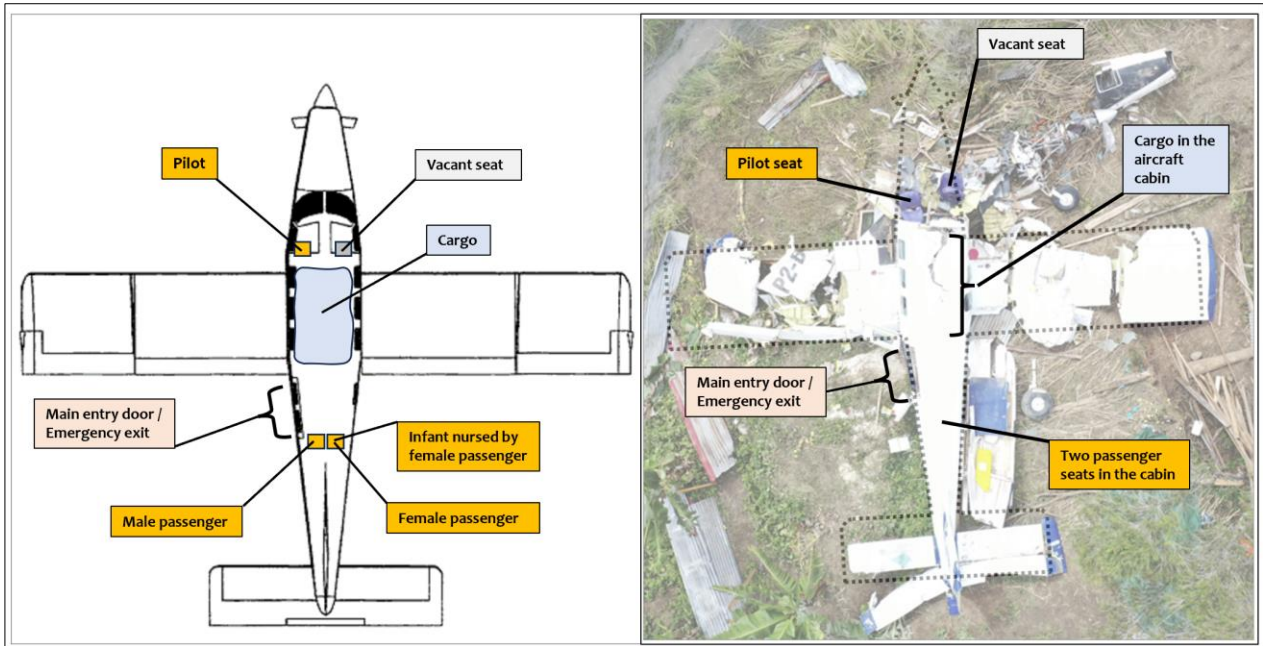
Figure 17: Aircraft schematic and main wreckage

The locals reported that the two adult passengers were found in a semi-conscious state, with their seatbelts still fastened; the male passenger in the left seat and the female passenger in the right seat. The infant was found unconscious amongst the cargo. The female passenger recalled that she lost consciousness following the initial impact and was unaware of the events in relation to the infant from thereon. The two adult passengers were assisted by the locals to egress the aircraft while the infant was carried out of the aircraft through the main entry door/emergency exit. (Refer to Figure 17).

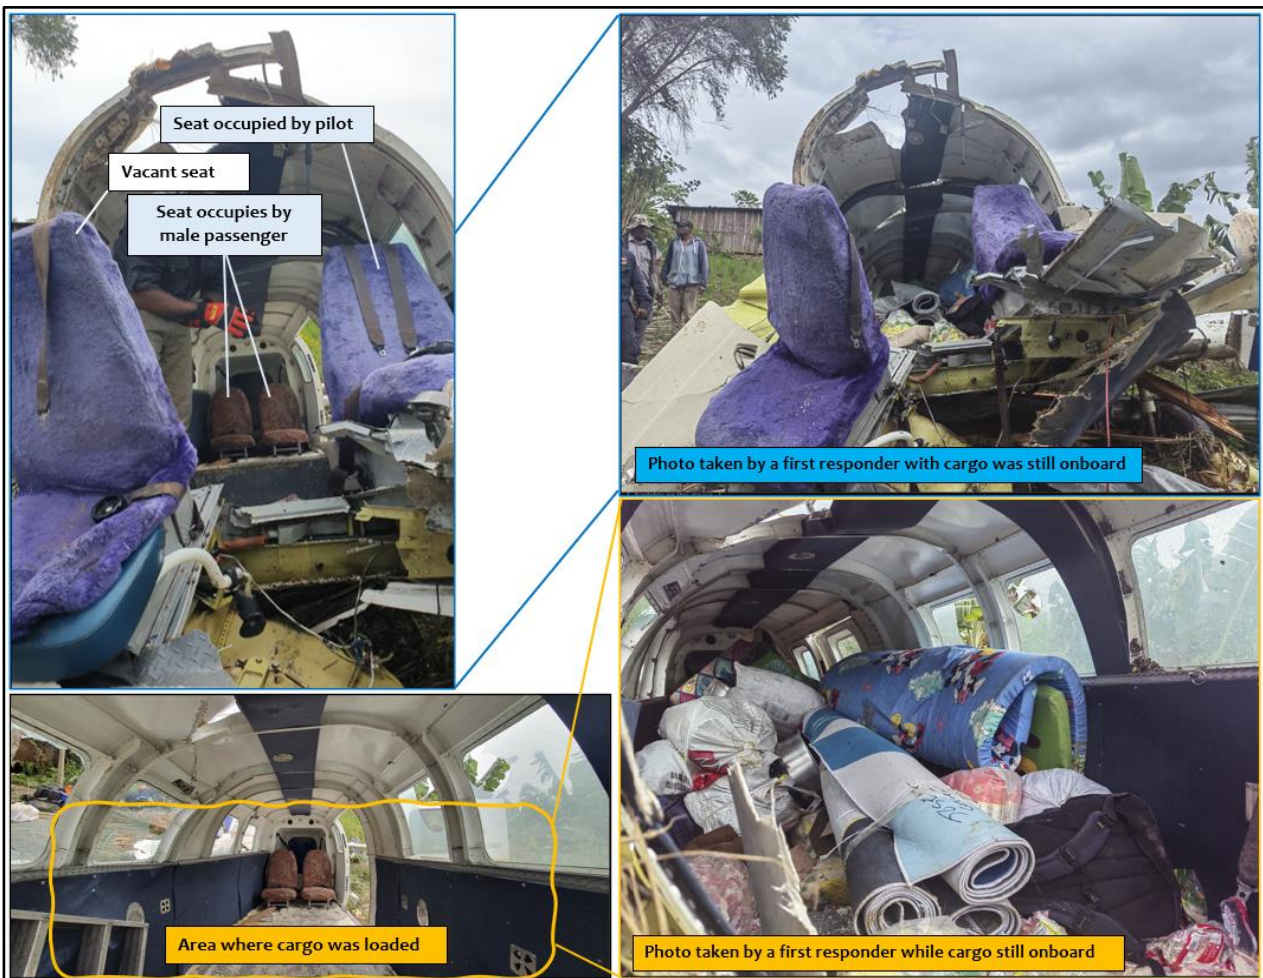
Figure 18: Aircraft seats and cabin with cargo and after cargo removed

Evidence gathered showed that the cargo that had been loaded in the cabin were not secured using safety restraints. (Refer to Figure 18).

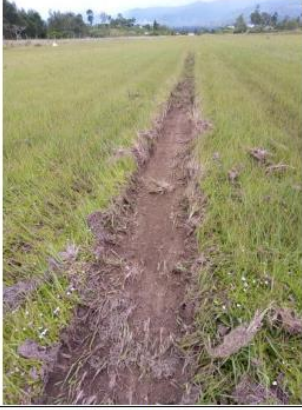
Picture taken on the runway centerline showing aircraft wheel ruts

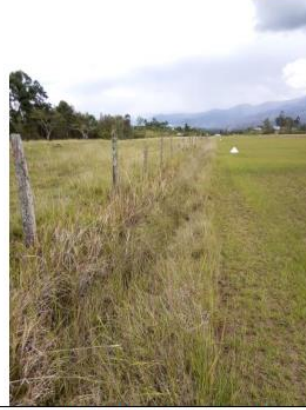
Picture showing barbed fencing at the airstrip. Fencing is right around.
