**PRELIMINARY REPORT**

**AIC 24-1003**

**P2-SAM**

**Aircraft Impact with Terrain**

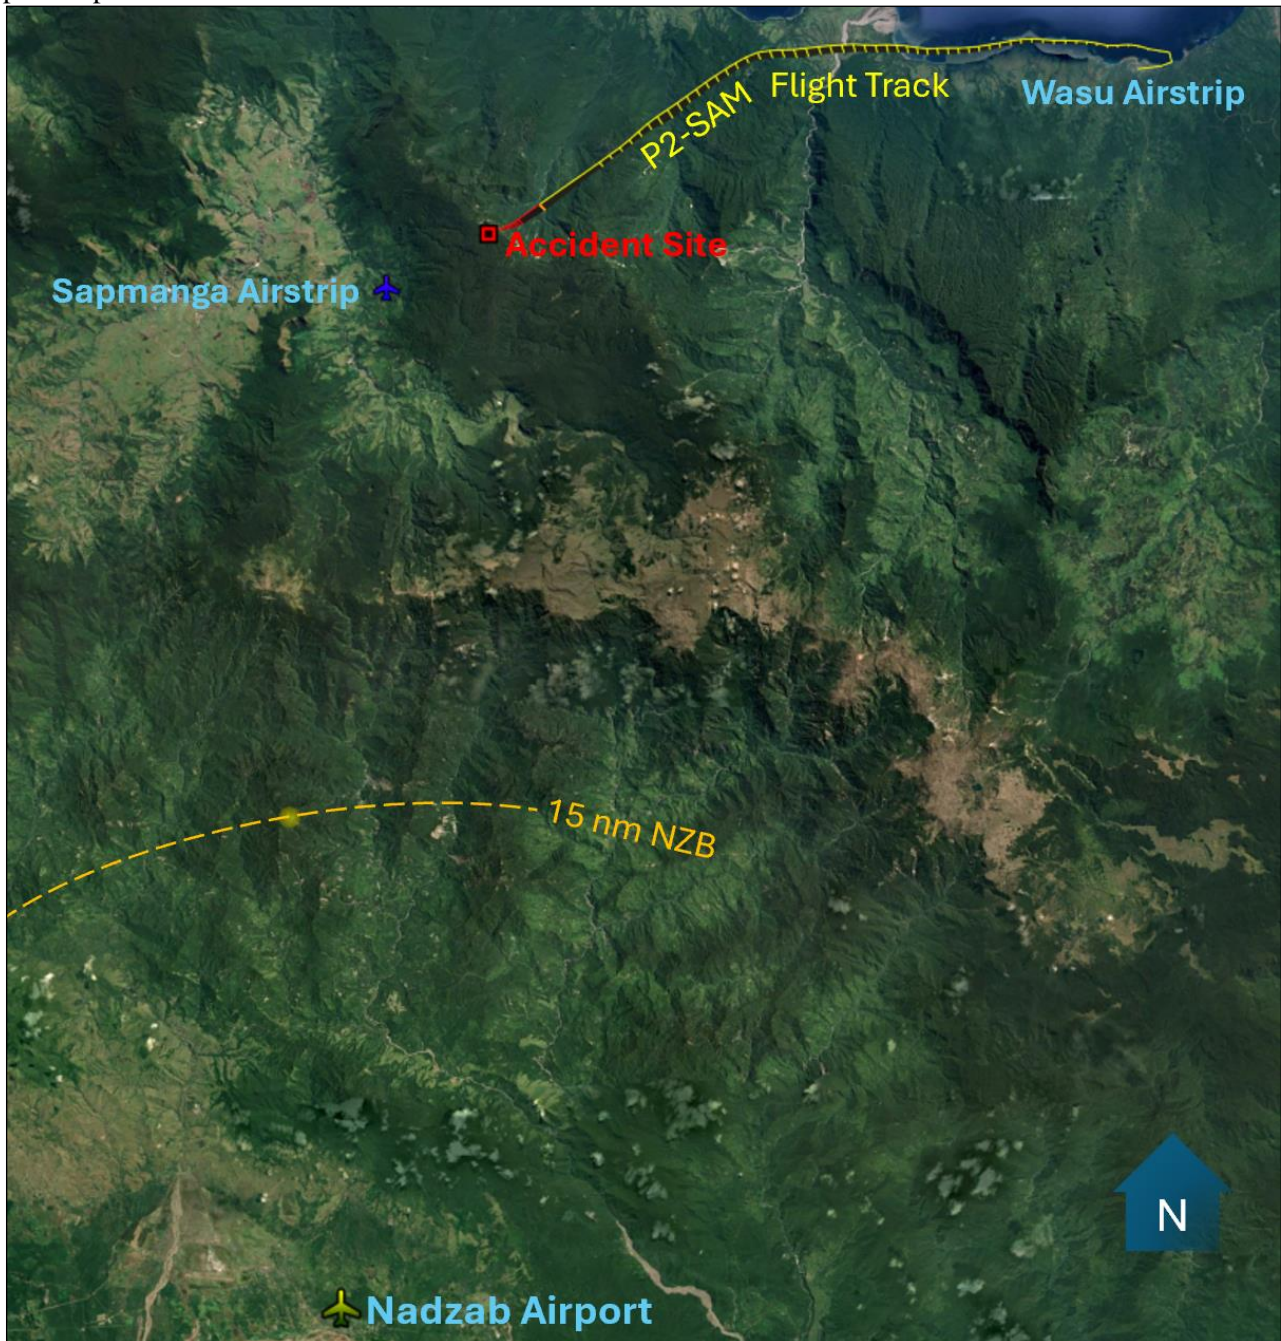
Figure 1: P2-SAM Accident recorded flight track from departure to accident. (Source: V2 Track recorded data<sup>5</sup>)

According to the Operator’s V2-Tracking System, at about 10:21, the aircraft took a left heading from the coast and began tracking Southwest while continuing the climb through 5,500 ft<sup>7</sup>. This track was maintained until the last recorded position at 10:26:59. The last recorded point showed that the aircraft was 5.7 NM Northeast of Sapmanga, at 85 kts<sup>8</sup>, and at an altitude of 8,002 ft. The wreckage position coordinates showed that the last recorded flight position was about 1.8 NM Northeast of the accident site.
