FINAL REPORT

AIC 24-2001

P2-BBM

Runway Excursion During Landing

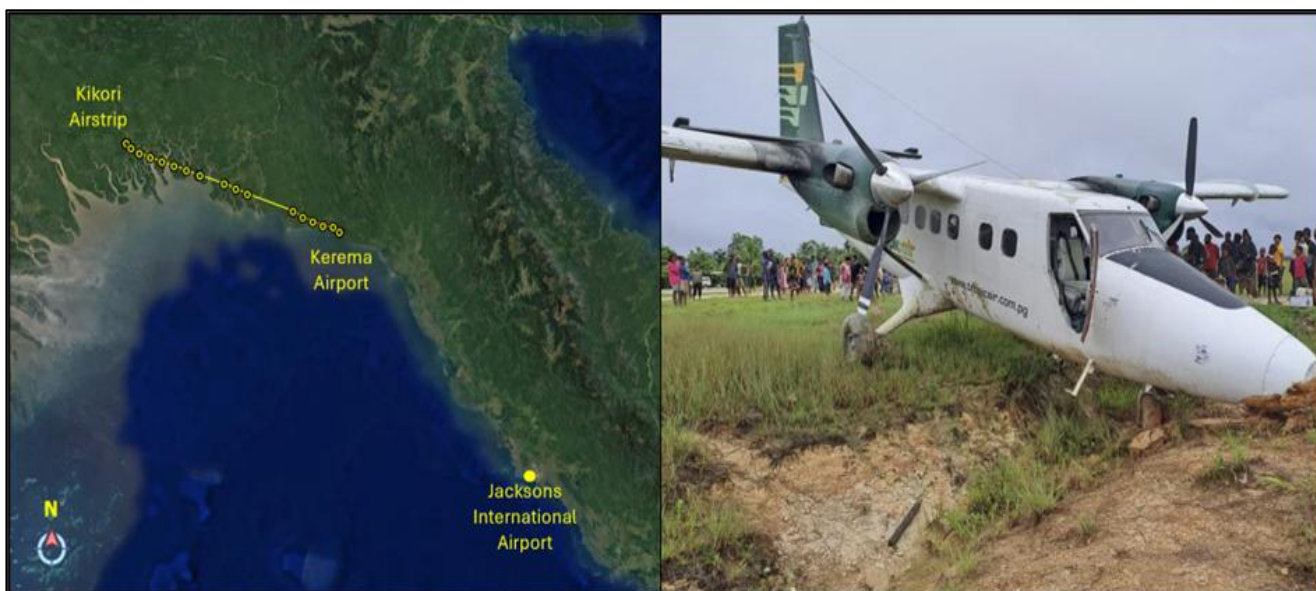
On 8 June 2024, at 11:43 local (01:43 UTC¹), a De Havilland Aircraft of Canada Ltd DHC-6-300 Twin Otter aircraft, registered P2-BBM, owned and operated by Tropicair Ltd, was conducting an IFR² Fares and Freight flight from Kerema Airport to Kikori Airstrip, Gulf Province, Papua New Guinea, when, during the landing roll at Kikori, it experienced a runway excursion and rolled into a drainage ditch which runs along the left side of the runway and impacted the embankment.

Figure 1. Serious incident at Kikori Airstrip.

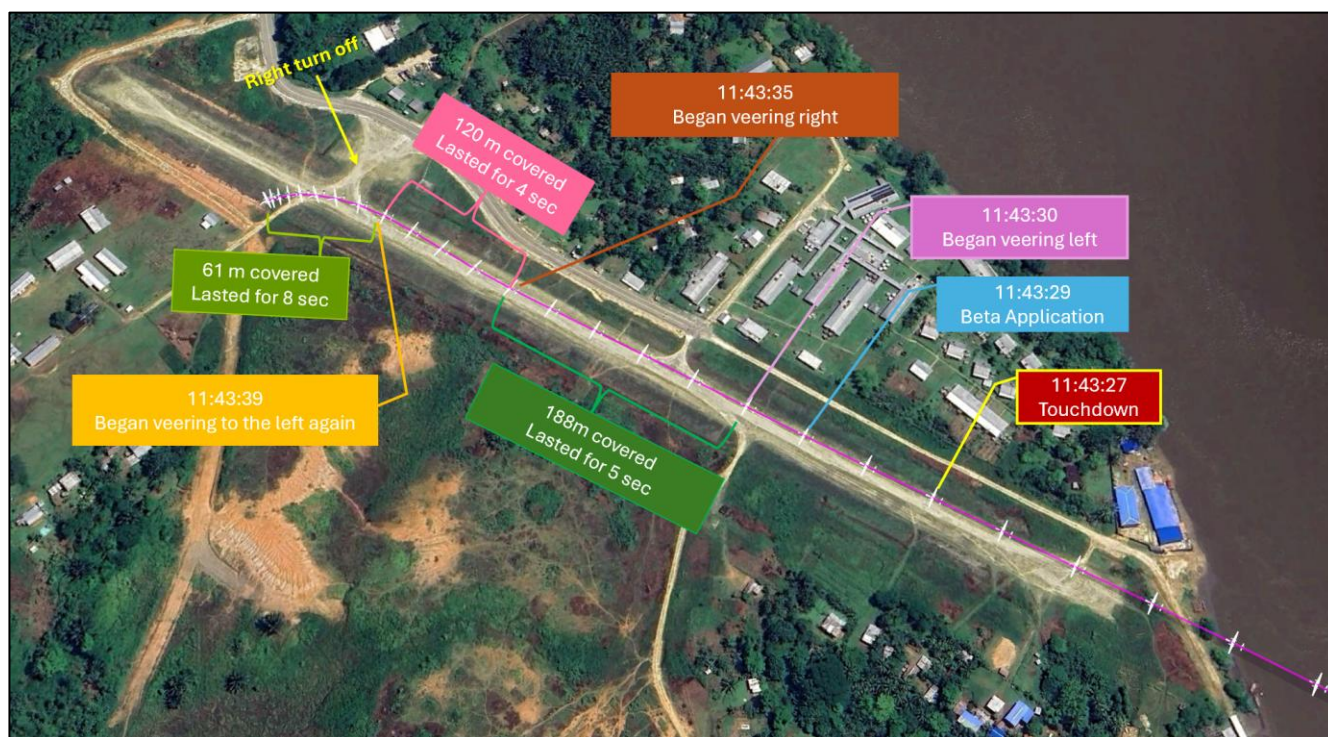
The PIC stated that he had also applied right rudder to assist with steering the aircraft back to the right, however, the rudder input was ineffective. He added that, when the aircraft rolled onto the grass surface of the strip edge, he then applied full reverse and braking, however, the aircraft continued to roll past the runway edge and into an adjacent drainage ditch.

Figure 4. Aerial view of the airstrip and P2-BBM track from touchdown to final resting position.

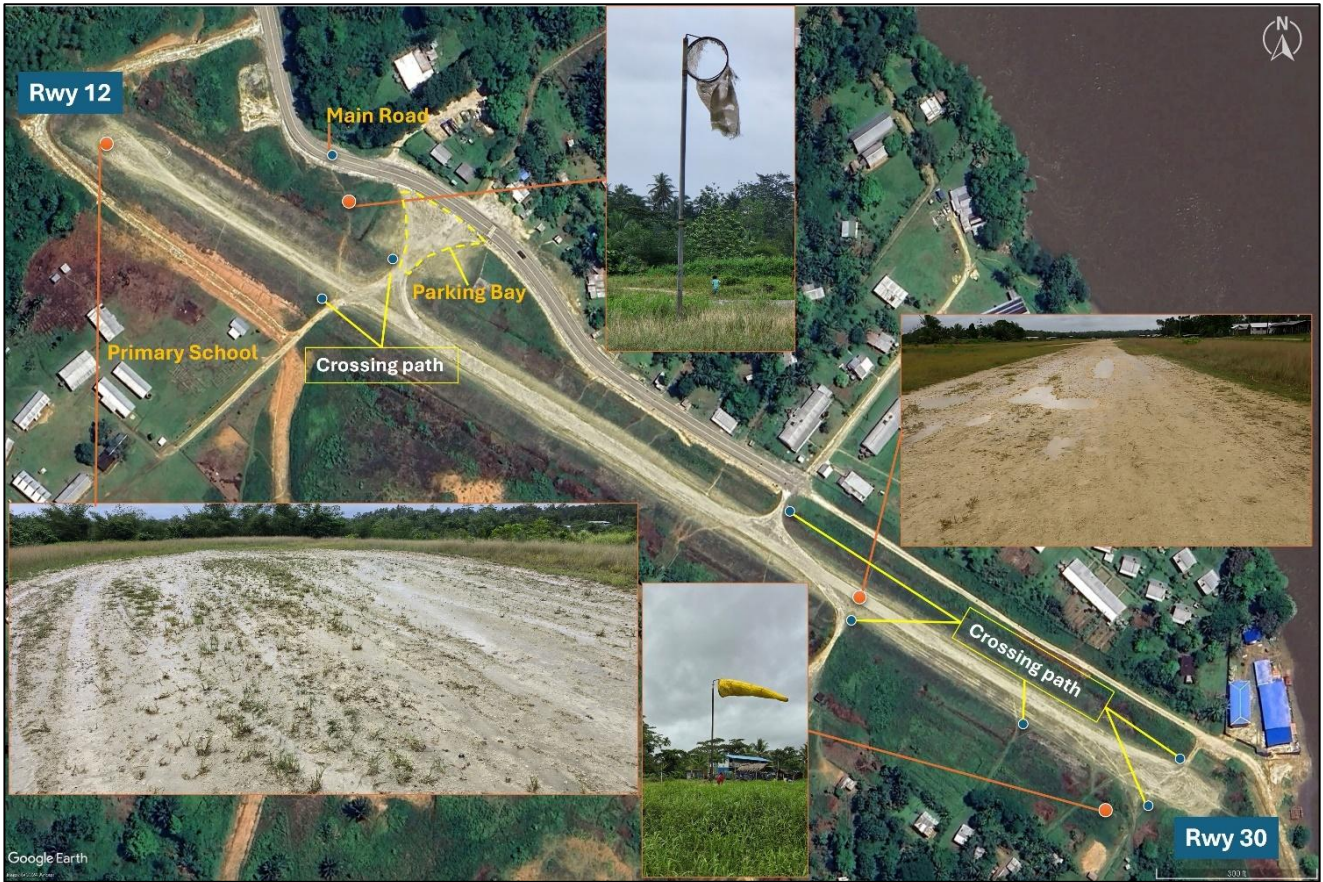
The airstrip had two windsocks. One windsock was situated near the parking bay at the northwestern section of the airstrip. On observation, this windsock was worn, torn and unserviceable. The other windsock situated near end of RWY 30 is serviceable.

Figure 9. Kikori Airstrip onsite assessment. (Source: Google earth, annotated by the AIC).

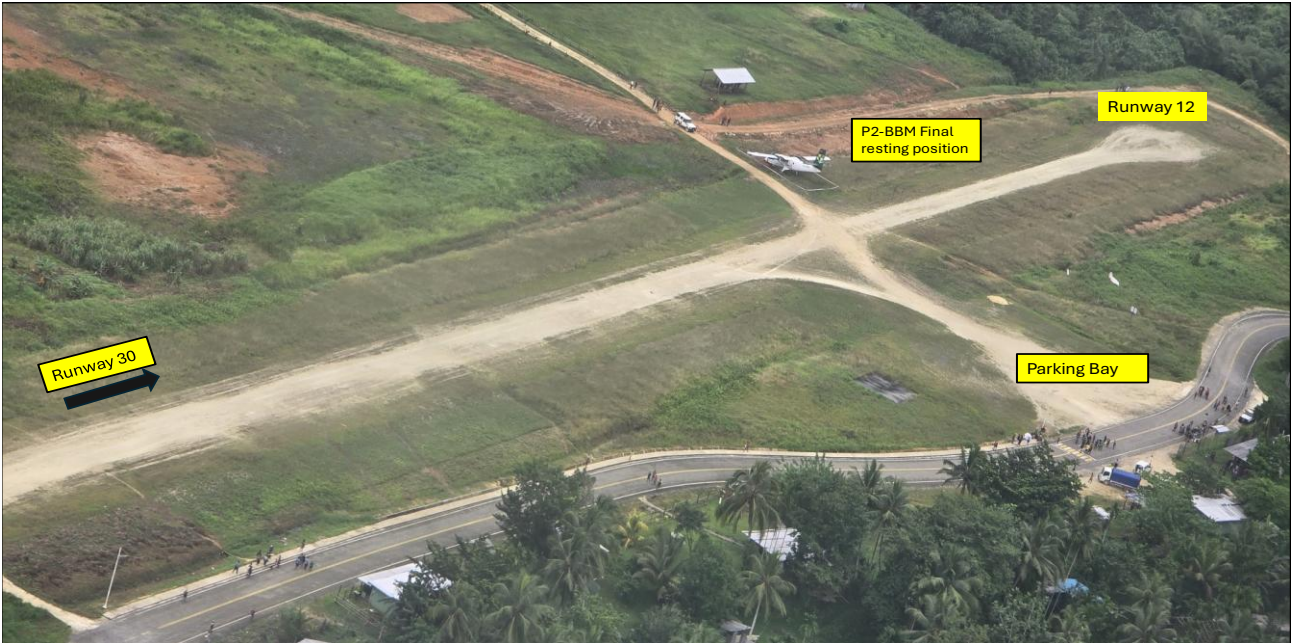
The aircraft impacted the embankment of the drainage ditch and came to rest. The PIC subsequently shut down the engines and advised the co-pilot to evacuate the passengers. The co-pilot and the passengers egressed the aircraft through the left rear exit door and the PIC egressed the aircraft from the left-side cockpit door. There were no reported injuries to the crew and passengers.

Figure 10. Aerial view of P2-BBM final resting position.

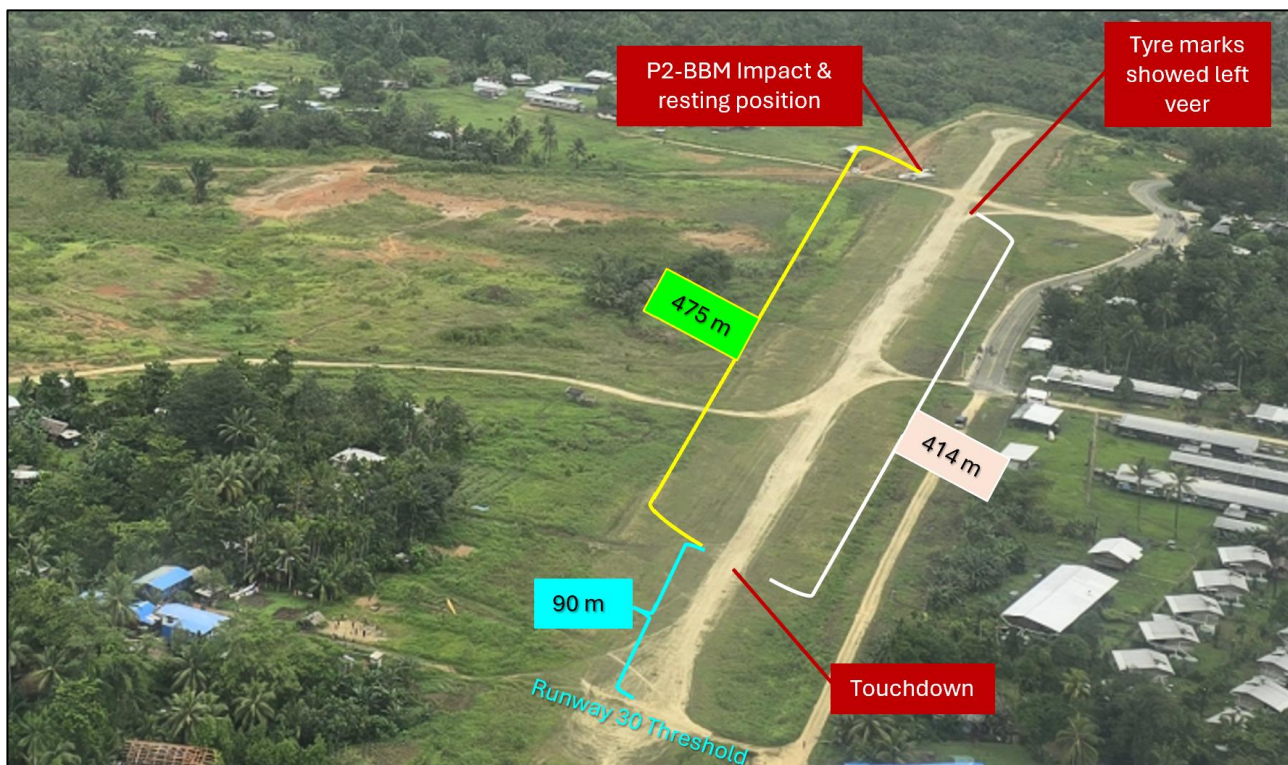
The AIC onsite investigation team observed that the tyre markings indicated that the aircraft initially touched down approximately 90 m beyond the RWY 30 threshold. The impact point was about 475 m from the touchdown point. The aircraft began veering left around 414 m from touchdown, as shown by the tyre markings. While the tyre marks were prominent between the point where the aircraft started the second veer to the left up until the point of impact, they were less distinct in certain areas, particularly between the touchdown point and the initial veer to the left. This was due to a heavy downpour following the runway excursion as reported by the crew. Additionally, the hard surface of the runway, and the tyre marks from the rescue aircraft, made it difficult to clearly identify the marks that were imprinted by P2-BBM.

Figure 11. Accident site overview.

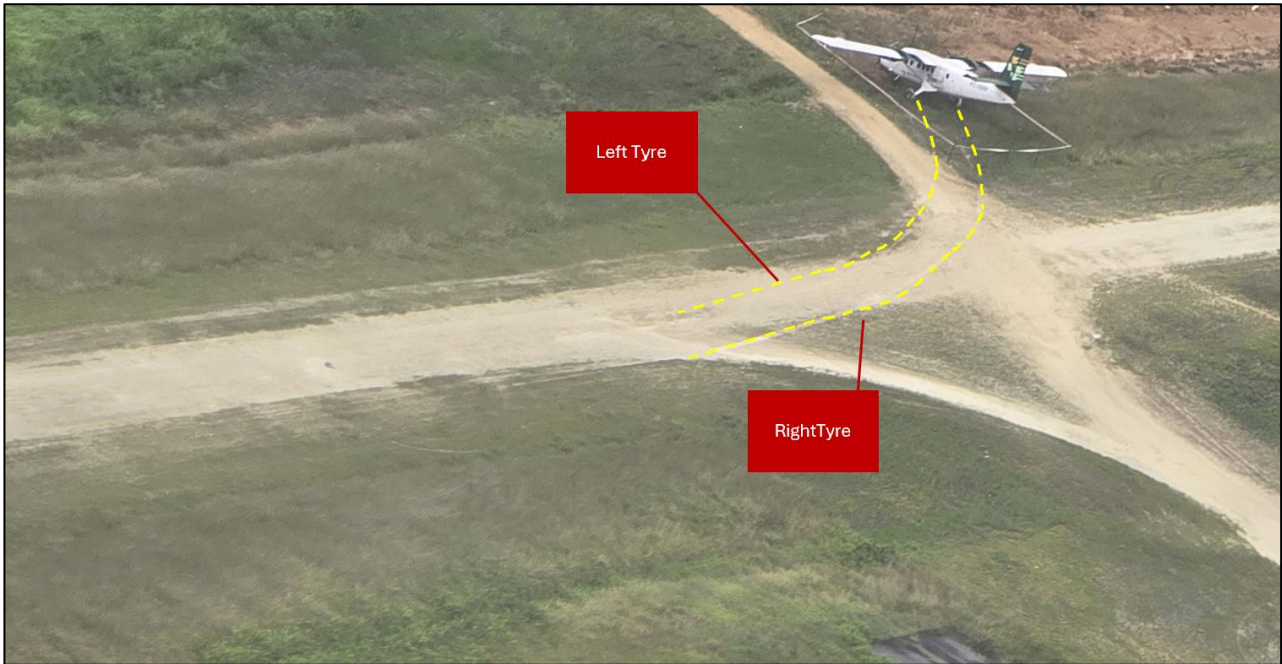
The tyre markings on both tyres showed that the aircraft began veering to the left along a trajectory. The distance covered by the markings of the aircraft's left veer on the right side of the runway to the point of impact on the airstrip was measured to be about 61m. The markings also indicated that heavy braking was applied during the final stages of the ground roll, before the aircraft entered a drainage ditch and struck the embankment, where it came to rest.

Figure 12. Tyre markings indicating the P2-BBM final tracks prior to impact.

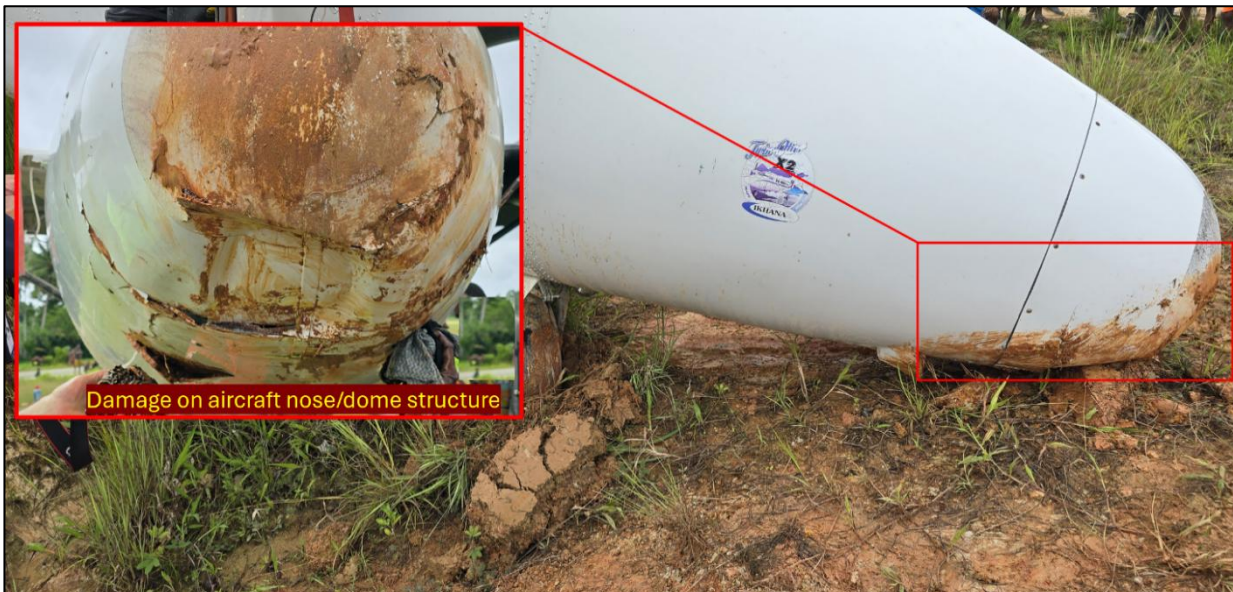
The aircraft sustained damage to the nose cone structure. Refer to *Section 1.12* for a detailed description of damage to the aircraft.

The onsite assessment of the damage revealed that the aircraft sustained damage to its nose dome structure. The extent of the damage suggested that the impact occurred with minimal force.

Figure 13. Damage to the nose cone/dome structure.

After the inspection was completed, minor repairs were carried out to prepare the aircraft to be ferried back to the Operator's base at Jacksons International Airport, Port Moresby. A Special Flight Permit was approved by CASA⁷ PNG on 10 June allowing the Operator to conduct the ferry flight.

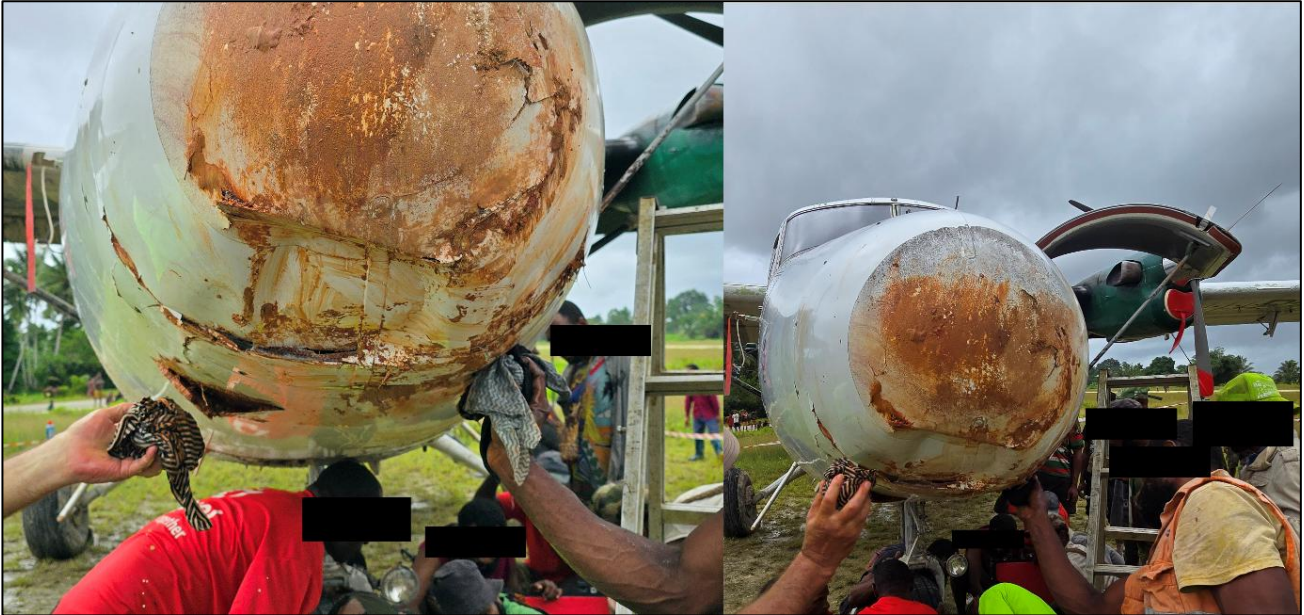
The aircraft was pulled out of the drainage ditch the day after the serious incident, on 9 June 2024 and an inspection was carried out by the Operator's engineers to determine the extent of damage. Refer to *Section 1.12 Wreckage and Distribution* for further details.

Figure 14. Removal of P2-BBM from the drainage ditch - Post occurrence.

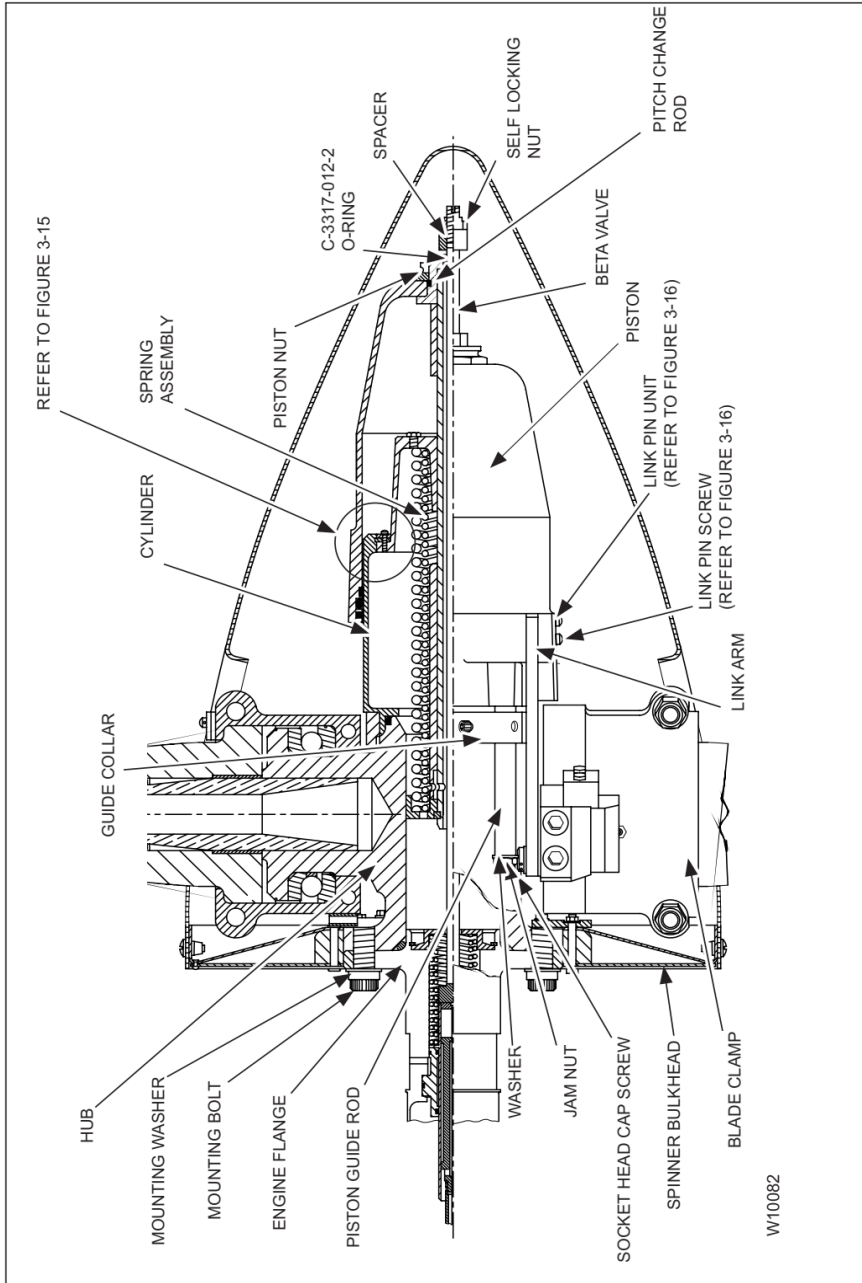
-7() Propeller Assembly
Figure 3-14

A full examination was carried out on the RH propeller and a report was provided to the Operator on 3 July 2024. According to the examination report, it was discovered that the noise was emanating from the interaction (catching) of the inner and outer feather compression springs in the Propeller Assembly. Wear marks had also been discovered on the outer spring, therefore, a new inner and outer spring of the spring assembly were installed and the spring assembly reassembled. In addition, new clamp gaskets and inner screws (undrilled) and a new mounting O’Ring were also installed (Refer to Appendix 5.4).
