FINAL REPORT

AIC 24 - 2002

B737-800 aircraft

Hazardous material, mercury spill in aircraft cargo compartment

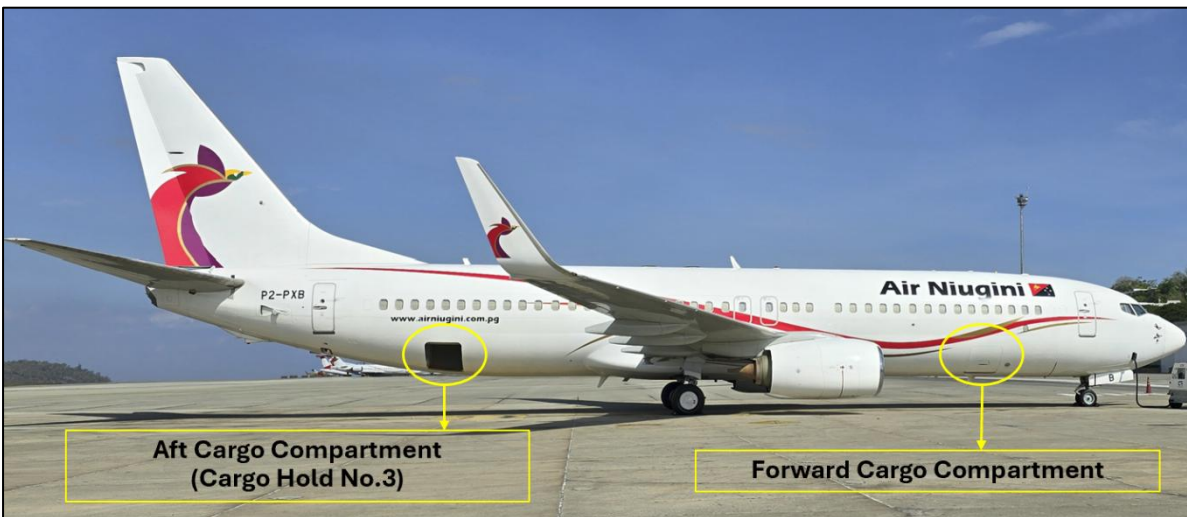
Figure 3: P2-PXB at the remote bay post occurrence indicating cargo compartment

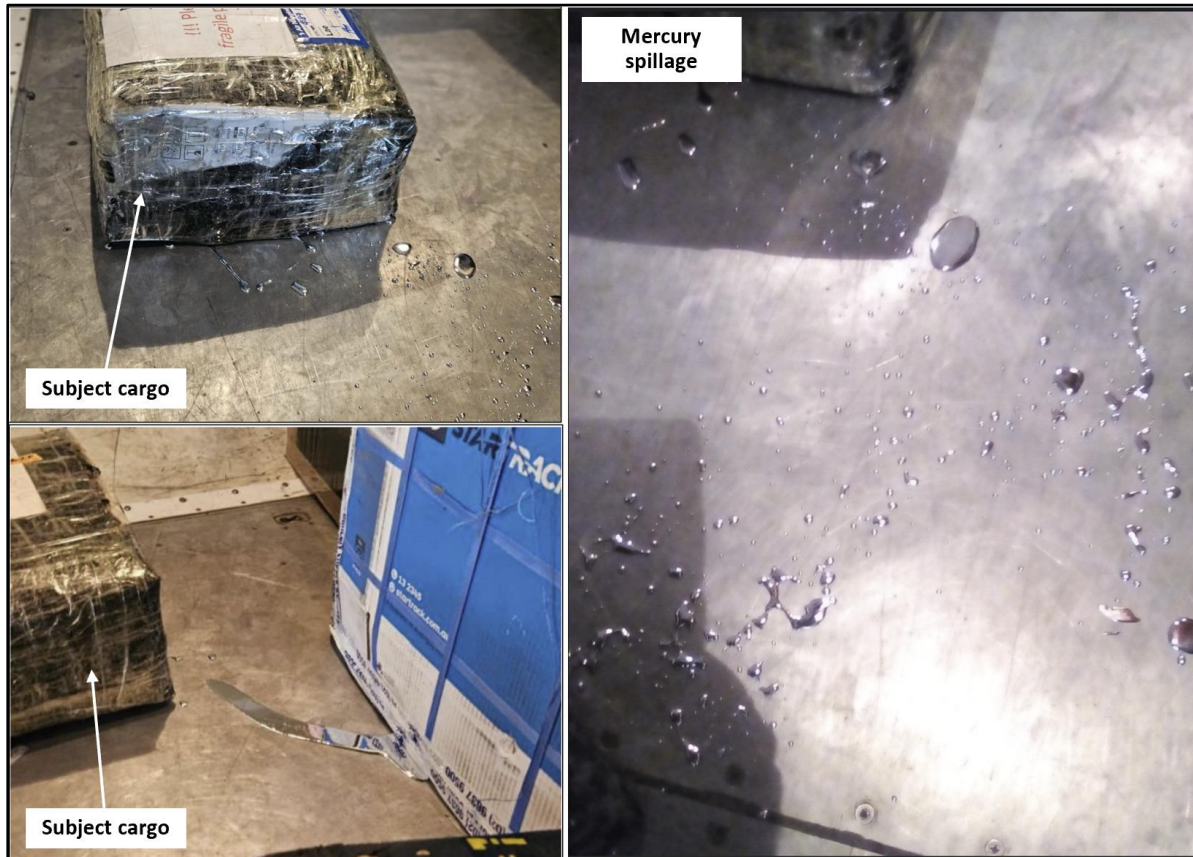
During loading, Porter 3 noticed a spill on the floor, which he suspected to be Mercury² and immediately alerted his colleagues. As a result, loading was halted, and the Porters informed their supervisor about the spillage. The source of the spill was traced to a general cargo item, weighing 37 kilograms (kg) and declared as ‘excavator parts’ under consignment number 656-41871701. *See Section 1.6.3.1 for more information.* The supervisor contacted a team of Aircraft Engineers. After examining the spill, the engineers concluded that it was mercury.

Figure 4: Photos of the cargo of interest and the mercury spillage (Source: Air Niugini Limited)

According to the operator's internal *Safety Investigation Report* it was estimated that approximately 200 grams (g) of the Mercury substance had leaked from the package, spreading from the doorway of the aircraft's Cargo Hold No.3 and onto the compartment floor. Refer to Section 1.6.3.3 for information on post occurrence maintenance information.

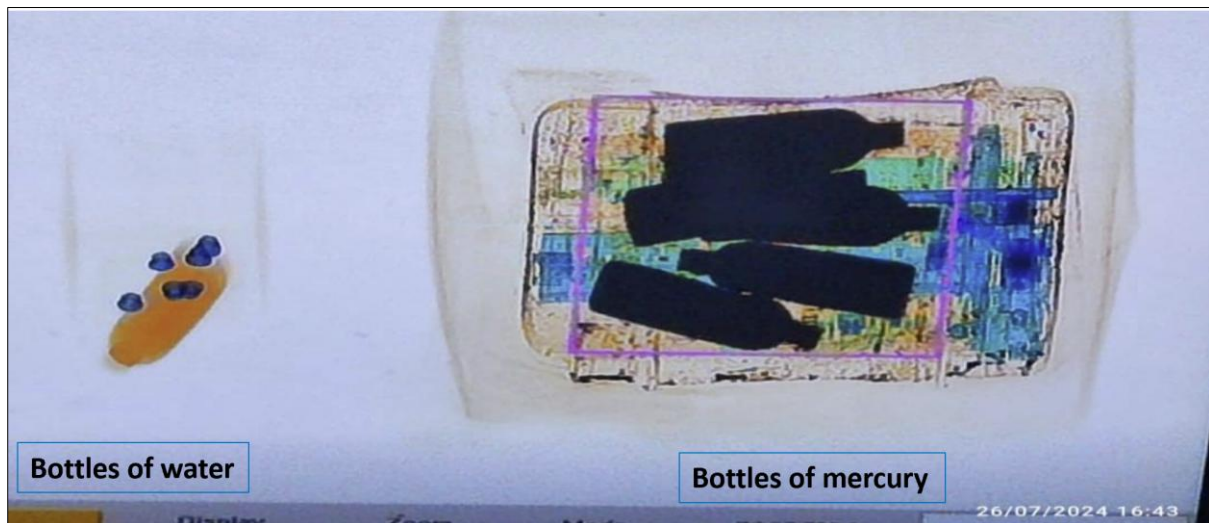
On 26 July 2024, the shipment re-scanned through the X-Ray screening machine, by the Cargo Team and AVSEC Team to establish if the mercury was picked up by the X-Ray Screening machine. The screened images showed that the mercury appeared dark, compared to the bottles of water which appeared orange in colour which indicated that the mercury was picked up by the X-ray screening machine.

Figure 6: Images of re-scanned shipment in comparison to scanned bottles of water (Source: Air Niugini Ltd)

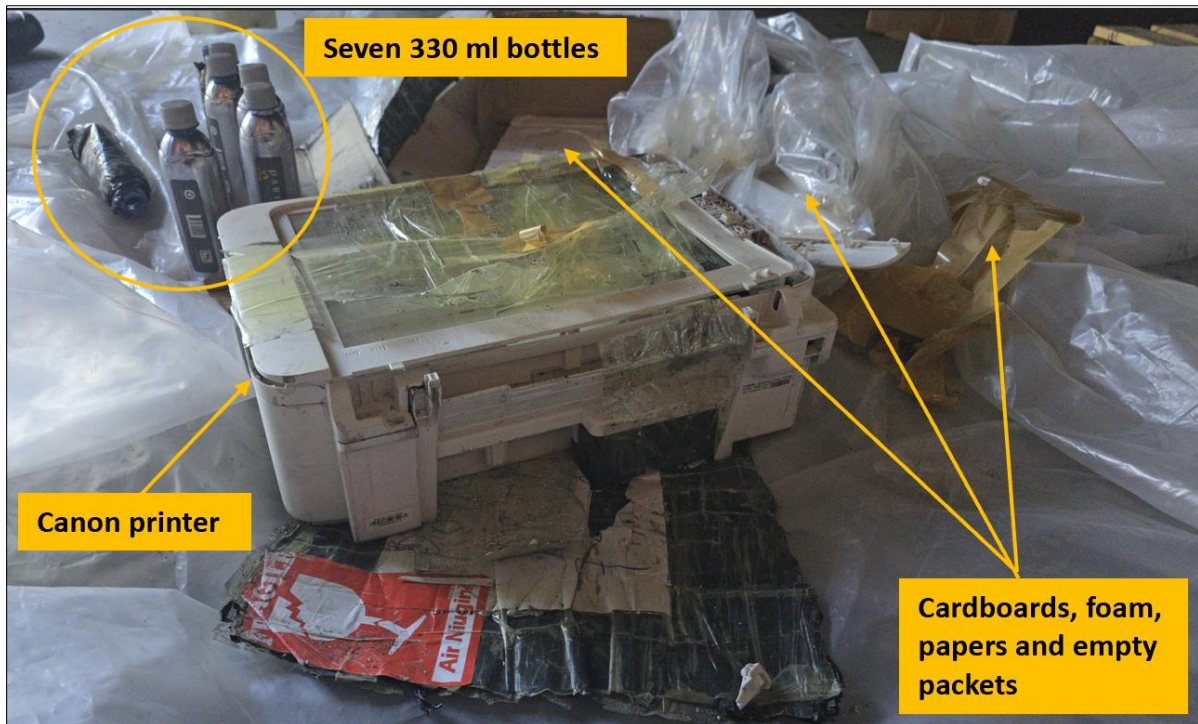
On 16 August 2024, the AIC investigation team inspected the subject cargo in the Cargo Storage Room and found that all contents of the shipment including the portable printer were packed in a clear plastic bag. The team discovered seven 330-milliliters (ml) bottles: six containing mercury, and one completely empty. The remaining contents of the package included a portable printer, several empty packets of various items and pieces of foam and cardboard, which appeared to have been used for padding and cushioning the bottles of Mercury. There were traces of mercury all over the rest of the cargo contents. The mercury was believed to have leaked out from the bottle that was found to be empty. This was also confirmed by the cargo personnel who had unpacked the cargo to check the contents, repacked it and re-screened it following the occurrence, on the day of the occurrence.

Seven bottles: five full of mercury and the empty bottle were identified as Air Niugini Particles water bottles and the other full bottle was identified as a Pure water bottle.

Figure 7: Contents of subject cargo

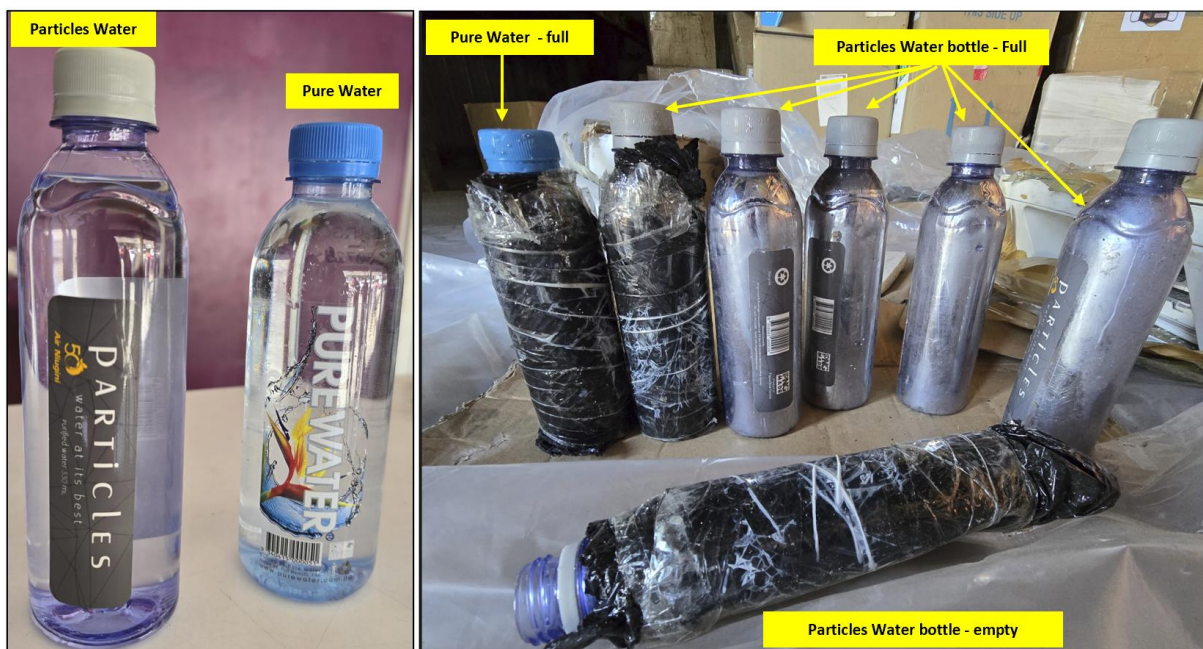
The investigation team weighed the six bottles containing Mercury, each of which was found to weigh 5 kg.

Figure 8: Bottles used to transport Mercury

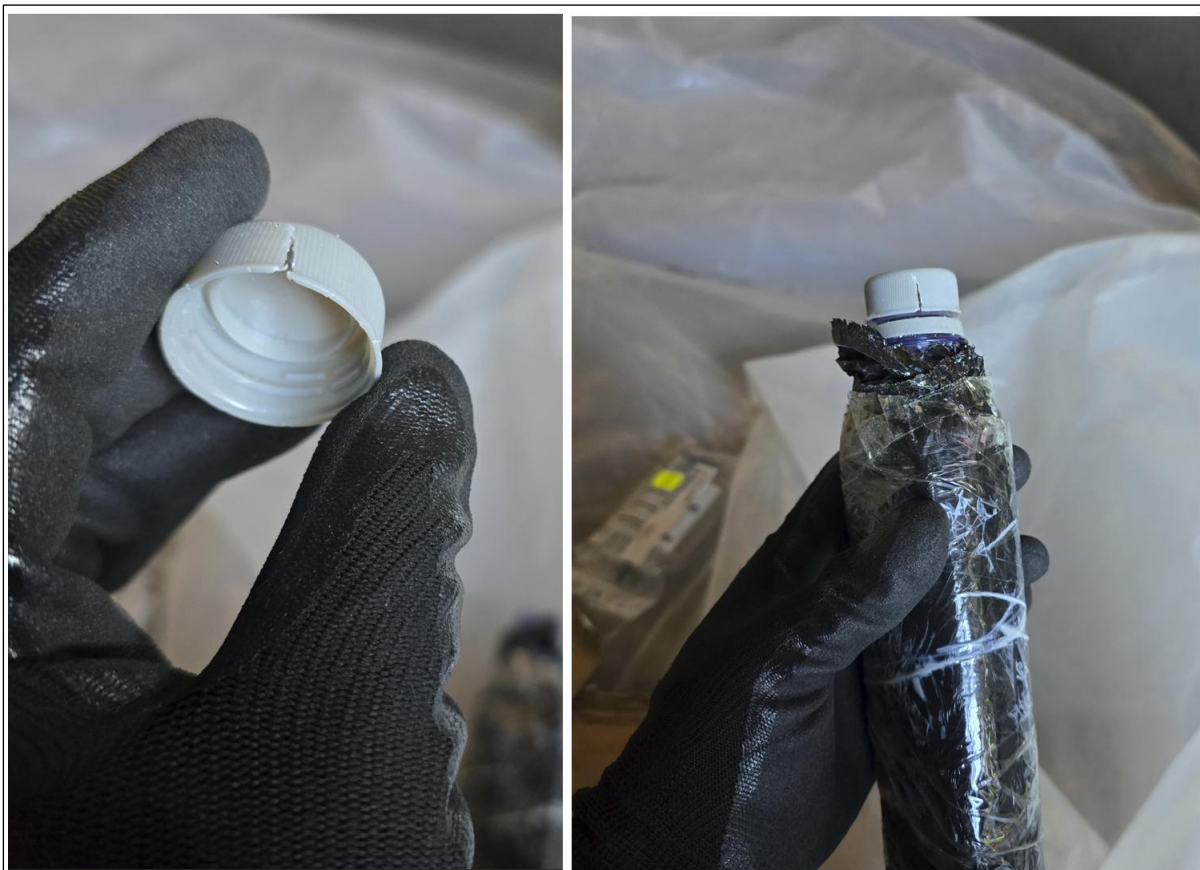
The empty bottle was examined, initially without the lid and it was found to be intact. After searching through the rest of the contents of the cargo package, the lid was located and appeared to be cracked or broken. Refer to Figure 9.

Figure 9: Empty bottles with broken lid from which the Spill occurred

Mercury expands significantly when exposed to heat. If the bottle is left in a warm environment, the mercury inside will expand as it heats up. The investigation found that the mercury was packed in plastic bottles and plastic is not a good conductor of heat, which means it can trap heat inside the bottle, causing the mercury to expand more than it would in a container made of a more conductive material like glass or metal. As mercury expands, it increases the pressure inside the bottle. Since plastic bottles are flexible, they might bulge or even burst if the pressure becomes too high. It is also important to handle mercury with care due to its toxic properties and to store it in appropriate containers designed to withstand temperature changes and pressure. It is the view of the AIC that since the mercury was placed in inappropriate containers (water bottles) which were not designed to withstand temperature changes and pressure, this may have resulted in the bottles of mercury expanding, causing the lid to break.

Incorrect handling of the subject cargo during loading and unloading for transportation may have caused the lid to break.
