**PRELIMINARY REPORT**

**AIC 25 - 1001**

**P2-AXL**

**Runway Excursion During Landing**

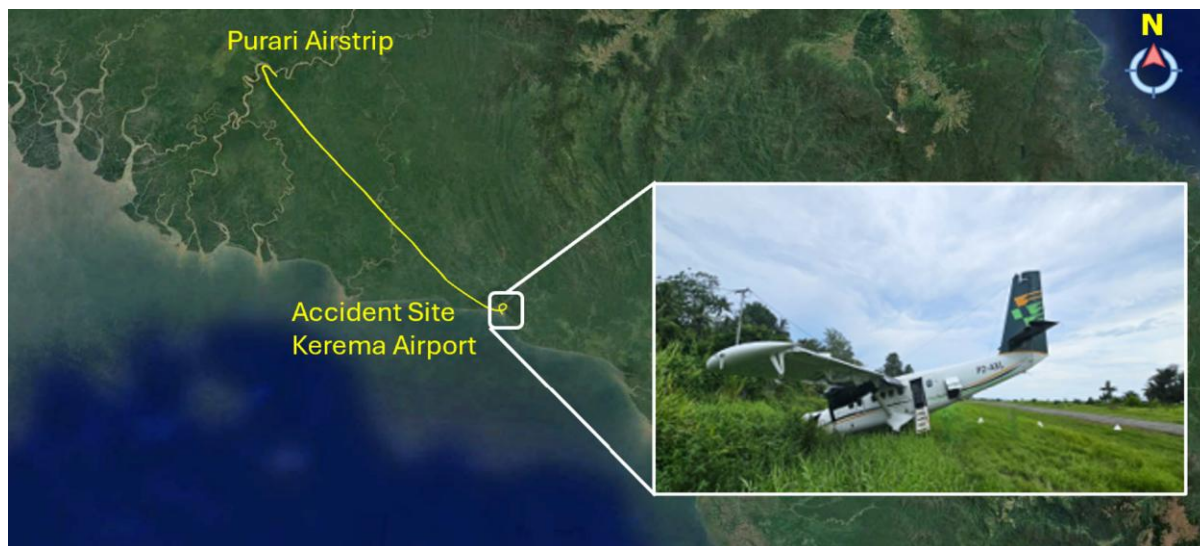
**Figure 1: Overview of P2-AXL flight path and accident site**

On 6 February 2025, at 10:28 local (00:28 UTC<sup>1</sup>), a De Havilland Aircraft of Canada, DHC-6-400 Twin Otter aircraft, registered P2-AXL, owned and operated by Tropicair Limited (Ltd), was conducting an IFR<sup>2</sup> Charter flight from Purari Airstrip to Kerema Airport, Gulf Province, Papua New Guinea, when during the landing roll at Kerema, it experienced a runway excursion and rolled into a drainage ditch which runs along the left side of the runway and impacted the embankment.

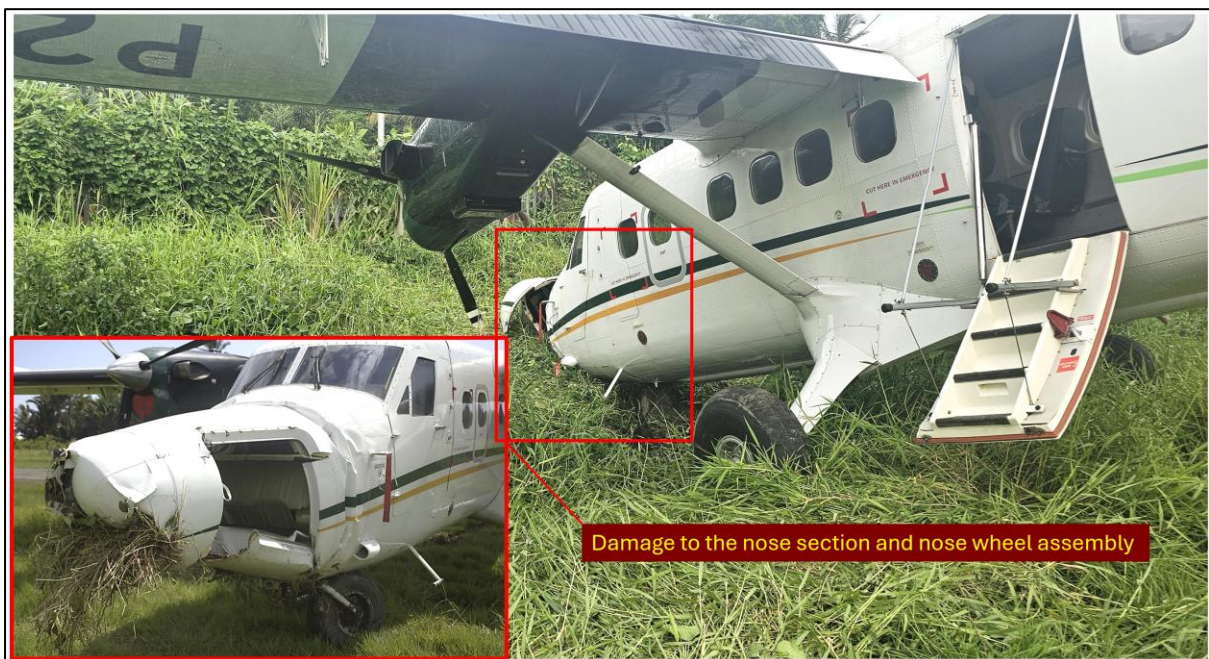
Figure 4: Overview of damage sustained by the aircraft

The aircraft sustained substantial structural damage to the nose section of the aircraft and nose landing gear assembly on impact (see Figure 4).

Type of operation	IFR Charter Flight	
Persons on Board	Crew: 2 Pilots (PIC and Co-pilot)	Passengers: 8
Injuries	Crew: Nil	Passengers: Nil
Damage	Substantial structural damage to the nose section of the aircraft and nosewheel assembly
