PRELIMINARY REPORT

AIC 25-2001

REGISTRATION : VH-NAB

OCCURRENCE DESCRIPTION : Abnormal Runway Contact – Hard Landing

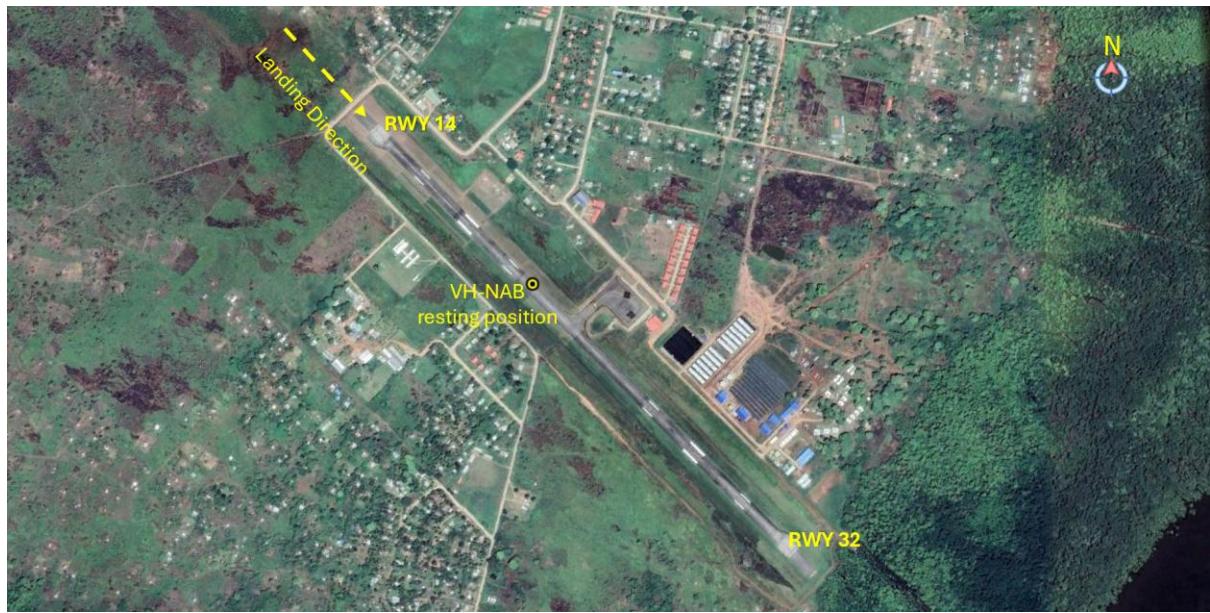
Upon arrival in Daru, the pilot conducted a normal approach and landed on runway 14. He reported that during the landing roll, he lost control of the aircraft as it veered to the right. He applied corrective input to regain directional control but heard what he described as a loud “bang” noise. He reported that the aircraft then veered toward the left on the runway before coming to rest near the edge of the runway.

Figure 2: Depiction of VH-NAB at the occurrence site, Daru Airport.

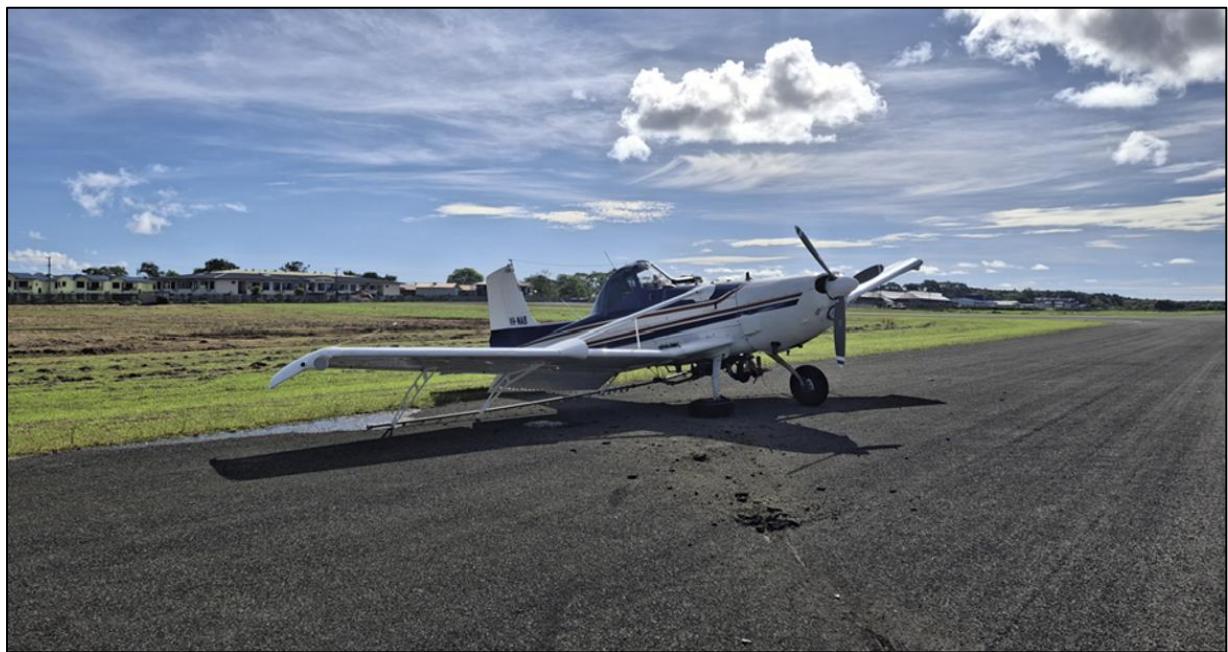
The pilot subsequently shut down the aircraft, contacted the aircraft operator, and exited the aircraft uninjured. After exiting, the pilot observed damage to the right main landing gear structure.

Figure 3: Depiction of VH-NAB at its resting position after the occurrence at Daru Airport.

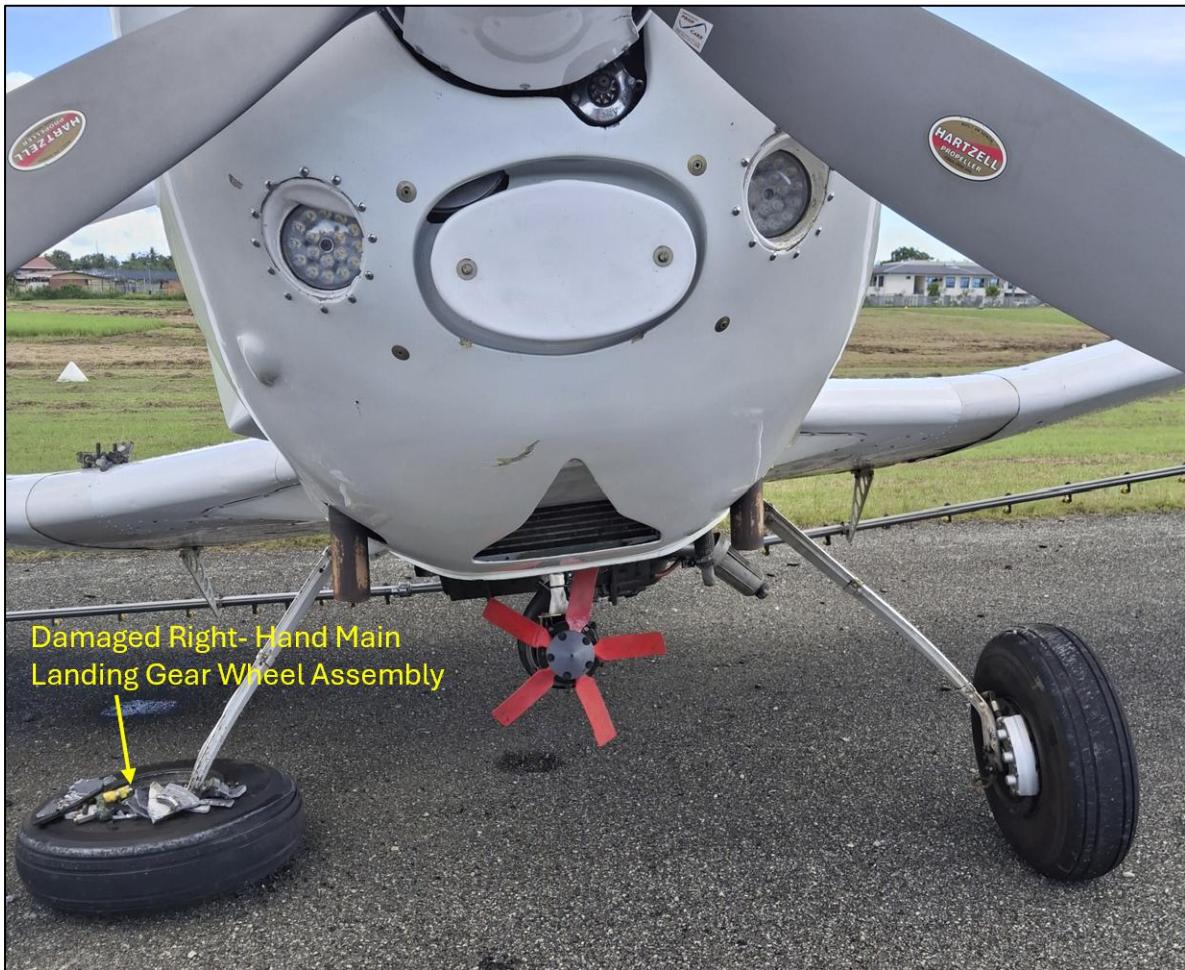
The aircraft sustained significant damage to the right main landing gear wheel assembly.

Figure 4: Damage sustained by VH-NAB
