FINAL REPORT

AIC 25-1002

18 MAY 2026

CONTRACTOR	:	Liddles Aerial Spraying Pty Ltd
OPERATOR	:	Ramu Agri Industries Limited
REGISTRATION	:	VH-SOY
MANUFACTURER	:	Cessna Aircraft Company
MODEL	:	T188C
CLASS/CATEGORY	:	Ground Impact During Low Altitude Operations (LALT)
LOCATION	:	Sangkiang Village, Ramu, Madang Province
OCCURRENCE DATE	:	23 April 2025

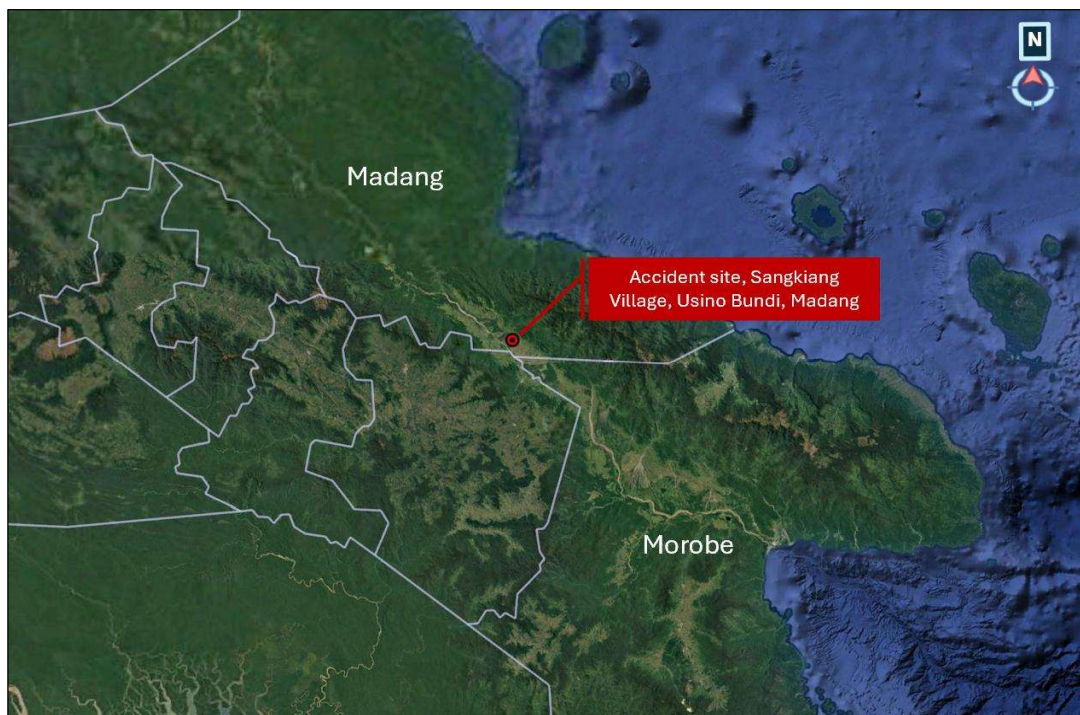
Figure 1. VH-SOY accident site, Sangkiang village, Madang Province.

The pilot was the sole occupant of the aircraft and was fatally injured.

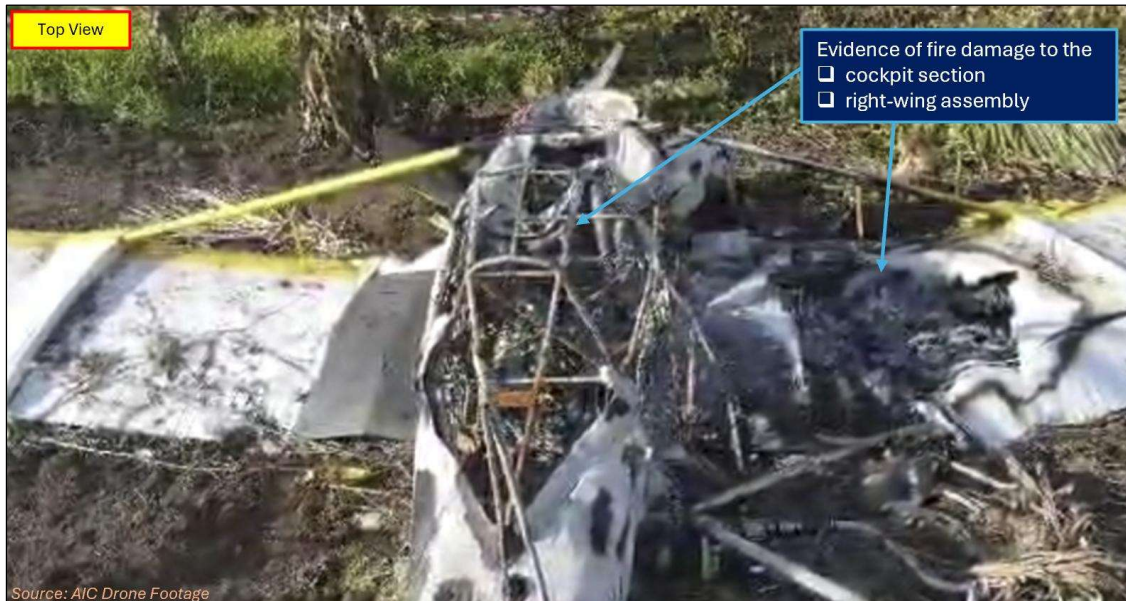
The aircraft was destroyed by a post-impact fuel-fed fire. The right fuel tank, located in the inboard section of the right wing was consumed by the fire (see Section 1.12, *Wreckage and Impact Information*).

Figure 4. Evidence of post-impact fire at the accident site.

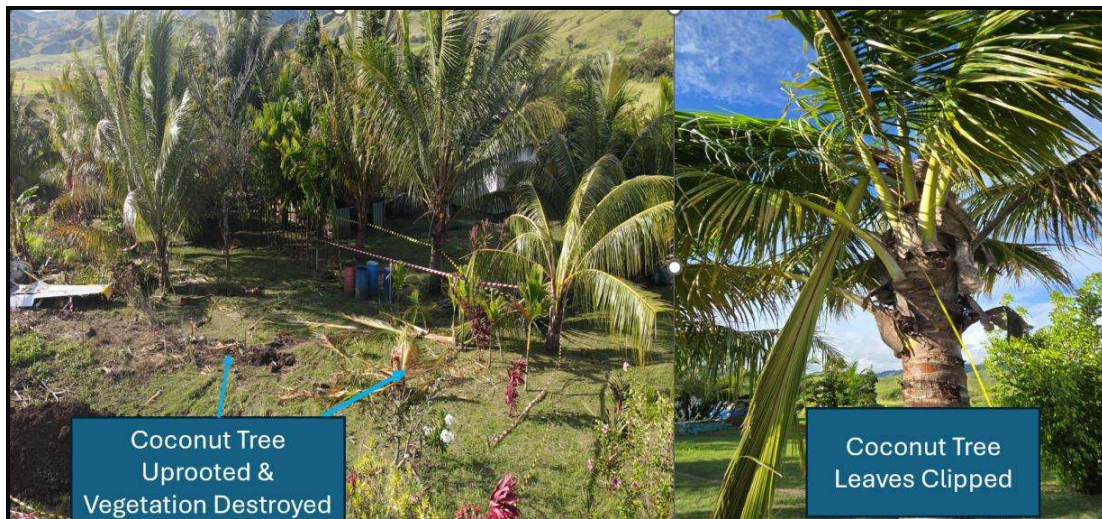
Vegetation at the accident site sustained localized damage from both the impact and post-impact fuel-fed fire.

Figure 5. Evidence of localised vegetation damage in the vicinity of the accident.

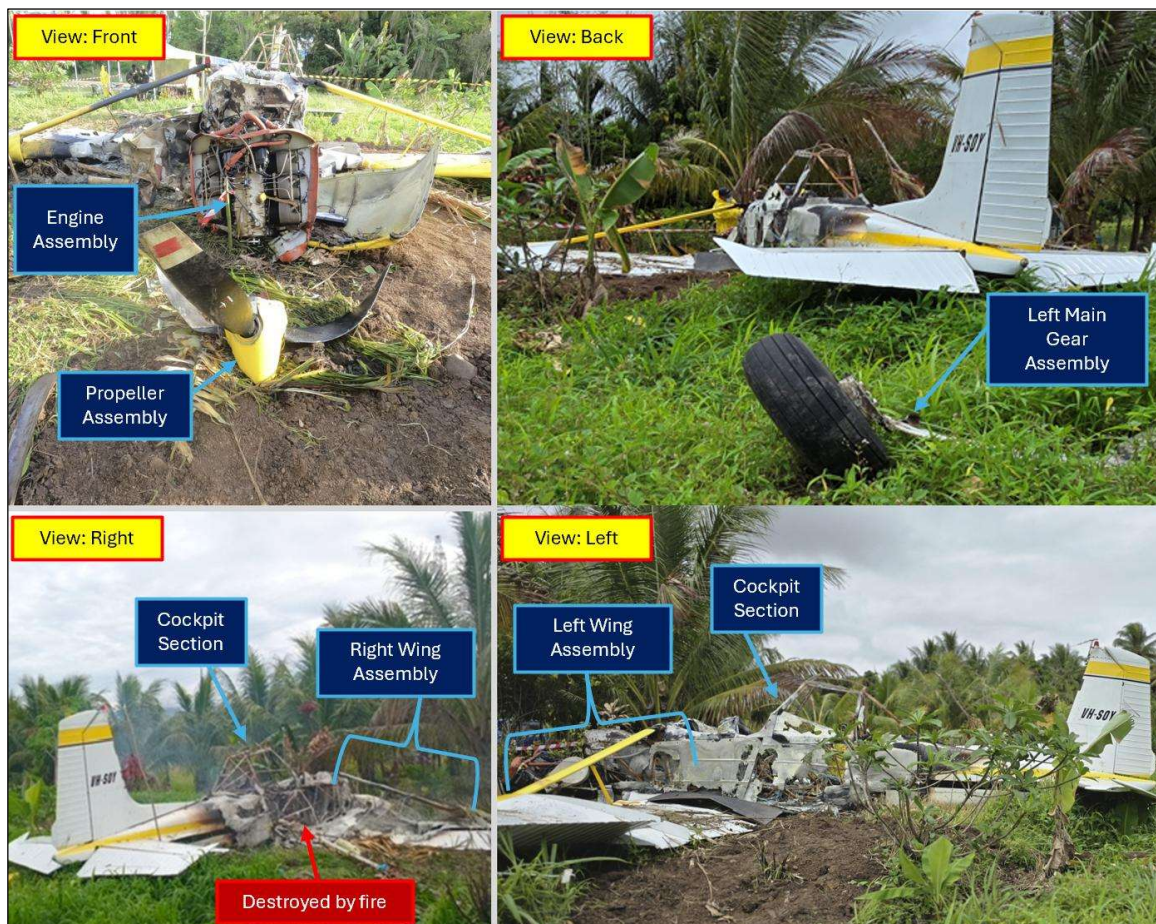
The aircraft sustained substantial damage as a result of the ground impact. On impact, the left main landing gear assembly separated from the airframe after tearing out of its attachment structure. The lower fuselage structure subsequently contacted the ground, and the aircraft slid along the surface for approximately 5 metres before coming to rest. Ground scarring clearly indicated the first point of ground contact and the aircraft's track to the final resting position.

Figure 6. Aircraft destroyed by impact forces and fire.

The investigation found that during the ground slide the aircraft rotated approximately 90 degrees right relative to the initial ground track.

The engine mounting frame had fractured, separated from the firewall attachments, and together with the engine assembly had collapsed forward due to impact forces. All four engine attachment mounts fractured. The manifold lever (power lever), propeller control lever, and fuel mixture control lever cables remained connected to the engine and were pulled (stretched) to their extension limits. These engine controls were found in the fully forward position (normally associated with maximum power). However, due to the forced extension to their physical limitations, the positions of these controls were not indicative of in-flight power settings.

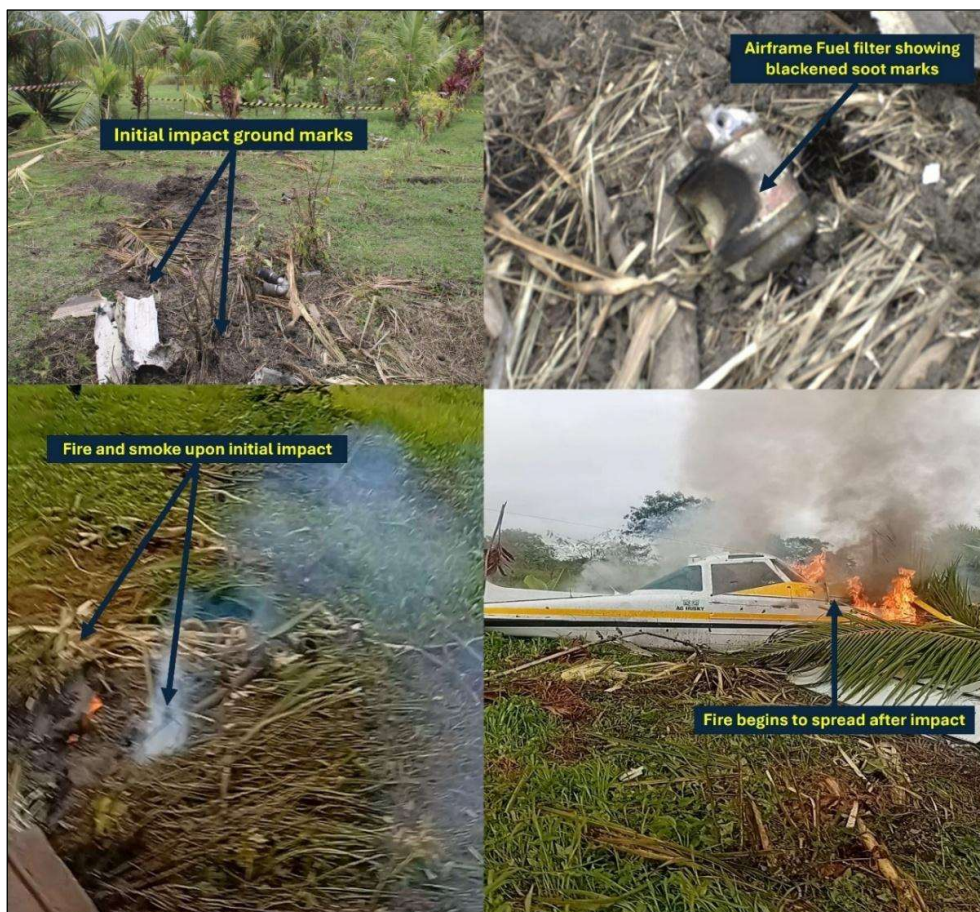
The Delphi 7111-296 fuel filter bowl assembly mounted to the sub-floor frame structure beneath the cockpit area, was found detached from the airframe in proximity to the initial ground impact point. Further examination indicated that this separation occurred after the collapse of the left main landing gear and subsequent contact of the aircraft belly structure with the ground.

The under-floor mounted fuel filter assembly separated from its mounting and fuel lines during the ground impact sequence. The fuel filter assembly was located near the first impact point. It exhibited soot marks.

Figure 7. Initial ground marks and fuel filter showing blackened soot marks.

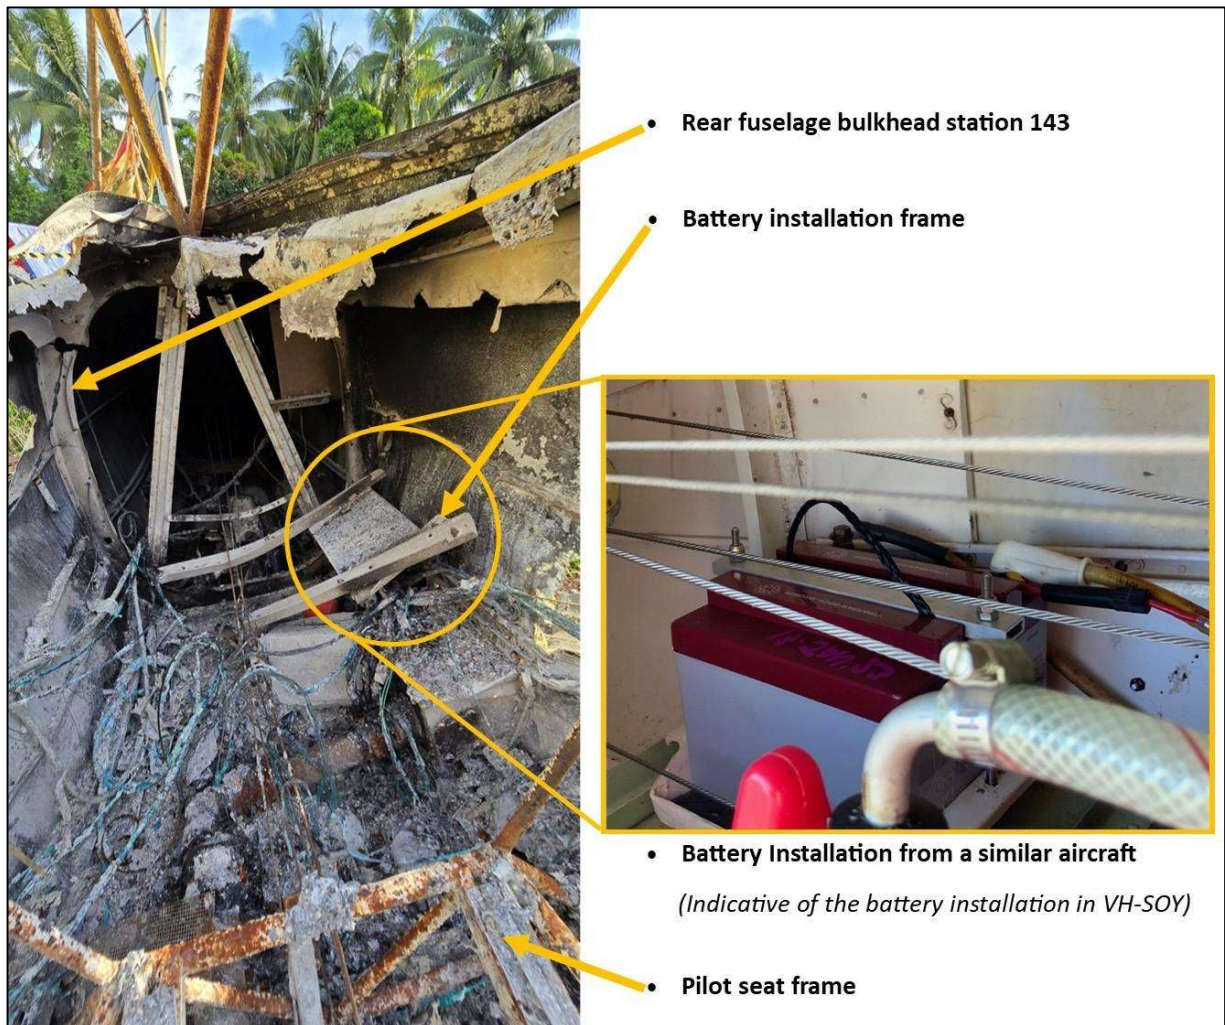
The aircraft battery, in a sealed container, was mounted on a frame immediately forward of rear fuselage Bulkhead Station 143. The battery was destroyed (melted) by the intense fire.

Figure 8. Rear fuselage showing battery installation area.

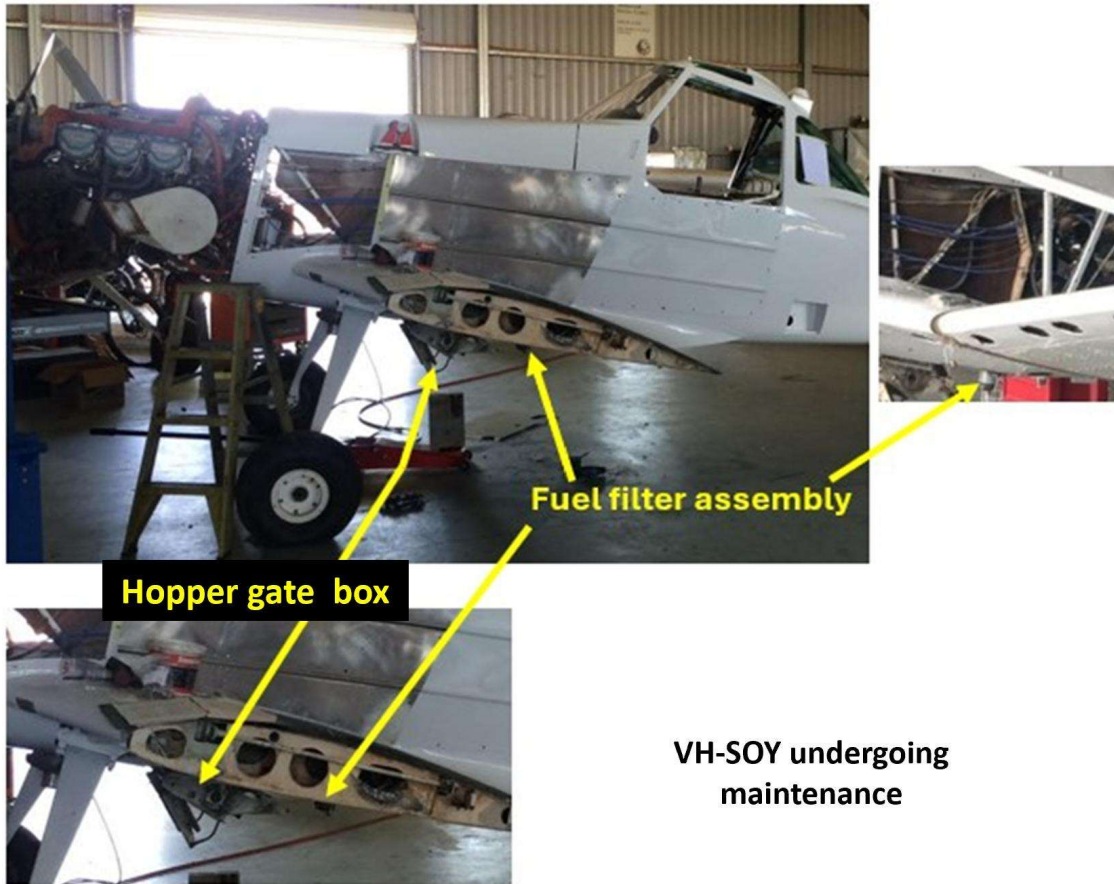
SAPL further advised that the filter assembly had historically been hard mounted to the sub-frame beneath the cockpit floor, protruding below the aircraft belly (see *Appendix 5.3*). The filter bowl cartridge could be replaced externally without removal of the assembly from the airframe.

The investigation noted that as a design feature for ease of access, the airframe fuel filter was attached to sub-frame below the cockpit floor, protruding through the belly skin aft of the hopper (chemical spray compartment) gate box. The position of the airframe fuel filter increased its exposure to chemical spray (See *Appendix 5.3*).

Appendix 5.3 Location of airframe fuel filter (Delphi 7111-296) on the Cessna T188C aircraft VH-SOY

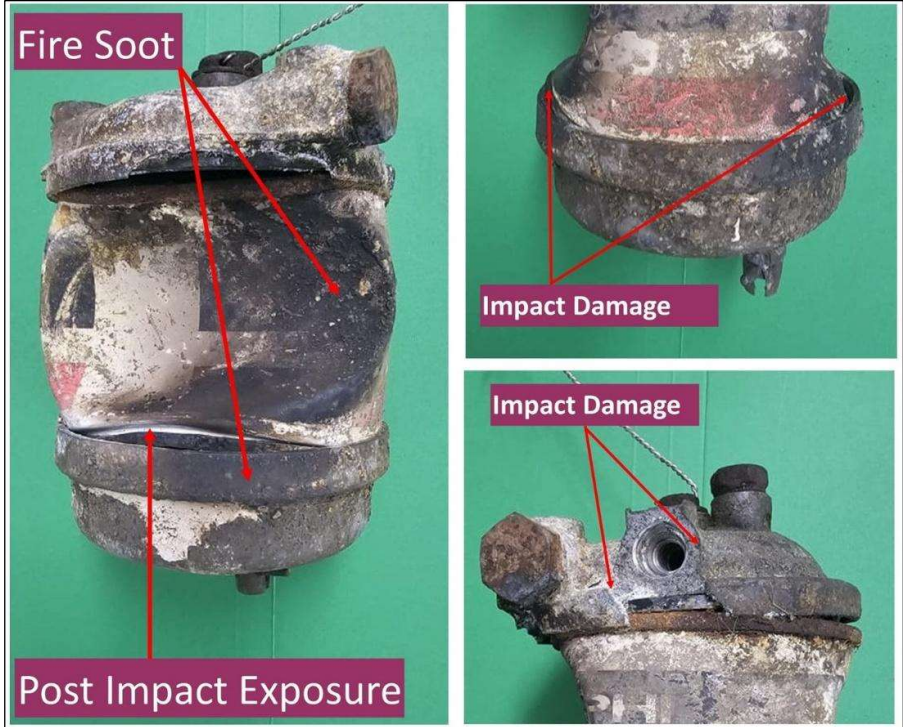
The airframe fuel filter assembly was recovered near the initial impact point. The filter housing indicated impact damage, soot deposits, and burn marks (Refer *Appendix 5.4*) there was no evidence of sustained ground fire in the immediate area where the filter was located. The filter assembly displayed:

- Soot and burn marks;
- Damage to inlet and outlet valve threads consistent with separation of fuel line fittings;
- Fracture of the filter housing mounting bracket;
- Impact deformation of the filter casing;

Appendix 5.4 (Fire and Impact Damage to Delphi 7111-296)

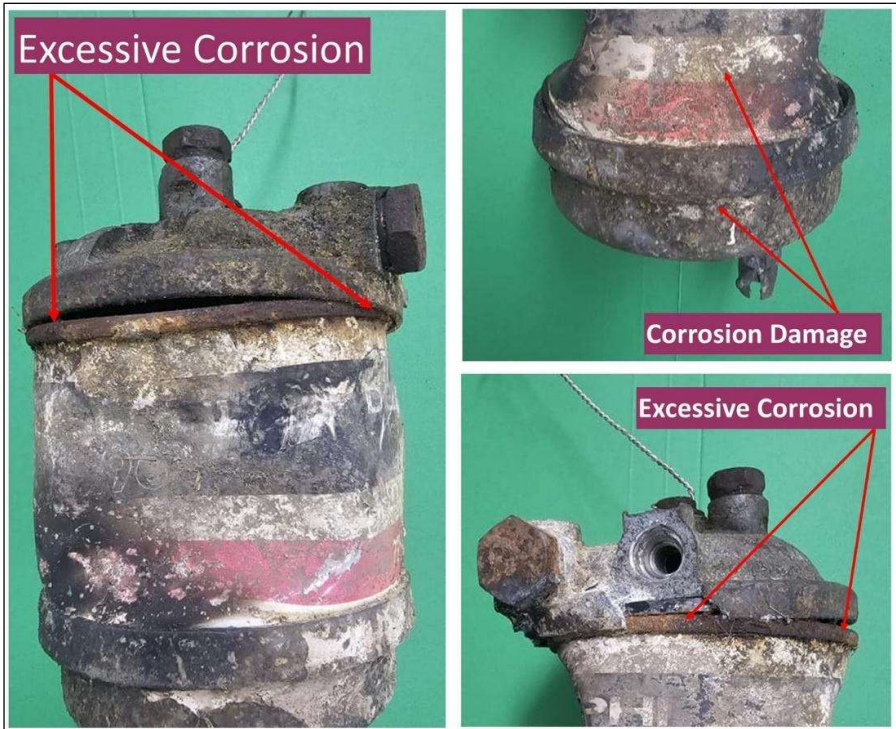
- Corrosion on the top and bottom cover assemblies; and
- Corrosion and impact damage to the drain valves.

Detailed examination identified corrosion damage that was assessed as unrelated to the impact sequence (Refer to *Appendix 5.5*).

There was no evidence that the corrosion observed on the airframe filter housing contributed to the accident. However, in the interest of safety enhancement, the following analysis is included in this report.

Most agricultural spraying chemicals such as herbicides, insecticides and fungicides contain high levels of various types of salts such as Glyphosate and Potassium Bicarbonate used as mineral salt in insecticides, herbicides and fungicides, as well as nitrates found in fertilizers.

Considering the location of the airframe fuel filter, as well as the contents of the various agricultural chemicals used in crop spraying operations, the investigation considered that the exposure to chemicals over time increased the likelihood of corrosion build up on adjacent airframe components such as the airframe fuel filter.

Additionally, the aircraft had previously operated in Australia, a region with predominantly dry, temperate conditions, before commencing operations in Papua New Guinea. Papua New Guinea's operating environment is characterised by high humidity and tropical temperatures, particularly for low-level agricultural operations. These environmental conditions are widely recognised to increase the likelihood of moisture exposure in aircraft fuel systems when routine protective measures, such as water draining or the application of corrosion-preventive treatments, are not conducted at regular intervals.

Appendix 5.5 (Corrosion Damage to Delphi 7111-296)

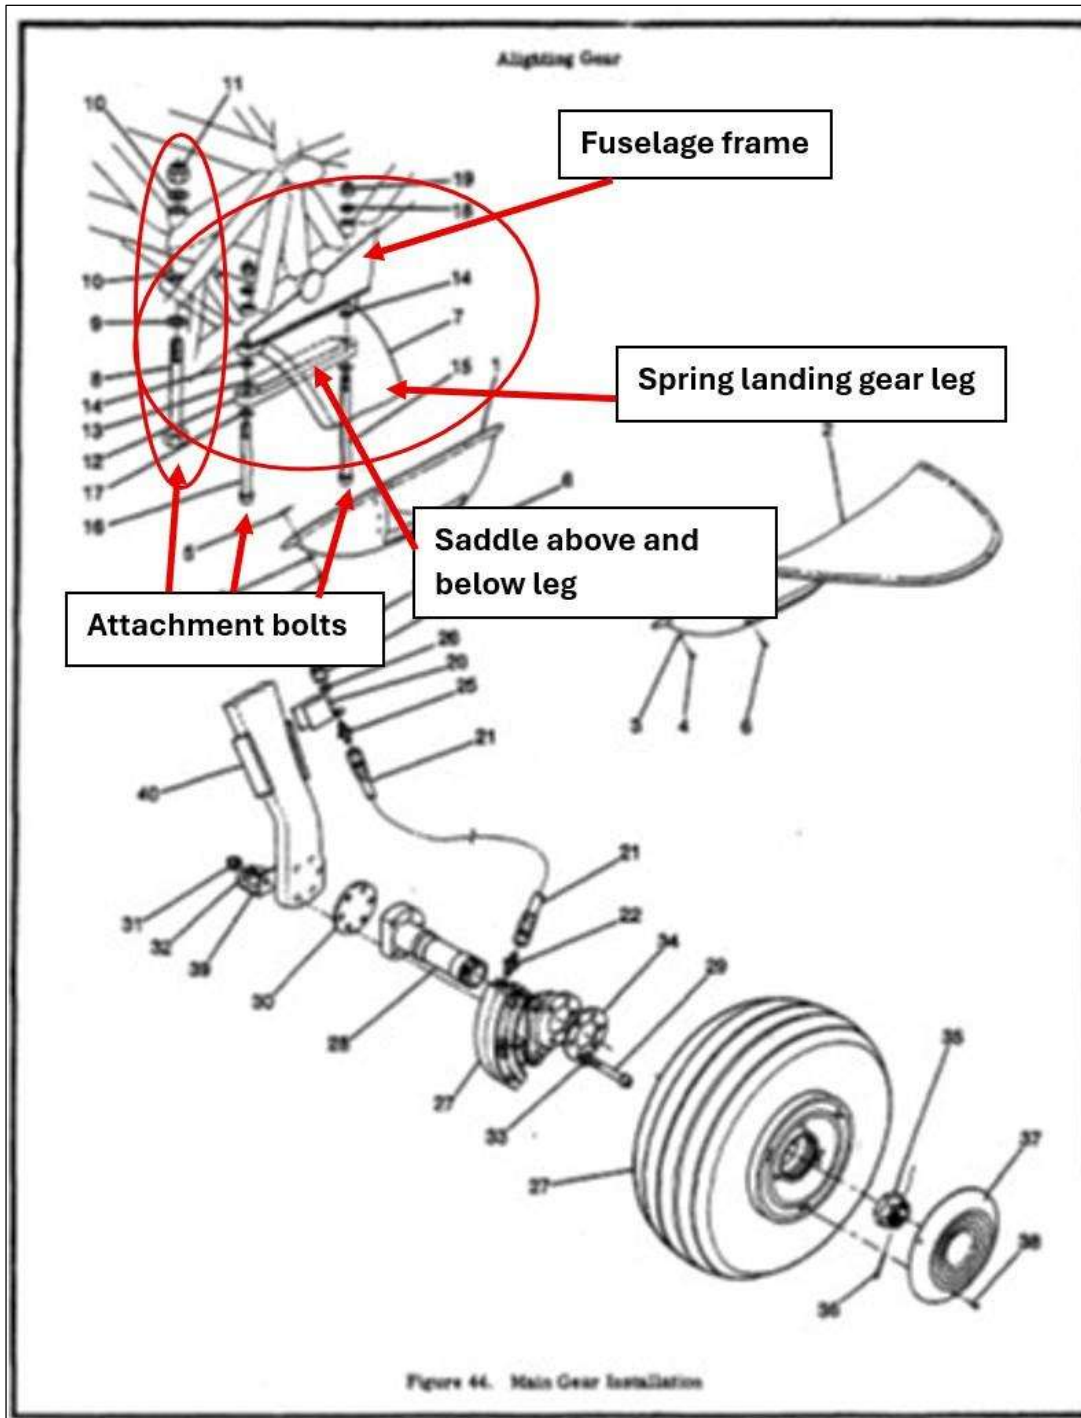
Appendix 5.6 Left main landing gear installation

The steel left main landing gear assembly separated from the airframe after tearing out of its steel attachment structure causing the belly of the aircraft to heavily contact the ground.

Left main landing gear tore out from structure in the area denoted by red ellipses.
