PRELIMINARY REPORT

AIC 18-1003

P2-NTZ

NOSE WHEEL SEPARATION ON LANDING

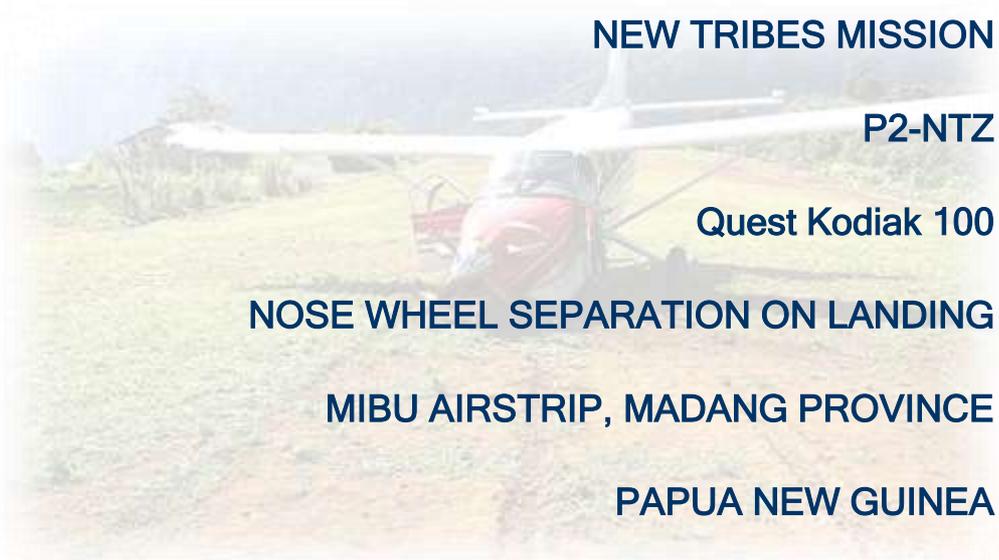
Aircraft bogged during landing roll - Nose landing gear failure

At about 23:25 UTC¹, during the landing roll, the aircraft's nose wheel sank into a soft patch on the strip surface. The aircraft came to an abrupt stop and the nose-wheel fork fractured on both sides of the oleo attachment plate resulting in the nose-wheel and nose-wheel fork assembly separating from the oleo. The pilots, the sole occupants, were not injured.

During the next landing roll the aircraft's nose wheel sank into the soft surface of the strip and became bogged. Subsequent substantial damage included the nose-landing gear, propeller, engine and cowling.
