FINAL REPORT
SERIOUS INCIDENT INVESTIGATION
AIC 17-2002

P2-502

CASA CN235-100M

Landed on closed runway

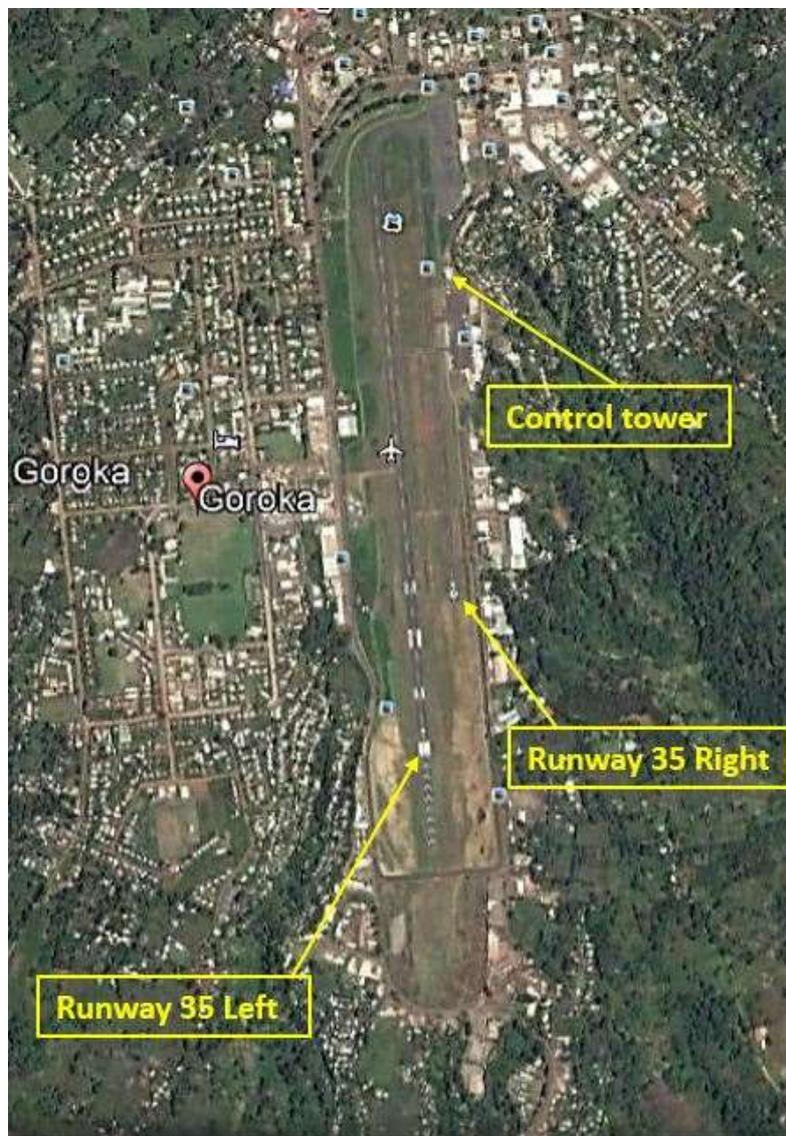
Figure 2. Goroka Airport

On 2 December 2017, at 04:12 UTC¹ (14:12 local), a CASA CN235-100M aircraft registered P2-502 using the call-sign Eagle 502 (Figure 1), owned and operated by the Papua New Guinea Defence Force, landed on a closed runway, runway 35 Left at Goroka Airport, Eastern Highlands Province. (Figure 2.) There were 31 persons on board, including two pilots and a pilot passenger who occupied the cockpit jump seat. None of the occupants were injured.
