**FINAL REPORT
AIC 18-1002**

**Air Vanuatu Operations Limited
YJ-AV71**

ATR 72-500

Loss of directional control during landing roll

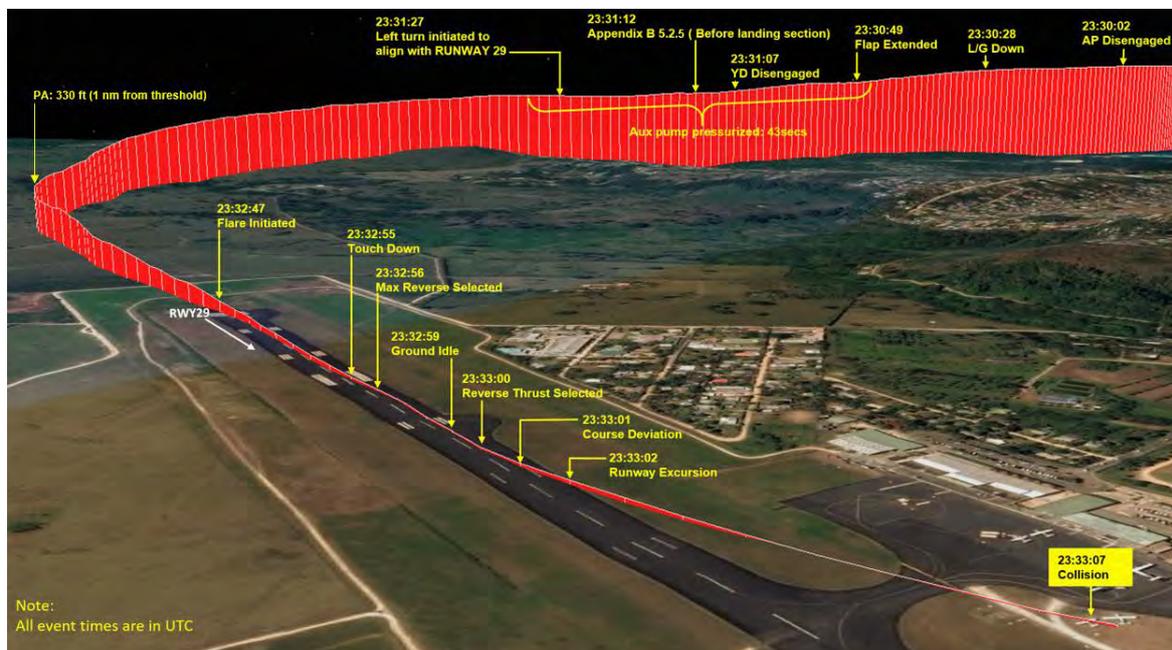
Figure 2: AV71 Approach and Landing

At 23:32:55, the aircraft touched down about 400 m past the runway 29 threshold near the runway touchdown zone (see *Figure 2*). The *power levers* were pulled into the maximum reverse thrust setting 1 second after touchdown.

The power levers remained in maximum reverse for 1 second before they were advanced back to ground idle. The speed started to decrease from 98 kts as the aircraft rolled down the runway. About 200 m further along the runway, at a speed of 65 kts, the *power levers* were pulled back into the reverse setting. The aircraft subsequently veered to the left and ran off the left of the runway and tracked 320 m over the grass field and across the taxiway before colliding with two parked, unoccupied, BN-2 aircraft (see *Figure 2*).

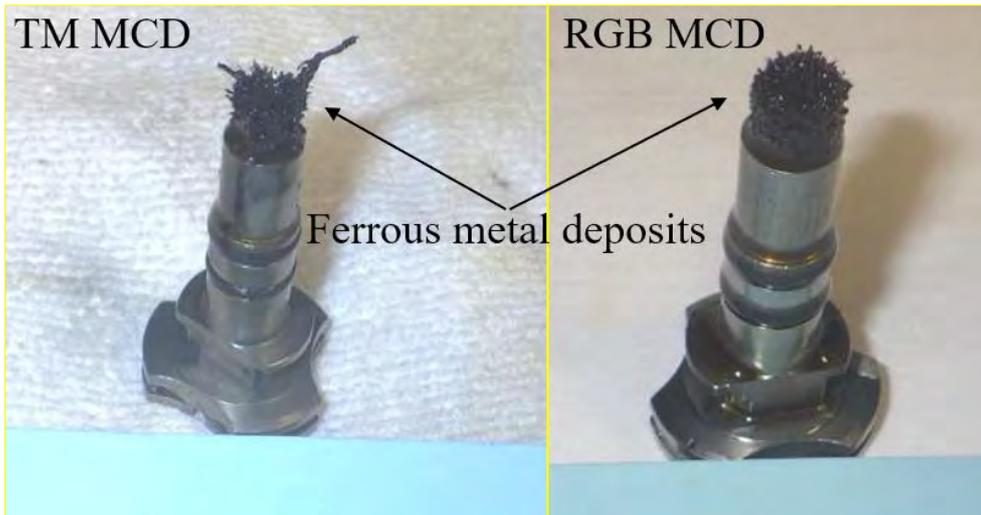
Figure 7: AV71 No. 2 engine magnetic chip detectors

The power turbine rotor rotated freely while the *low-pressure* and *high-pressure rotors* were seized. The *turbo machinery (TM)* and the *reduction gearbox (RGB) magnetic chip detectors (MCD)* had collected ferrous debris to a different extent (*see Figure 7*). The debris on the *MCD's* was collected and sent to the chemical laboratory for analysis and revealed metallic particles similar to M50 and similar to 400 series stainless steel.

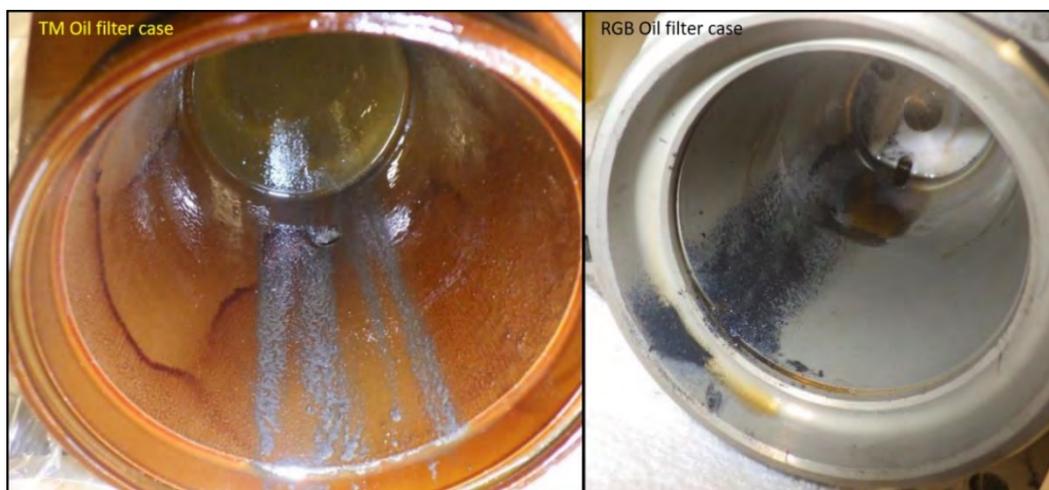
Figure 8: Oil filter cases

Metallic particles were also found in the *TM* and *RGB oil filters and cover (see Figure 8)*. The particles in the oil filter cover were collected and sent to the chemical laboratory for analysis and revealed metallic particles similar to M50 and similar to 400 series stainless steel.

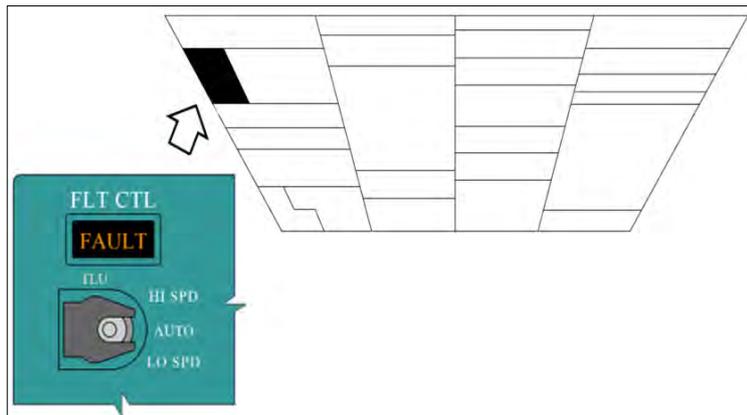
Figure 22: TLU FLT CTL and Fault Indicator (overhead panel)

With the *DC BTC* already isolated during the *QRH 'ELECTRICAL SMOKE'* checklist action when the *No. 2 engine* was shut down, the *TLU's* *AUTO* control function was lost. A fault light appeared next to the *TLU* switch on the overhead panel (see Figure 22). The *TLU* remained in the *HI-SPD* mode throughout the approach and landing. When the airspeed decreased below 180 kts, the crew were required to manually switch over to the *LO-SPD* setting to enable full rudder authority.

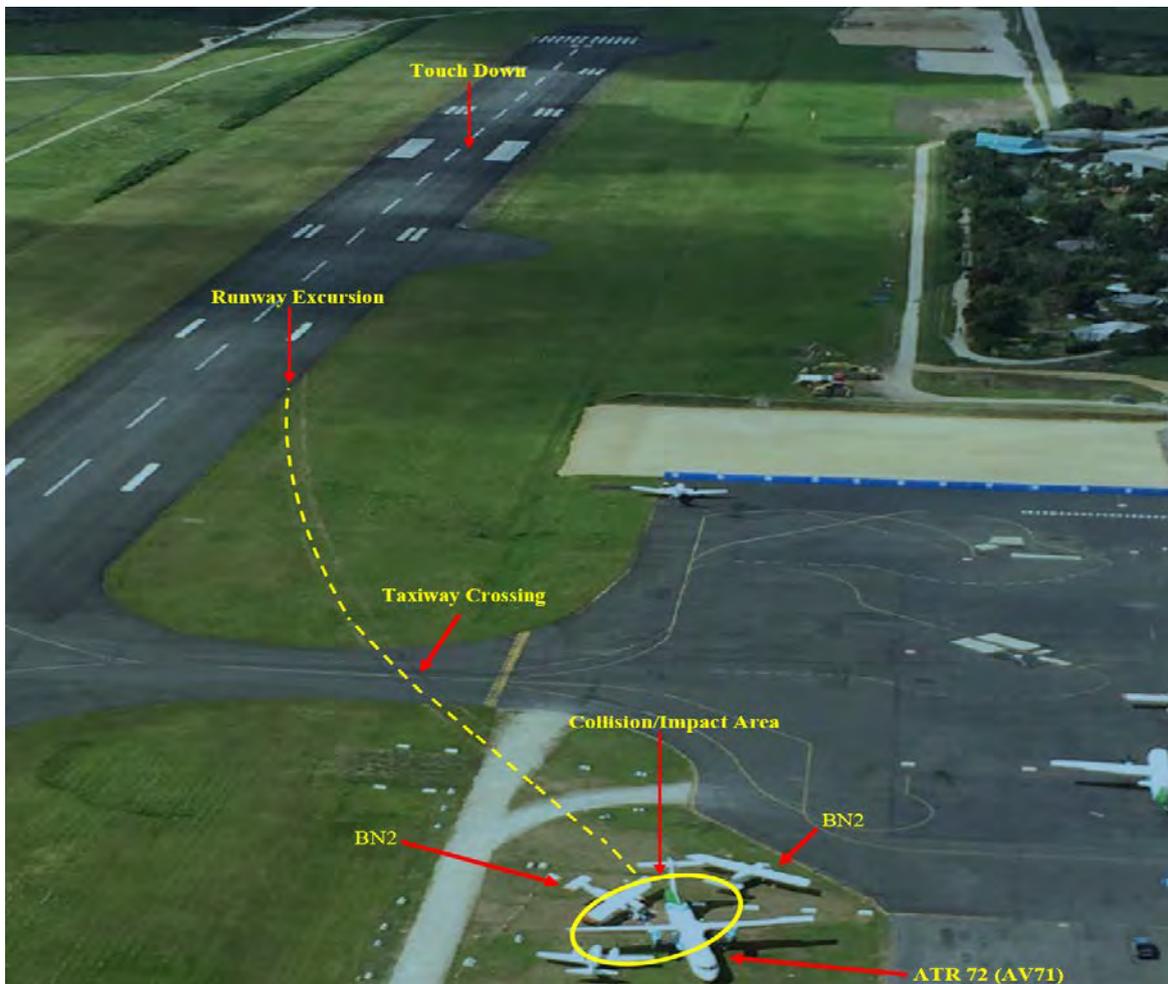
Figure 27: AV71 Runway Excursion

The aircraft touched down on runway 29 (290° M²⁴) near the landing zone, on its left main landing gear, followed by the right main and nose landing gear. It momentarily turned left with the initial application of reverse thrust for 1 second. That was followed by a right turn when the thrust was set to ground idle and the aircraft again lined up with the runway direction. About 200 metres further along the landing roll, approximately 8 seconds after the touchdown when maximum reverse thrust was applied, the aircraft veered left off the runway and rolled across the taxiway, slowing to 45 kts before it impacted the two Britten-Norman BN-2 Islander aircraft. Impact damage was more prevalent on the starboard side of AV71.

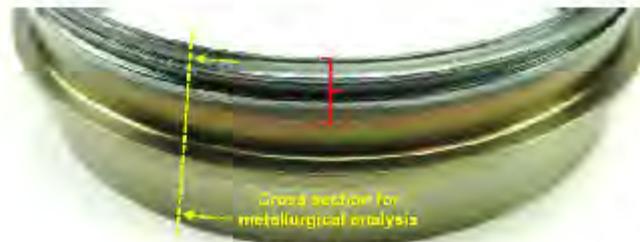
Photo No. 51

- 3.1 Visual examination of the No. 3 bearing rear spacer showed discoloration resulting from a high temperature exposure most probably created by the friction of within the No. 3 bearing inner race thrust side (Red bracket, Photo No. 51). Scanning electron microscope (SEM) of the cross section taken through the No. 3 bearing rear spacer using energy dispersive spectrum (EDS), semi-quantitative and standardless method showed the proportions of the major elements to be consistent with the drawing requirement (Photo No. 52).

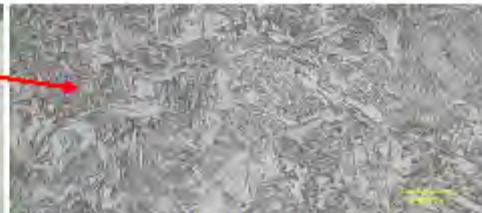
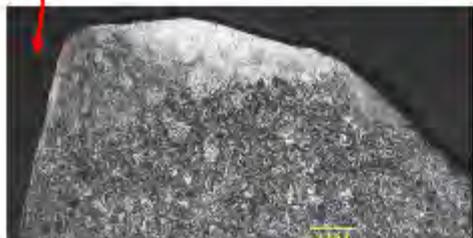
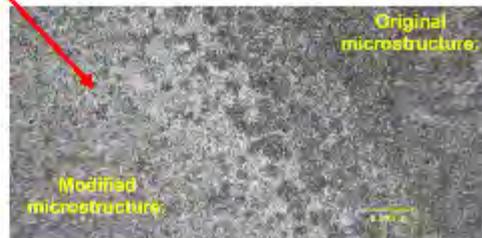
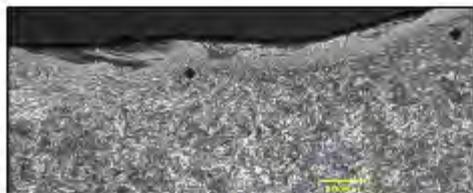
- 3.2 Magnified views of the cross section through the No. 3 bearing rear spacer showed the discoloration adjacent to the wear marks (red oval, Photo No. 53). The microstructure in the material and their relative hardness vary into the material. The material of the spacer hardened in the portion that was heated by friction transforming the tempered martensite into a re-hardened slightly tempered martensite and into an untempered as white martensite (Photos No. 54 to 58). The original microstructure in the non-affected zone revealed martensite as per drawing requirement. The hardness observed in the non-affected zone is as per drawing requirement. The hardness of the No. 3 bearing spacer becomes harder on the section that was heated.

Hardness	HV _{0.05}	-RC
Base Metal	205	-
Modified martensite / transition zone	115	42.1
White metal side	506	49.3
Cold work microstructure under wear groove	163	16.1

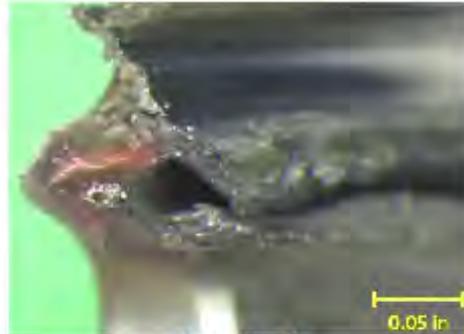
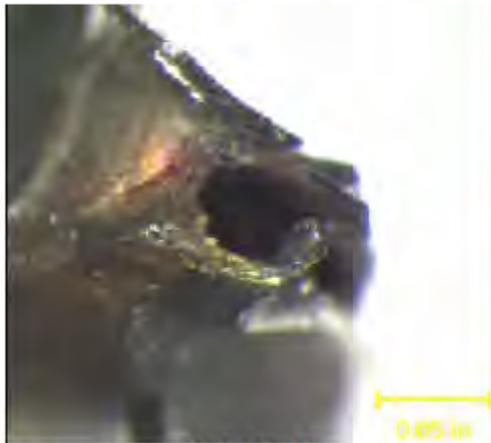
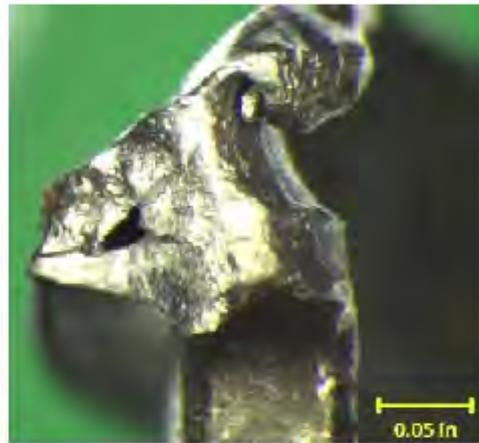
3.3 Visual examination of the No. 3 bearing air seal showed 6 fracture surfaces (yellow ovals, Photo No. 59). Magnified view of the fracture surfaces showed the extent of the damage on each of them. Almost all of the fractographic features have been obliterated by rubbing during the event (Photos No. 60 to 63).

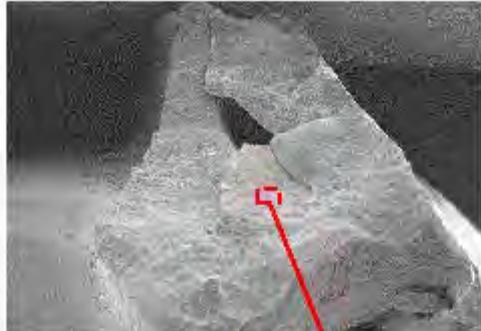
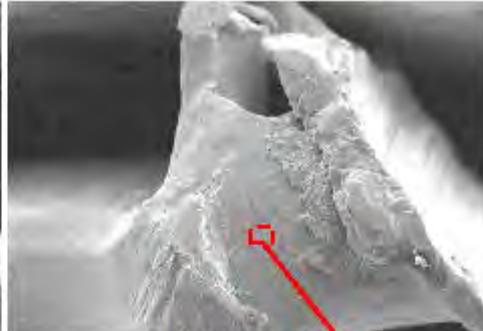
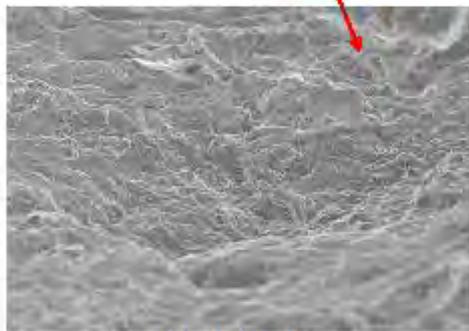
- 3.4 SEM view of two different fracture surfaces from the No. 3 bearing air seal showed dimples and no fractographic evidence of fatigue or any other progressive failure. These fractured surfaces suggest that they occur in overload and are secondary damage (Photos No. 64 to 67). The hardness of the No. 3 bearing air seal was within drawing limits.

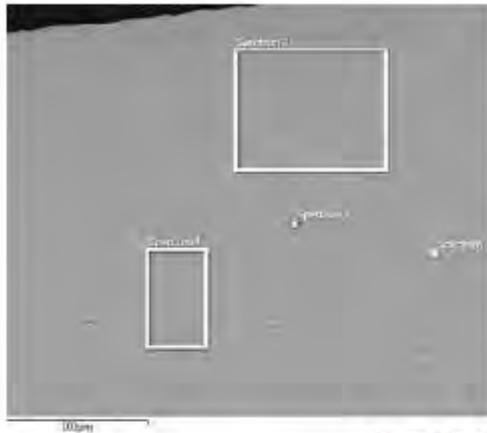
Photo No. 68

- 3.5 SEM magnified of the cross section taken through the No. 3 bearing air seal using EDS semi quantitative method showed that the proportions of the major alloying elements were as per drawing requirements (Photo No. 68).

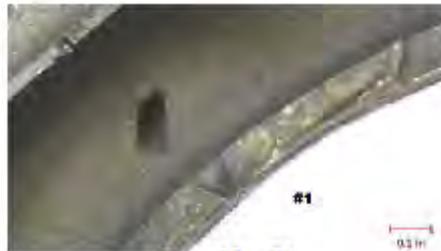
Photo No. 70

- 3.6 General views of the LP diffuser case showing the four fracture surfaces (Photo No. 69) at the No. 3 bearing stator seal web. Magnified view of the 4 fracture surfaces of interest showed that only one fracture surface revealed fractographic features (Photo No. 70). The other 3 fracture surfaces were completely obliterated during the event (Photos No. 71 to 73).

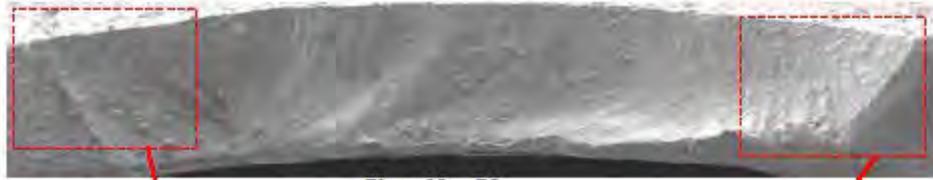
Photo No. 75

- 3.8 SEM view of the fracture surface No.1 showing the progression marks (white dotted line, Photo No. 76) and the suggested direction of the propagation which pointed to the origin at the external surface (Photo No. 75). SEM magnified view next to the origin revealed no material anomalies next to the origin. SEM magnified view of fracture surface on the opposite site revealed river lines, characteristic of final propagation of the fatigue crack (black arrow, Photo No. 77). The fracture surface suggests low nominal and cyclic stresses consistent with high cycle fatigue (HCF) typical of vibrations.

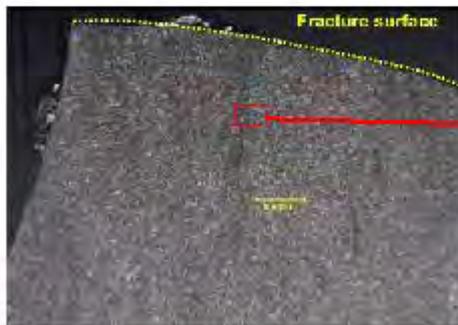
Photo No. 78

- 3.9 Microstructure view of the cross section through the suspected origin of the fatigue crack showed a tempered martensite (Photos No. 78 & 79) Micro hardness measurement taken is higher than the drawing requirement. Results of the SEM revealed that the proportions of the major alloying elements were consistent with the drawing requirements.

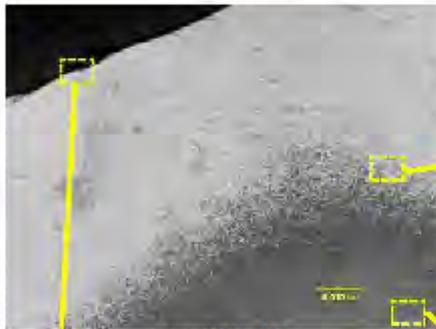
Photo No. 82

3.10 Visual examination of the No. 3 bearing outer ring showed transferred material on the raceway and discoloration on the flange most likely due to high temperature exposure (Photo No. 80). No evidence of crack was observed on the No. 3 bearing outer ring. Magnified view of the cross section taken through the outer race showing the microstructure modification due to high temperature exposure and rapid cooling near the track. The micro hardness measured in the modified microstructure is higher than the original tempered martensite (Photos No. 81 to 85). The transition zone exhibited the lowest hardness measured.

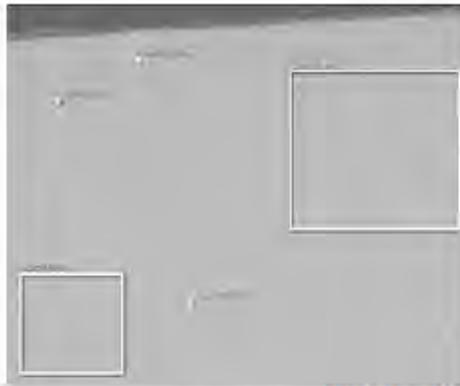
Photo No. 86

3.11 SEM magnified view of the cross section taken through the No. 3 bearing outer ring showing the analysed region using EDS semi quantitative and standardless method revealed that the major alloying material elements were consistent with the drawing requirements (Photo No. 86).

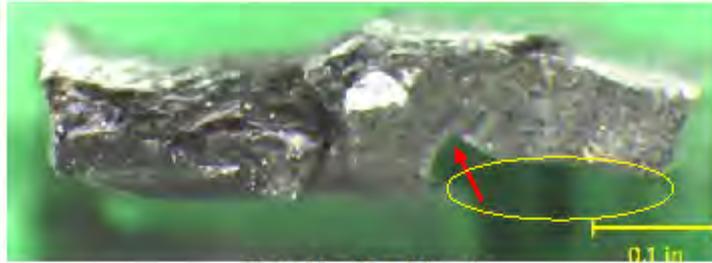
Photo No. 88 View A

- 3.12 Visual examination of the No. 3 bearing inner rings showed damage on the raceway and discoloration most likely due to high temperature exposure. The No. 3 bearing inner ring thrust side was fractured and distorted next to the fracture (Photo No. 87). Magnified view of the fracture surfaces on the No. 3 bearing inner race thrust side showed overload fracture characteristic. Missing material (yellow ovals) and groove (red arrows) were noticeable on the inner diameter of the No. 3 bearing inner ring thrust side shoulder (Photos No. 88 to 89).

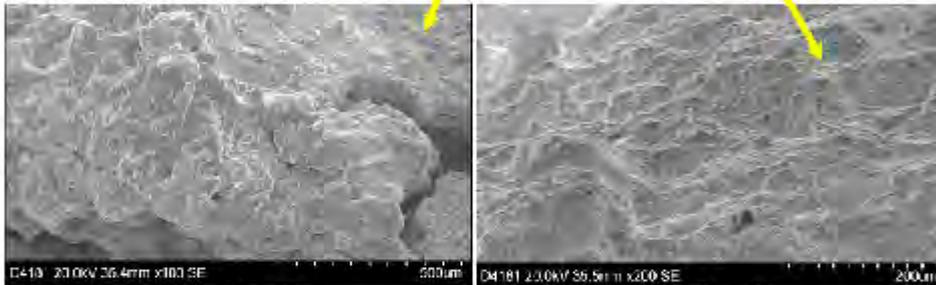
- 3.14 SEM view of the fracture surface of the inner ring (Photo No. 91) showing that the surface is mostly covered by splattered material covering the microfractographic features (Photo No. 92). A small section exhibited dimples characteristic of an overload fracture (Photo No. 93).

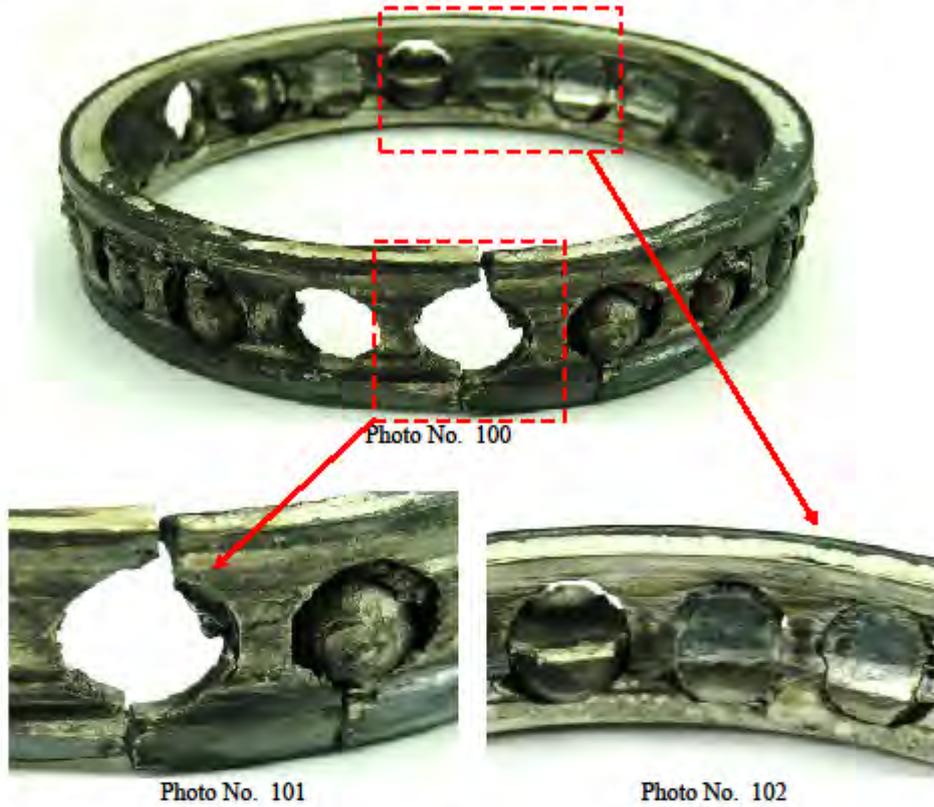
3.17 Visual examination of the No. 3 bearing cage showed the extent of the damage (Photo No. 100). The No. 3 bearing cage was fractured at 3 locations (Photo No. 101). The No. 3 bearing balls have been seized in the No. 3 bearing cage's pocket and worn down by the No. 3 bearing inner race thrust side (Photo No. 102).

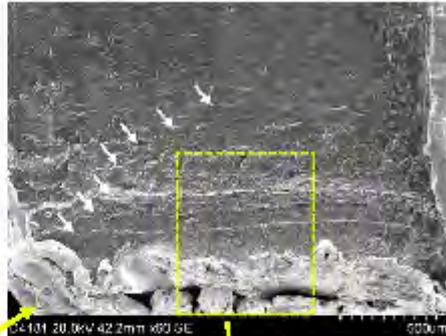
Photo No. 104

- 3.18 SEM magnified view of a No. 3 bearing cage fracture surface showing progression marks (white arrows) suggesting fatigue crack propagation initiated at the surface at the internal diameter of the cage (red arrows) and propagated toward the external diameter (Photos No. 103 to 105).

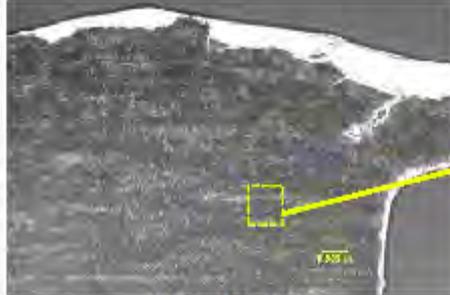
Photo No. 106

- 3.19 SEM magnified view of a cross section through the No. 3 bearing cage bearing showed a microstructure of martensite and the remnants of silver plating at the external surface (white layer, Photos No. 106 & 107). The average hardness of the No. 3 bearing cage is higher than the drawing requirements.

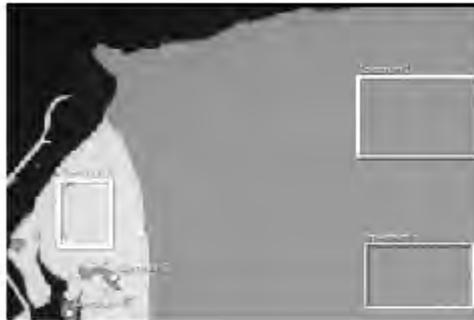
Photo No. 108

3.20 SEM-EDS using semi-quantitative and standardless method magnified view of the cross section through the cage pocket showing that the proportions of the major alloying elements were consistent with the drawing requirements (Photo No. 108).

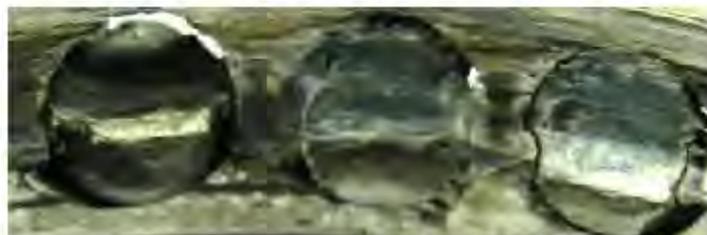
Photo No. 109

3.21 Visual examination of the No. 3 bearing balls showed the extent of the damage. The No. 3 bearing balls have been worn down by the No. 3 bearing inner ring thrust side and most of them have been seized within the No. 3 bearing cage's pocket (Photos No. 109 & 110).

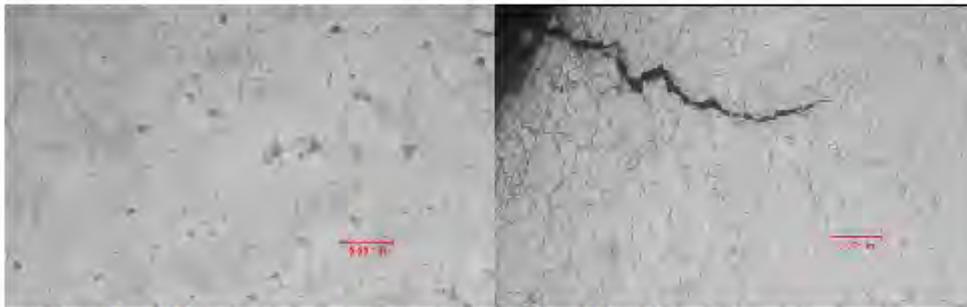
- 3.22 Magnified view of the cross section of a ball showing a microstructure consisting exclusively of untempered white martensite (Photos No. 111 & 112). The white martensite exhibited by the No. 3 bearing balls most likely resulted from high temperature exposure. Hardness measurement taken at the center of the balls were within the drawing requirement while the hardness measurement taken near the damage was lower than the drawing requirements.
