AIC 14-1001

**PAPUA NEW GUINEA
ACCIDENT INVESTIGATION COMMISSION
SHORT SUMMARY REPORT**

**Sunbird Aviation Limited
P2-SBC
Pilatus Britten Norman
BN2T Islander
Kikori Aerodrome, Gulf Province
PAPUA NEW GUINEA
23 April 2014**

Runway excursion – landing, involving Britten Norman Islander (Turbine) BN2T, P2-SBC

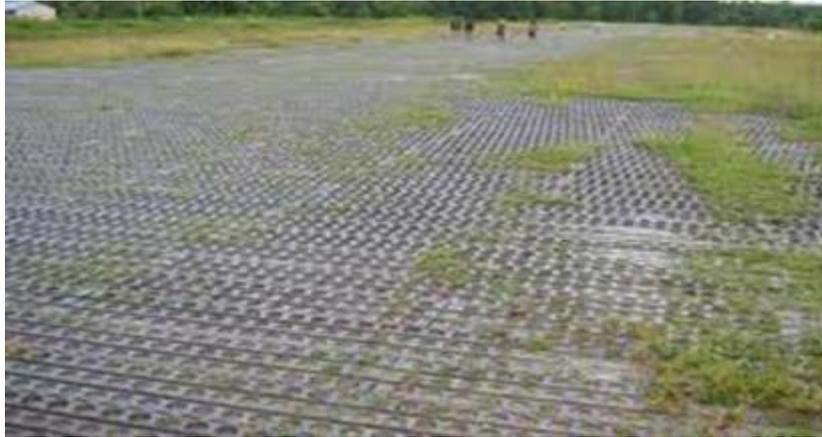
Figure 2: Steel Marsden matting⁴

The pilot, the sole occupant, taxied at Port Moresby at 2300. The aircraft departed Port Moresby at 2306 (90 minutes after the planned ETD) and climbed to 10,000 feet, and the pilot reported to air traffic control that he estimated Kikori at 0041. The pilot cancelled SARWATCH³ in the circuit area at Kikori at 0040. He informed the Accident Investigation Commission (AIC) that he joined the circuit upwind (see Fig. 3) for a left downwind and, after completing the pre-landing checks, set up for a landing on runway 30. The pilot reported that, after touchdown, he held the nose wheel off the ground. He stated that the initial landing and roll-through on the steel matting surface were normal (see Fig. 2).
